ALERT SERVICE BULLETIN

412-24-197

- MODEL AFFECTED:** 412/412EP
- SUBJECT:** CAP ANGLE, P/N 212-030-191-001, SPECIAL INSPECTION INTERVAL, REDUCTION OF.
- HELICOPTERS AFFECTED:** **PART I:** Serial numbers 33001 through 33213, 34001 through 34036, 36001 through 36693.

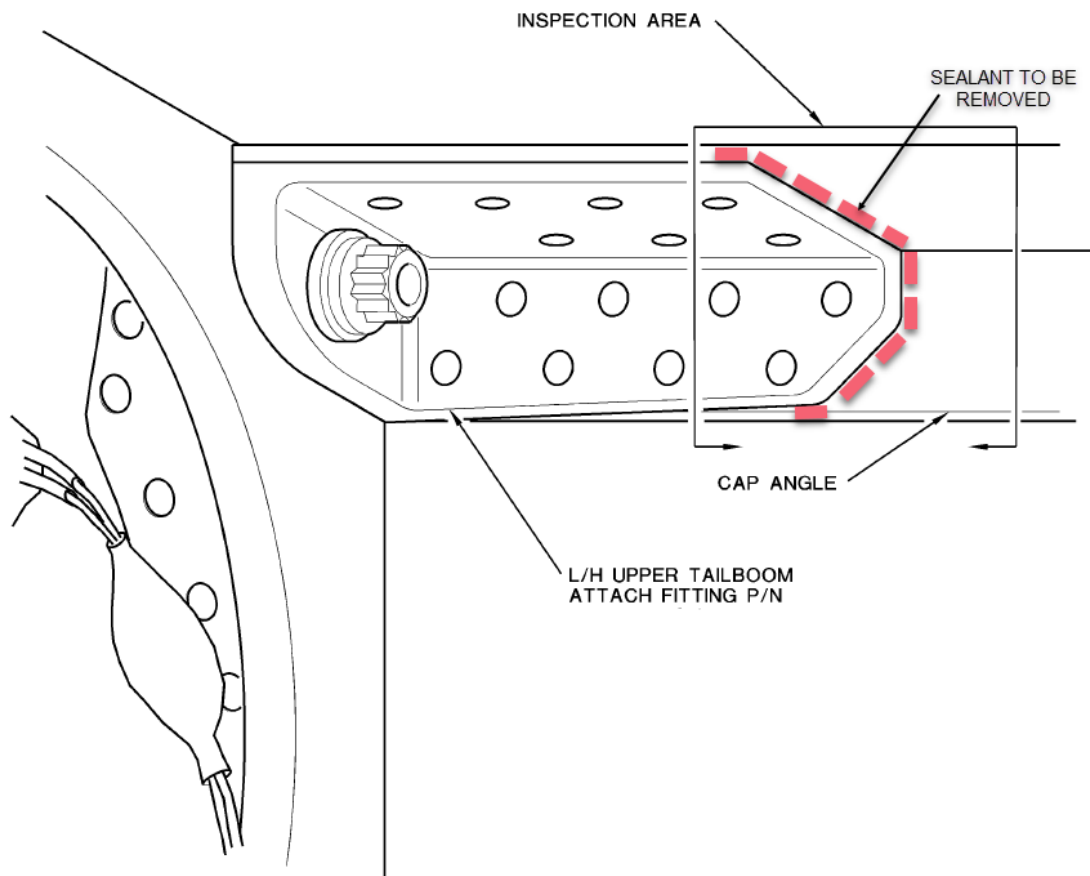
Figure1. Fuselage Tailboom Attachment Inspection.

Bell has investigated reports of fractured 212-030-191-001 cap angles. Some were found during routine inspection and some during the scheduled 100 Hours Tailboom Attachment Inspection. The investigation indicates that the 100 flight hour Special Inspection interval established in 2000, introduced by the ASB 412-00-100 and the FAA AD 2000-18-09, is not adequate to detect all cracks before complete fracture of the cap angle.

2. If sealant is present, remove sealant from edge of fitting (Figure 1).
3. Inspect the cap angle area shown with a 10x magnifying glass and bright light.

4. If a crack is found, replace the cap angle before further flight. If the helicopter is at a location where the cap angle cannot be replaced, contact Product Support Engineering.
5. Touch up primer if damaged during sealant removal. Paint touch up is optional. Do not reapply sealant.
6. If no cracks are found, the helicopter can be returned to service.
7. Make an entry in the helicopter logbook and historical service records indicating findings and compliance with this Alert Service Bulletin.
