ALERT SERVICE BULLETIN

412-24-198

MODEL AFFECTED: 412EP

SUBJECT: UPPER LEFT HAND TAILBOOM ATTACHMENT FITTING, SEALANT REMOVAL OF.

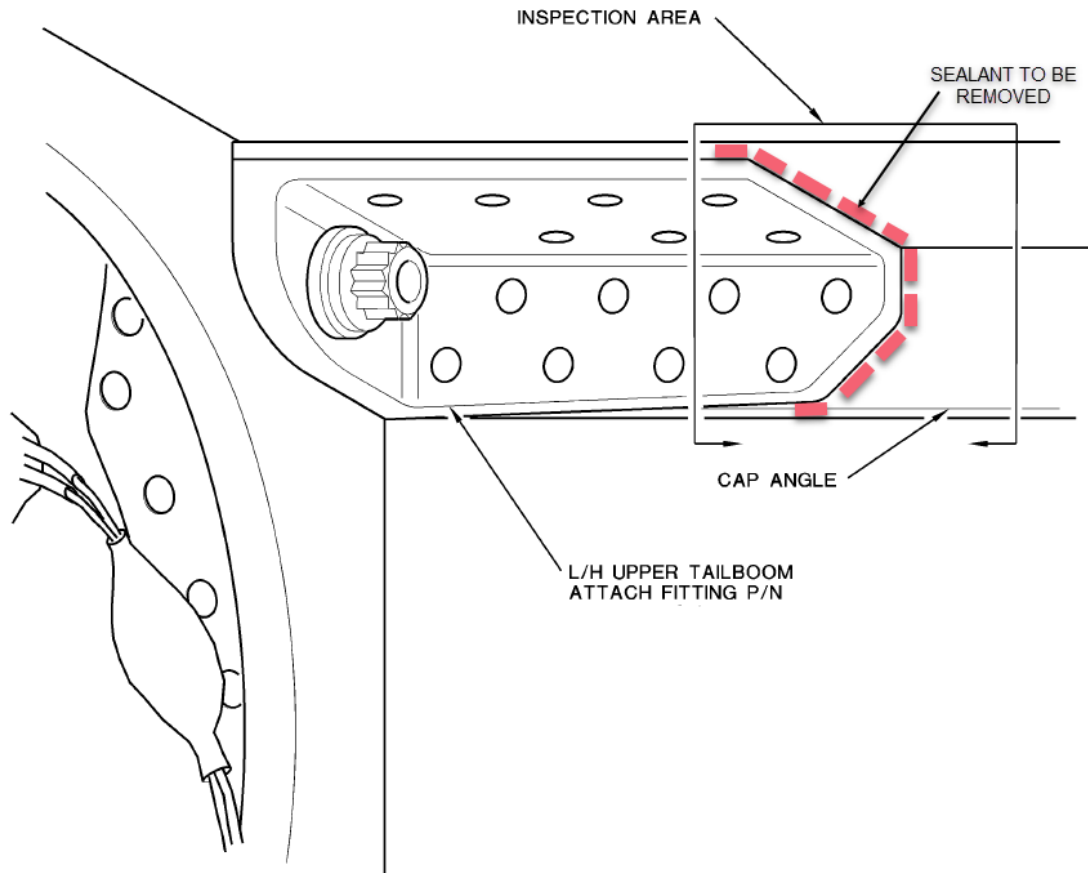
Figure1. Fuselage Tailboom Attachment Fitting Sealant Removal.

During manufacture, sealant may have been applied at the edge of the 212-030-501-101 left hand upper tailboom attach fitting where it contacts the 212-030-191-001 cap angle. This bulletin mandates the removal of the sealant to allow for proper inspection of the cap angle.

2. If sealant is present, remove sealant from edge of fitting (Figure 1).
3. Touch up primer if damaged during sealant removal. Paint touch up is optional. Do not reapply sealant after inspection.
4. Make an entry in the helicopter logbook and historical service records indicating compliance with this Alert Service Bulletin.
