ALERT SERVICE BULLETIN

206L-20-185
16 November 2020

MODEL AFFECTED: 206L Series

SUBJECT: MAIN ROTOR BLADES P/N 206-015-001-115 /-117 /-119 GRIP PLATES AND ROOT END DOUBLERS, INSPECTION OF.

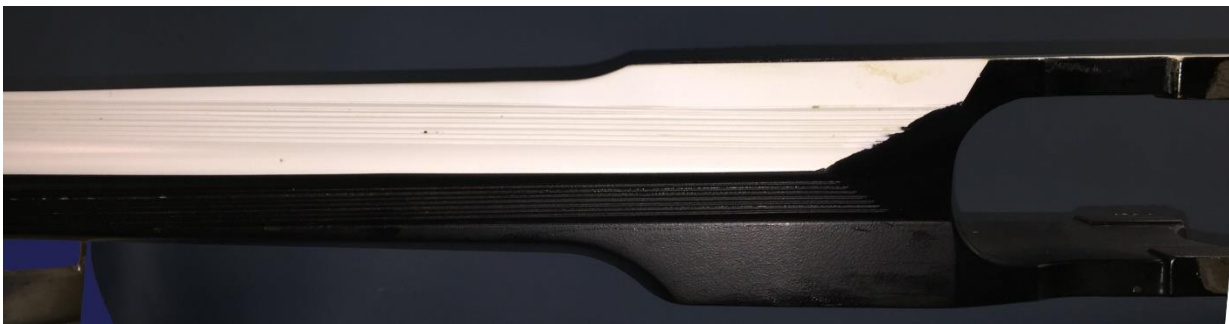
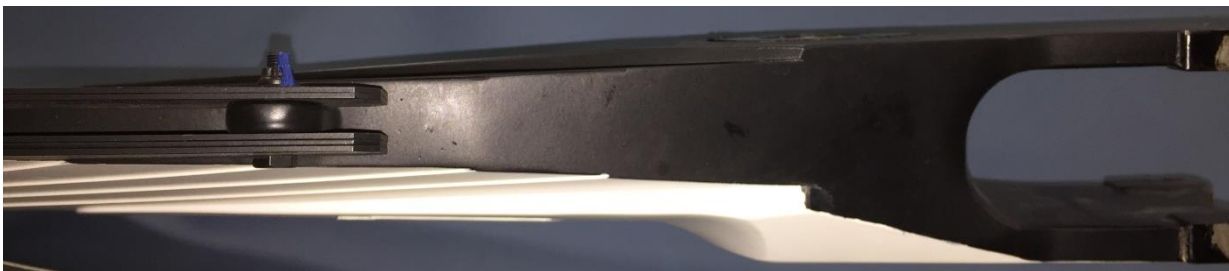
Any potential cracks in the bond lines between the doublers or grip plates will be indicated by the presence of excess alcohol bleeding out of an edge void. This excess alcohol in the void will appear as a dark line between the bond lines of the doublers. Proceed with the inspection of an area immediately after the alcohol wipe.

Figure 2. Inspect the leading edge from STA 15.0 to STA 58.0 and trailing edge from STA 15.0 to STA 56.0 of the blade for crack between each doublers and the grip plates.

- c. If cracks in the finish are found between doublers, grip plates and skin edges, sand the affected area in a spanwise direction with an abrasive cloth or paper (C-406) 180 to 220 grit to determine if the grip plate/doublers are cracked or voided.

- d. If any edge voids are found between doublers, grip plates and skin, determine the depth and length with a 0.0015 inch (0.038 mm) feeler gauge. If edge voids are suspected near the outboard tip of the doublers and grip plate, carry out a tap test of the affected area. Refer to the Maintenance Manual for limits and repair instructions (BHT-206L-MM-1, Chapter 65; BHT-206L1-MM-1, Chapter 65; BHT-206L3-MM-1, Chapter 62 or BHT-206L4-MM-1, Chapter 62). If any void is found outside of limits, contact Product Support Engineering.
