## **ALERT SERVICE BULLETIN**

**206L-23-188**

**MODEL AFFECTED:** 206L, 206L-1, 206L-3 and 206L-4

**SUBJECT:** HORIZONTAL STABILIZER AND CARGO HOOK FITTINGS – SELF LOCKING INSERTS, INSPECTION OF

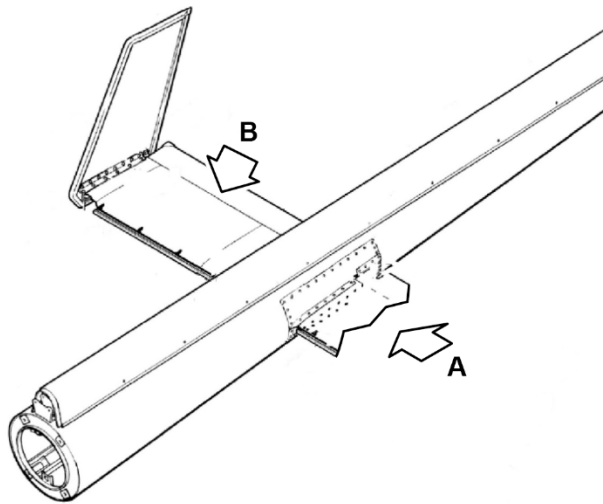
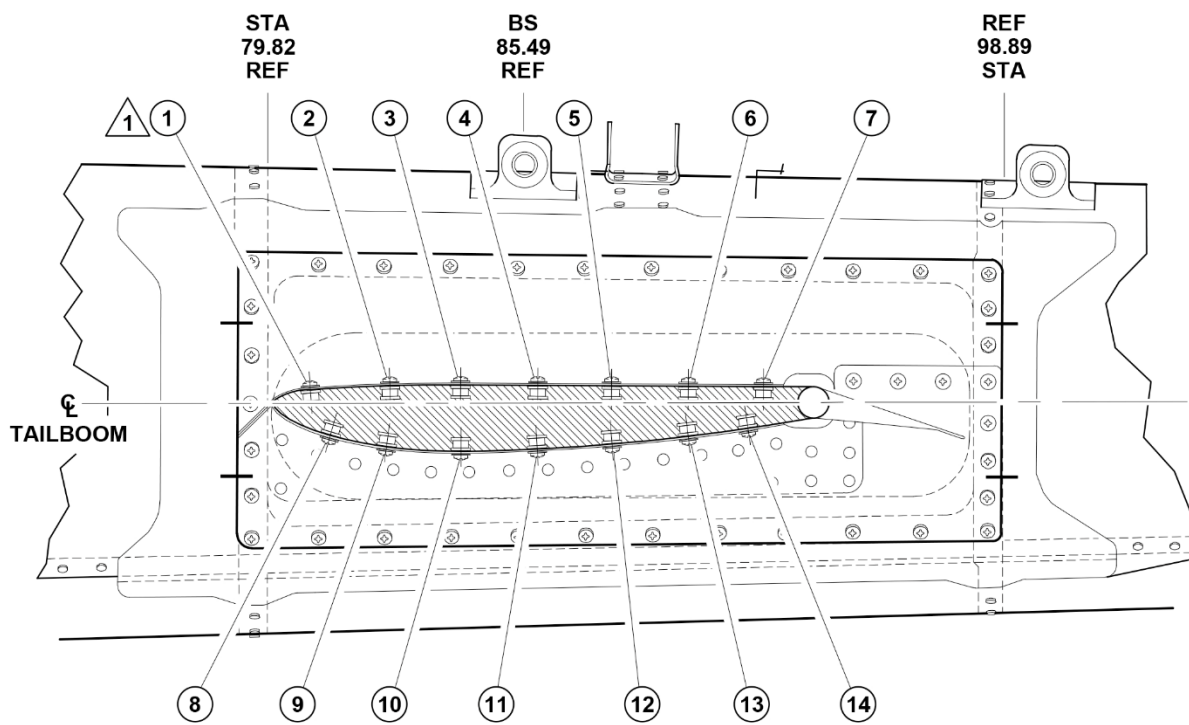
**Figure 1 (Sheet 1 of 2) – Horizontal Stabilizer Inspection**

A gap under the screw head, cracks in the paint around the screw head, loose washer or black fretting dust could indicate fastener looseness.

- a. Fasteners (Qty 28) attaching the horizontal stabilizer to the tailboom (Figure 1, Sheet 1).
  - b. Fasteners (Qty 16) attaching the slats to the horizontal stabilizer (Figure 1, Sheet 2).

- a. Remove the fastener and measure the tare torque of the insert (BHT-ALL-SPM Chapter 2, Section 2). The minimum tare torque of the inserts shall be 2.0 inch-pounds (0.23 Nm).

- b. If the tare torque of the insert meets the minimum value, re-install the fastener (BHT-206L-MM, Chapter 53).
  - c. If the tare torque of a specific insert is below the minimum value, do the following:

- (1) Replace the existing fastener with a new one.
    - (2) Measure the tare torque as per step 8.a.
    - (3) If the tare torque is sufficient, install the new fastener. (BHT-206L-MM, Chapter 53)

- (4) If the tare torque is not sufficient, apply a drop of low strength threadlocker Loctite 080 (C-320) on the threads of the new fastener, install the fastener and apply a stripe of torque seal lacquer (C-049) on the affected fastener. (BHT-206L-MM, Chapter 53)

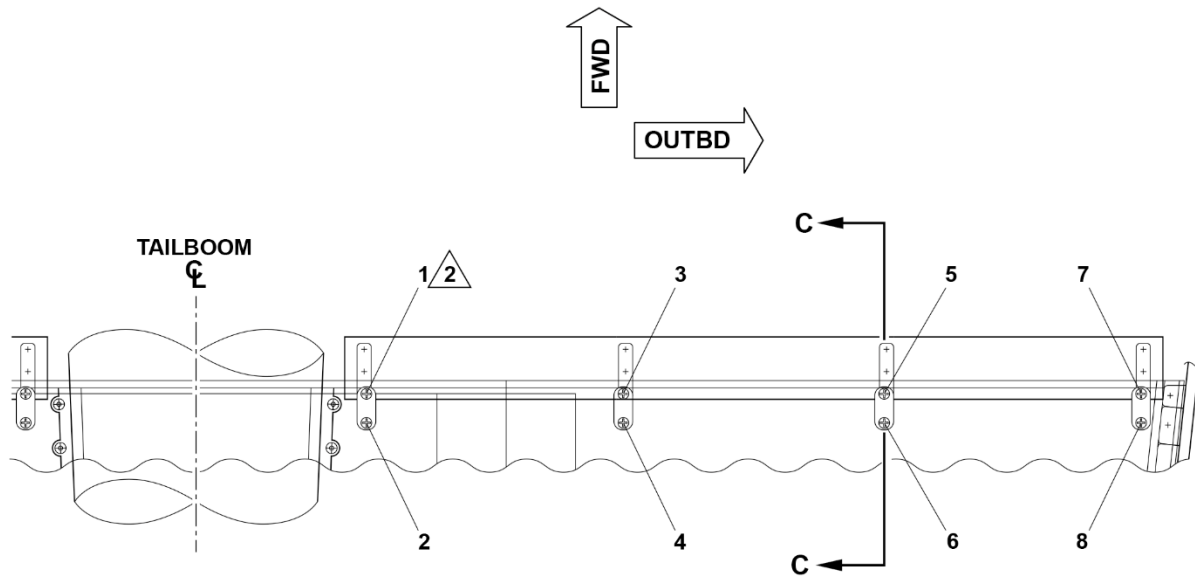
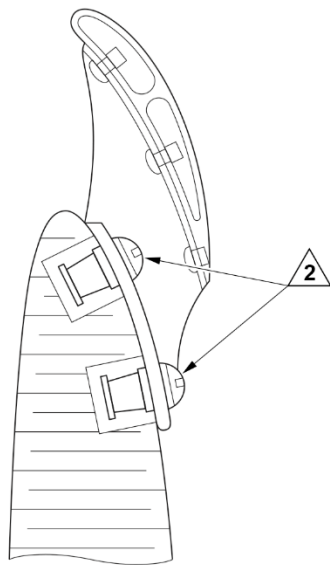
**Figure 1 (Sheet 2 of 2) – Horizontal Stabilizer Inspection**

**1** Inspect at 14 locations on LHS and RHS
-

**2** Inspect at 8 locations on LHS and RHS

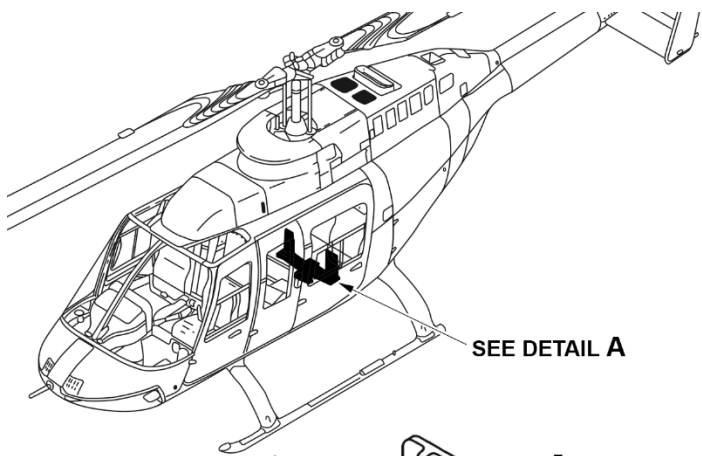
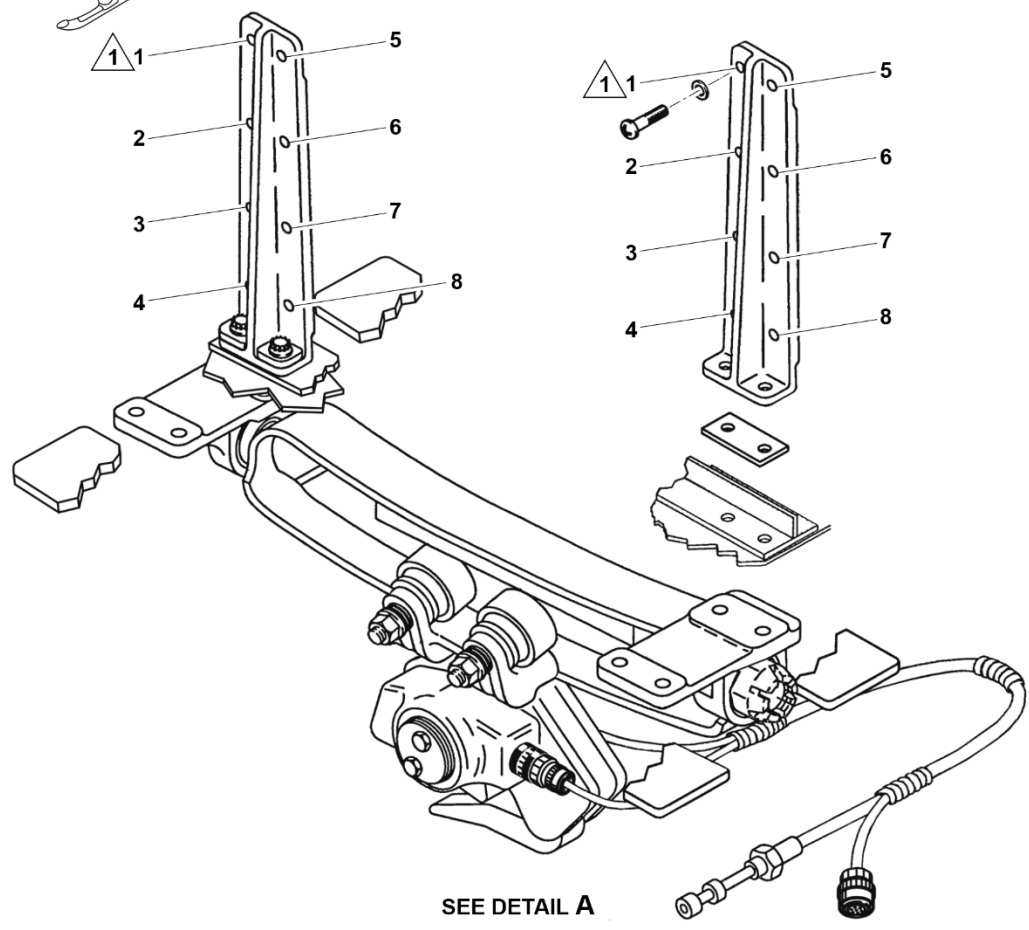
**Figure 2 – Cargo Hook Fittings Inspection**

5. Verify the tare torque on the attaching fasteners (Qty 16) of the cargo hook fittings on the passenger seat bulkhead (Figure 2) as follow. Verify one fastener at a time. (BHT-206-SI-2012)
  - a. Measure the tare torque of the insert (BHT-ALL-SPM Chapter 2, Section 2).
  - b. The minimum tare torque of the inserts shall be 2.0 inch-pounds. (0.23 Nm).
6. If the tare torque of a specific insert does not meet the minimum value, do the following for each discrepant insert:
  - a. Remove and discard the screw installed in the discrepant insert. Retain washer if it is serviceable.
  - b. Remove and discard a screw installed in a vertically adjacent insert. Retain washer if it is serviceable.

**NOTE**  
 1 Inspect at 8 locations on LHS and RHS

- c. Install new bolts NAS6603H4 with one washer NAS1149D0332J at the locations where the original screws were discarded.
  - d. Torque the bolts to 20-25 inch-pounds (2.3-2.8 Nm) plus tare torque.
  - e. Safety the new bolts together using (C-405) safety wire (BHT-ALL-SPM, Chapter 8).
7. Torque all other disturbed fasteners to 20-25 inch-pounds. (2.3-2.8 Nm) plus tare torque.
