ALERT SERVICE BULLETIN

206L-23-188

MODEL AFFECTED: 206L, 206L-1, 206L-3 and 206L-4

SUBJECT: HORIZONTAL STABILIZER AND CARGO HOOK FITTINGS – SELF LOCKING INSERTS, INSPECTION OF

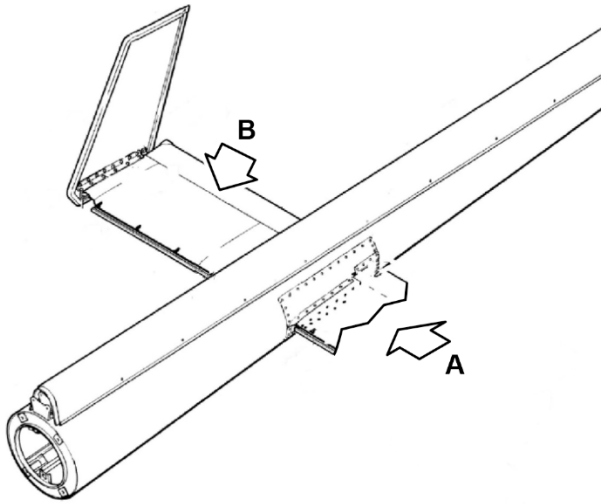
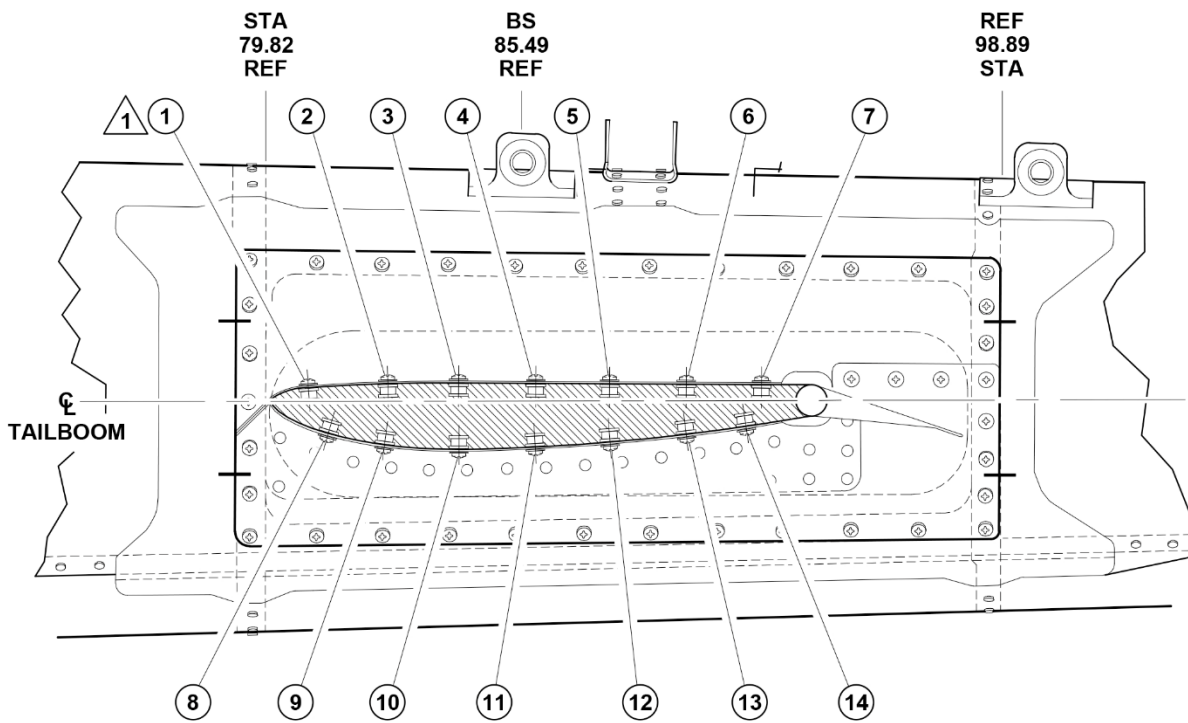
Figure 1 (Sheet 1 of 2) – Horizontal Stabilizer Inspection

Bell was made aware that some self-locking inserts installed on the horizontal stabilizer and inserts of the cargo hook fitting attachments may potentially have been damaged during assembly. The self-locking feature of the affected inserts could potentially be below the minimum tare torque value.

A gap under the screw head, cracks in the paint around the screw head, loose washer or black fretting dust could indicate fastener looseness.

6. Perform a visual inspection of the following horizontal stabilizer fasteners for signs of looseness:
 - a. Fasteners (Qty 28) attaching the horizontal stabilizer to the support (Figure 1, Sheet 1).

8. If any sign of fastener loosening is detected at the horizontal stabilizer to support attachment, perform the following for every suspected insert:
 - a. Remove the fastener and measure the tare torque of the insert (BHT-ALL-SPM Chapter 2, Section 2). The minimum tare torque of the inserts shall be 2.0 inch-pounds (0.23 Nm).

- b. If the tare torque of the insert meets the minimum value, re-install the fastener (ASB 206L-99-115, Part III, Step 38).
 - c. If the tare torque of a specific insert is below the minimum value, do the following:

- (1) Replace the existing fastener with a new one (ASB 206L-99-115, Part III, Step 38).
 - (2) Measure the tare torque as per step 8.a.
 - (3) If the tare torque is sufficient, install the new fastener (ASB 206L-99-115, Part III, Step 38).

- (4) If the tare torque of the horizontal stabilizer to support is not sufficient, apply a drop of low strength threadlocker Loctite 080 (C-320) on the threads of the new fastener and a layer of sealant (C-251) on the shank of the screw (ASB 206L-99-115, Part III, Step 38). Install the fastener and apply a stripe of torque seal lacquer (C-049) on the affected fastener.

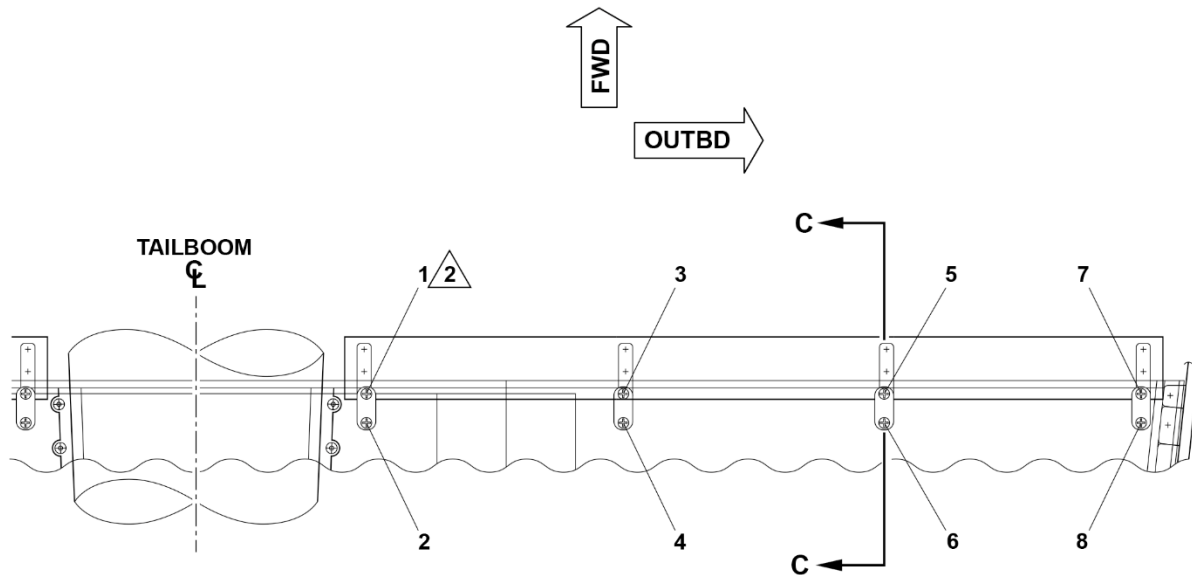
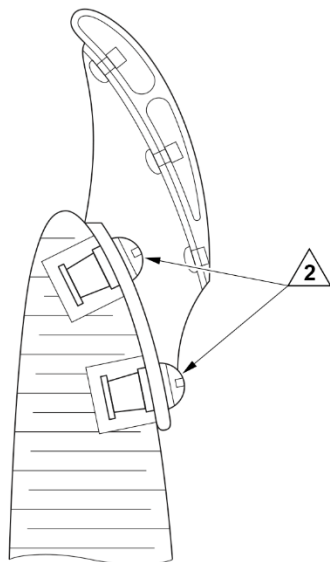
Figure 1 (Sheet 2 of 2) – Horizontal Stabilizer Inspection

- b. Fasteners (Qty 16) attaching the slats to the horizontal stabilizer (Figure 1, Sheet 2).
7. If there are no signs of fastener loosening, proceed to step 11.

9. If any sign of fastener loosening is detected at the slats to horizontal stabilizer attachment, perform the following for every suspected insert:
 - a. Remove the fastener and measure the tare torque of the insert (BHT-ALL-SPM Chapter 2, Section 2). The minimum tare torque of the inserts shall be 2.0 inch-pounds (0.23 Nm).

- b. If the tare torque of the insert meets the minimum value, re-install the fastener (BHT-206L-MM, Chapter 53).
 - c. If the tare torque of a specific insert is below the minimum value, do the following:

- (1) Replace the existing fastener with a new MS27039-1-06 screw.
 - (2) Measure the tare torque as per step 9.a.
 - (3) If the tare torque is sufficient, install the new fastener. (BHT-206L4-MM, Chapter 53)

- (4) If the tare torque of the fasteners attaching the slats to the horizontal stabilizer is not sufficient, apply a drop of low strength threadlocker Loctite 080 (C-320) on the threads of the new fastener. Install the fastener and apply a stripe of torque seal lacquer (C-049) on the affected fastener (BHT-206L4-MM, Chapter 53).

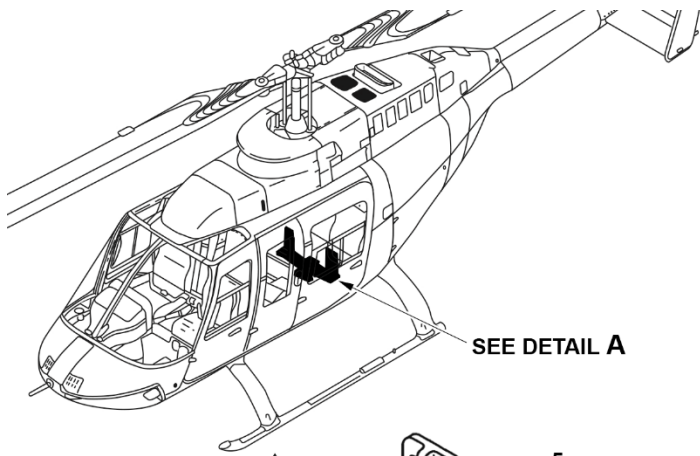
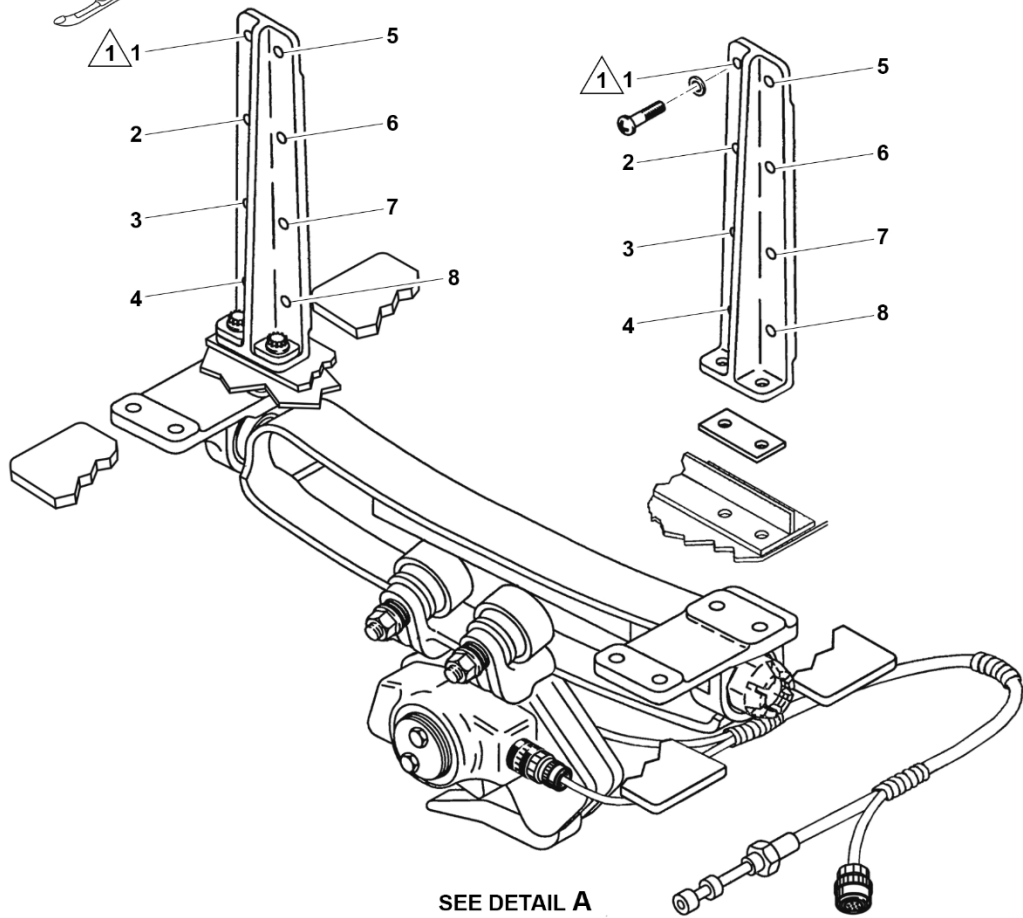
Figure 2 – Cargo Hook Fittings Inspection

PART II of this bulletin applies only to the aircraft fitted with the cargo hook provisions kit. It mandates an inspection of the fasteners attaching the cargo hook fittings and safetying of the fasteners if required.

5. Verify the tare torque on the attaching fasteners (Qty 16) of the cargo hook fittings on the passenger seat bulkhead (Figure 2) as follow. Verify one fastener at a time. (BHT-206-SI-2012)
 - a. Measure the tare torque of the insert (BHT-ALL-SPM Chapter 2, Section 2).
 - b. The minimum tare torque of the inserts shall be 2.0 inch-pounds. (0.23 Nm).
6. If the tare torque of a specific insert does not meet the minimum value, do the following for each discrepant insert:
 - a. Remove and discard the screw installed in the discrepant insert. Retain washer if it is serviceable.
 - b. Remove and discard a screw installed in a vertically adjacent insert. Retain washer if it is serviceable.

- c. Install new bolts NAS6603H4 with one washer NAS1149D0332J at the locations where the original screws were discarded.
 - d. Torque the bolts to 20-25 inch-pounds (2.3-2.8 Nm) plus tare torque.
 - e. Safety the new bolts together using (C-405) safety wire (BHT-ALL-SPM, Chapter 8).
 - f. Torque all other disturbed fasteners to 20-25 inch-pounds. (2.3-2.8 Nm) plus tare torque.
7. If inserts with tare torque below the minimum requirement are found, report the results to Product Support Engineering at productsupport@bellflight.com.
8. Make an entry in the helicopter logbook and historical service records indicating compliance with **PART II** of this Alert Service Bulletin.
