ALERT SERVICE BULLETIN

214-12-73
25 May 2012

MODEL AFFECTED: 214B/B-1

SUBJECT: MAIN ROTOR HUB ASSEMBLY SPINDLE ASSEMBLY, P/N 214-010-103, MANDATORY INSPECTION AND OVERHAUL REQUIREMENTS.

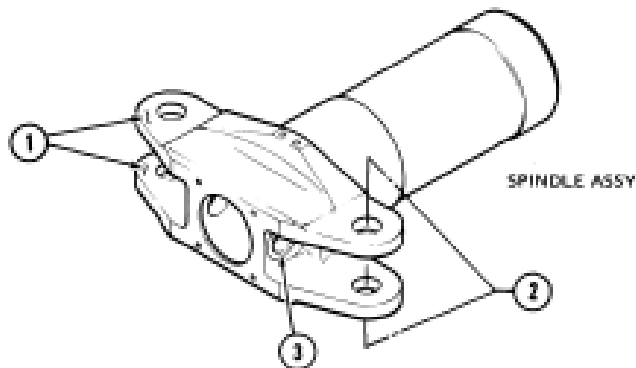
Figure 65-7. Main Rotor Hub Conditional Inspection (Sheet 4 of 6)

NO.	ITEM	REUSE SPINDLE	SCRAP SPINDLE-STRAPS-PINS	SCRAP HUB ASSY
	NOMENCLATURE			
1	Spindle lug faces, eight places	No visible deformation on lug face when checked with a straight edge	Any visible deformation on both sides of a lug when checked with a straight edge	
2	Spindle to yoke attachment bushings	Unworn 214-040-129 pin shall fit through the spindle tangs without interference. Hole round within 0.0005 inch.	Any significant bind or looseness. Out-of-round exceeds 0.0005 inch.	
3	Strap Pin Hole	Hole round within 0.0005 inch.	Out-of-round exceeds 0.0005 inch.	Out-of-round exceeds 0.0015 inch with larger dimension in a spanwise direction.

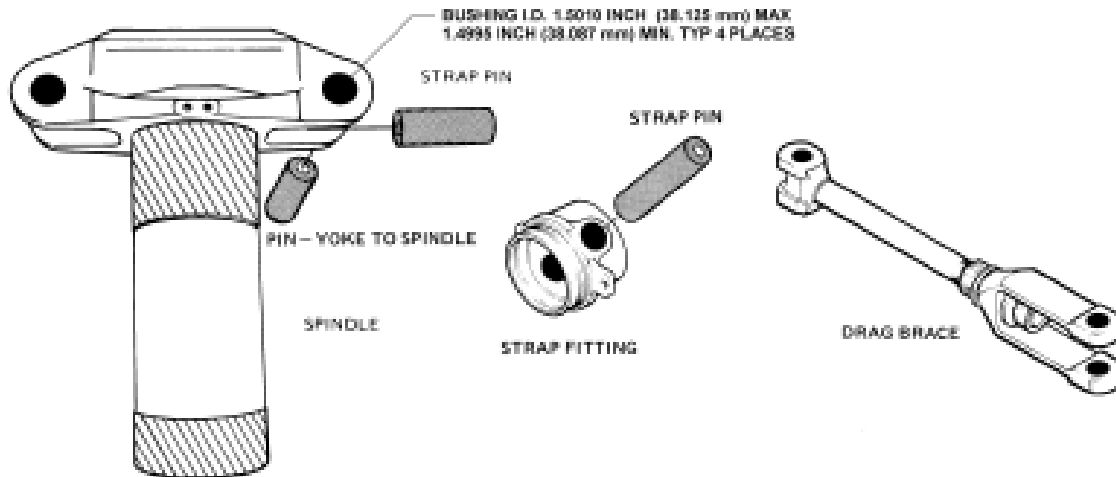
Figure 65-8. Main Rotor Hub Mechanical and Corrosion Damage Limits (Sheet 2 of 7)

TYPE OF DAMAGE	MAXIMUM DEPTHS AND REPAIR AREAS		
	0.001 Inch (0.0254 mm)	0.010 Inch (0.254 mm)	0.004 (0.1016 mm)
MECHANICAL DAMAGE	0.001 Inch (0.0254 mm)	0.010 Inch (0.254 mm)	0.004 (0.1016 mm)
CORROSION DAMAGE	0.001 Inch (0.0254 mm)	0.010 Inch (0.254 mm)	0.004 (0.1016 mm)
MAXIMUM AREA PER FULL DEPTH REPAIR	0.50 Inch Square (322.88 mm sq)	Not Critical	0.50 Inch Square (322.88 mm sq)
NUMBER OF REPAIRS	Two	Not Critical	Two Per Shaded Area
EDGE CHAMFER	0.010 Inch (0.254 mm)	0.040 Inch (1.016 mm)	0.010 Inch (0.254 mm)
MOUNT BOLT BORE DAMAGE:	0.001 Inch for 1/4 of Circumference, size limits apply.		
CRACKS:	No cracks allowed.

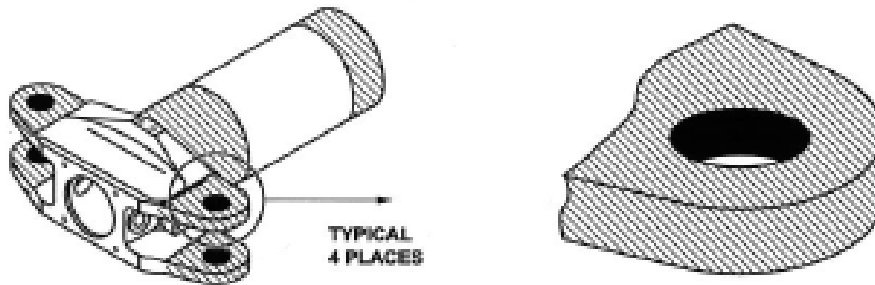
Figure 65-8. Main Rotor Hub Mechanical and Corrosion Damage Limits (Sheet 3 of 7)

MECHANICAL DAMAGE	0.010 INCH (0.254 mm)	0.004 INCH (0.1016 mm)
CORROSION DAMAGE	0.010 INCH (0.254 mm)	0.004 INCH (0.1016 mm)
MAXIMUM AREA PER FULL DEPTH REPAIR	NOT CRITICAL	0.50 SQ. INCH (322.588 sq. mm)
NUMBER OF REPAIRS	NOT CRITICAL	TWO PER SHADED AREA
EDGE CHAMFER	0.040 INCH (1.016 mm)	0.010 INCH (0.254 mm)
BUSHING BORE DAMAGE: ● DAMAGE MAY BE WORKED TO DIMENSIONS SHOWN BELOW ONLY.		
BORE DIAMETER		
(BUSHING REMOVED) - STANDARD 1.6875 to 1.6980 INCH (42.862 to 42.875 mm)

- OVERSIZE 1.7075 to 1.7180 INCH (43.376 to 43.383 mm)		
CRACKS:	NO CRACKS ALLOWED

Measured twice (90° apart) at top and bottom of each hole.
-

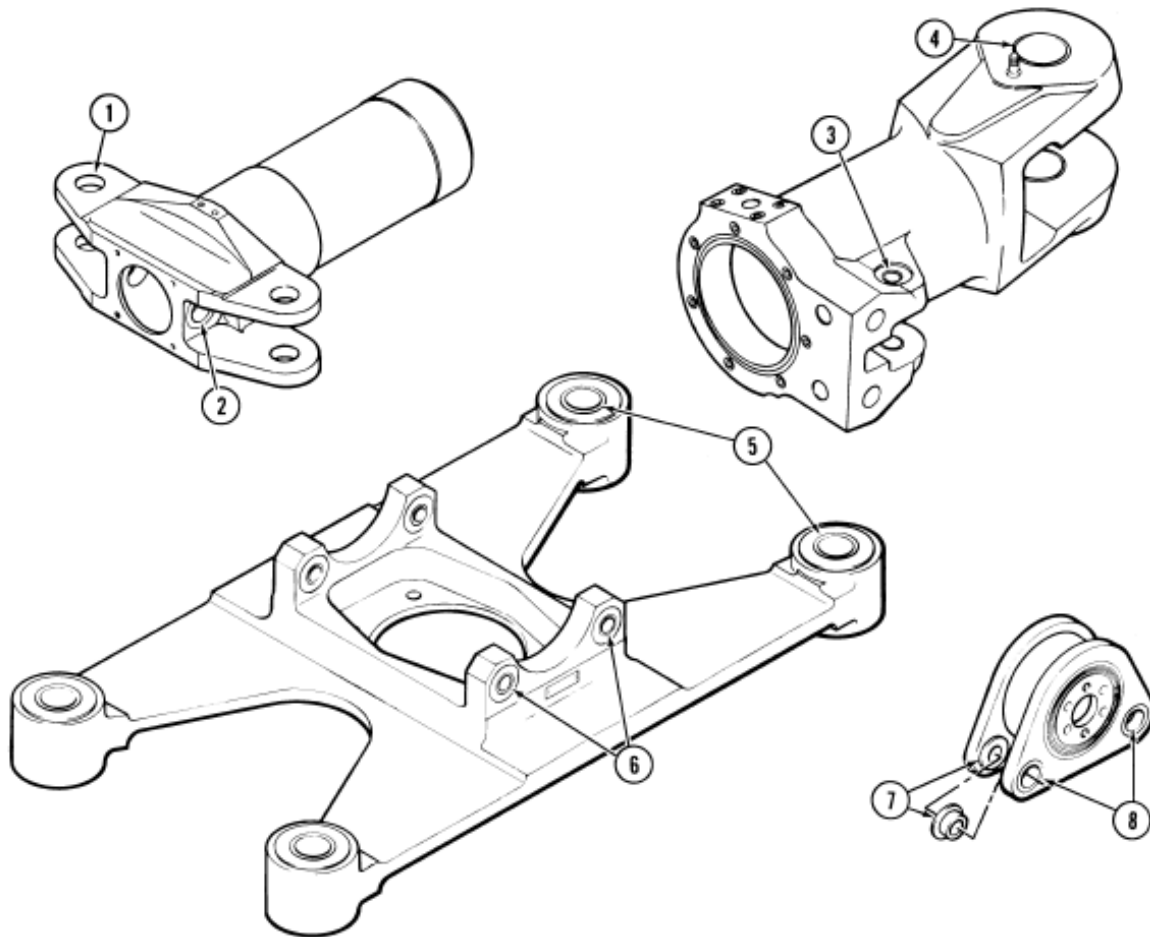
Figure 65-9. Main Rotor Hub Hole Wear Limits (Sheet 1 of 2)

HOLE NO.	NOMENCLATURE	HOLE DIAMETER	
		MIN.	MAX.
1	Bushings, Spindle to Yoke	1.4995	1.5010
2	Hole, Strap Pin	1.625	1.6265
3	Bushings, Drag Brace Installation	1.000	1.002
4	Bushings, Main Blade Bolt	2.875	2.877
5	Bushings, Spindle Installation	1.4995	1.5005
6	Bushing, Bearing Installation	0.7495	0.7505
7	Bushing, Bearing to Yoke	0.7495	0.7510
8	Bushing, Slip Bushing Installation	1.0000	1.0015
