ALERT SERVICE BULLETIN

214-13-74

MODEL AFFECTED: 214B/B-1

SUBJECT: P/N 214-040-606-005/-101 TAIL ROTOR HANGER BEARING, INSPECTION AND REPLACEMENT OF

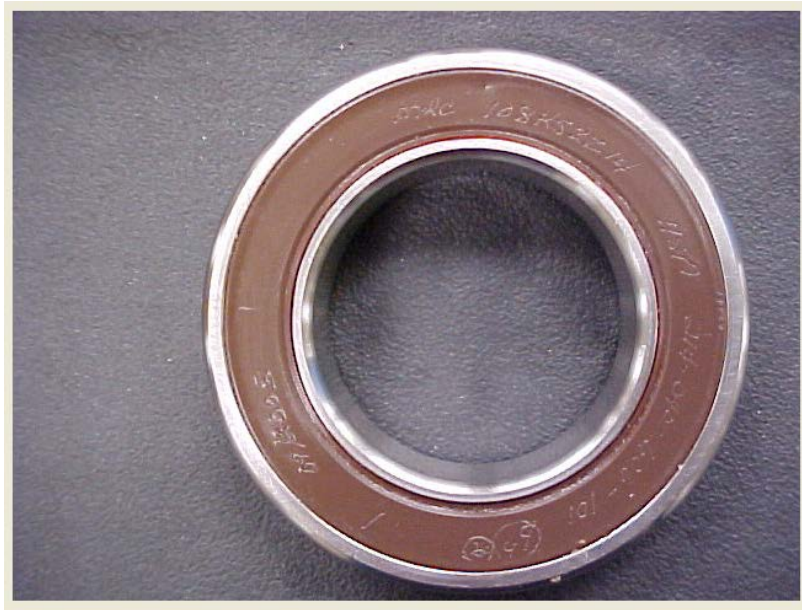
FIGURE 1

- a. The correct seal material will have a red/orange to brown color. As necessary, gently wipe the face of the seal with a clean cloth to remove any dried grease or dirt. Inspect both sides of the bearing.

BEARING SEALS MADE WITH THE CORRECT MATERIAL
WILL HAVE A RED/ORANGE TO BROWN COLOR

- b. Incorrect seal material will have a black color.
2. Bearings with the correct seal material (red/orange to brown in color) are acceptable and may be continued in service without further action.

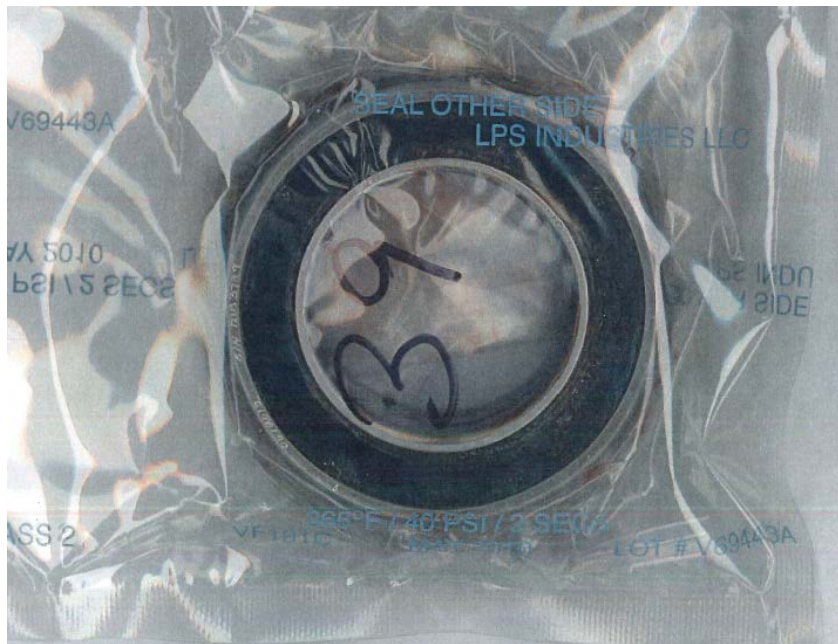
Bell Helicopter has been notified by its supplier that all P/N 214-040-606-005/-101 bearings delivered to Bell Helicopter between May 2011 and June 2012 were manufactured with the wrong seal material. This seal material does not meet the Bell operating/environmental temperature specifications and under extreme conditions could result in seal failure and grease loss. Defective bearings can be identified by a black colored seal. Bearings with the correct seal material will have a red/orange to brown colored seal.

BEARING SEALS MADE WITH THE INCORRECT MATERIAL
WILL HAVE A BLACK COLOR

3. Bearings with the wrong seal material (black) are to be disposed of as follows:
 - a. Bearings installed on the helicopter:
 - (1) Inspect each bearing with black seals for leakage/slung grease and/or evidence of damage to the bearing.

- (a) Grease leakage and/or evidence of bearing damage requires the bearing to be removed from service before further flight.
 - (b) If there is no evidence of grease leakage or bearing damage, the bearing may be continued in service subject to a visual inspection each 10 flight hours until replacement of the bearing is accomplished in accordance with Part 2. Inspect per paragraph 3.a.(1) above.

1. All installed bearings with defective seals must be replaced within 500 flight hours after receipt of this ASB or by 31 December 2013, whichever occurs first.
2. Refer to 214B Maintenance and Component Repair and Overhaul Manuals for replacement procedures.
