**ALERT SERVICE BULLETIN**

**214-18-77**

**MODEL AFFECTED:** 214B/B-1

**SUBJECT:** MAIN DRIVESHAFT OUTER COUPLING 214-040-659-005, INSPECTION OF.

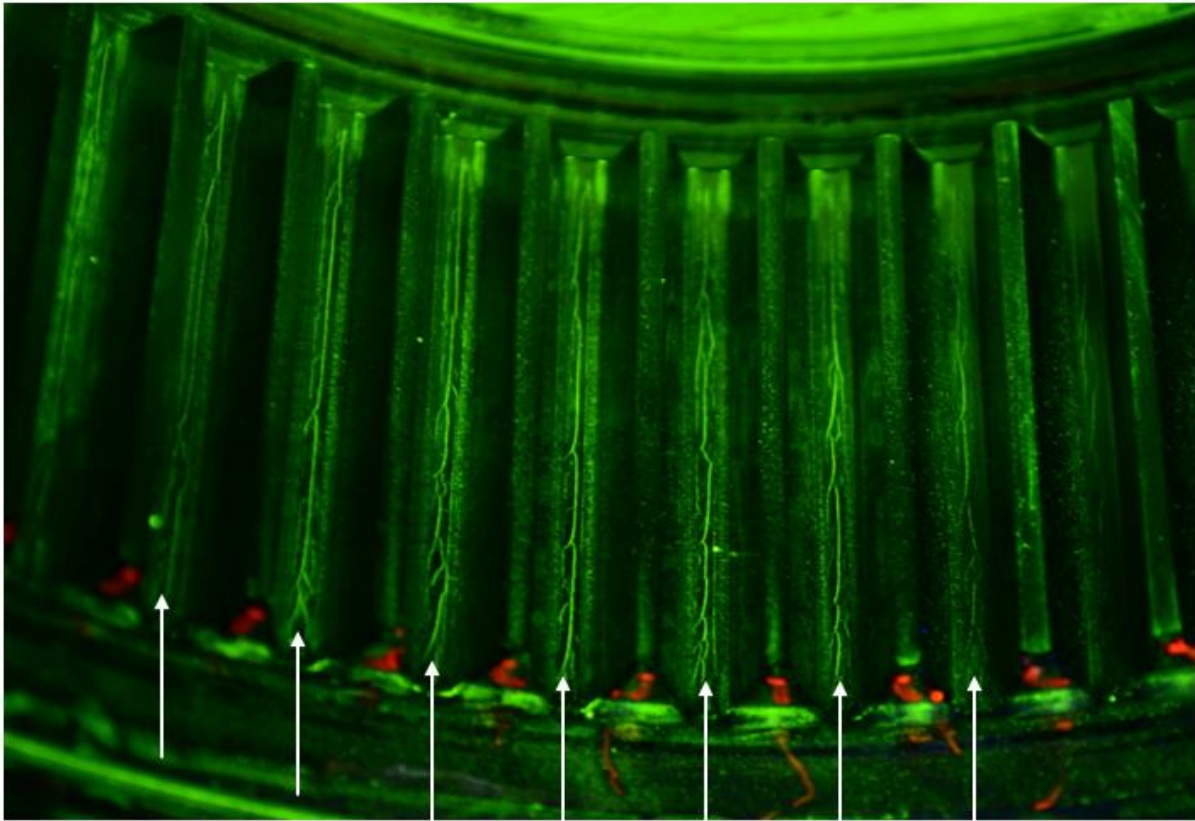
Figure 1. Crack Indications

Bell Helicopter has found that some main driveshaft outer couplings 214-040-659-005 may have a manufacturing defect. The defect, which was found to be cracks induced during manufacturing of a particular lot of parts, is in the root of the splines and can be detected by magnetic particle inspection (MPI) as shown in Figure 1. Six outer couplings are in the affected manufacturing lot, see Table 1 in the Accomplishment Instructions section for the list of serial numbers.

Crack indications in root of splines

1. Prepare the helicopter for maintenance.
2. Remove the main driveshaft. (BHT-214-MM)
3. Disassemble the driveshaft to the extent necessary to remove the affected outer couplings 214-040-659-005. (BHT-214-CR&O)
4. Inspect the coupling for cracks by MPI, no cracks are acceptable. Pay particular attention to the coupling spline root area. (BHT-214-CR&O and BHT-ALL-SPM)
  - a. If cracks are found replace the affected 214-040-659-005 outer coupling. If no cracks are found, return the part to service.
5. Re-assemble and install the main driveshaft. (BHT-214-CR&O and BHT-214-MM)
6. Make an entry in the helicopter logbook and historical service records indicating compliance with Part II of this Alert Service Bulletin.

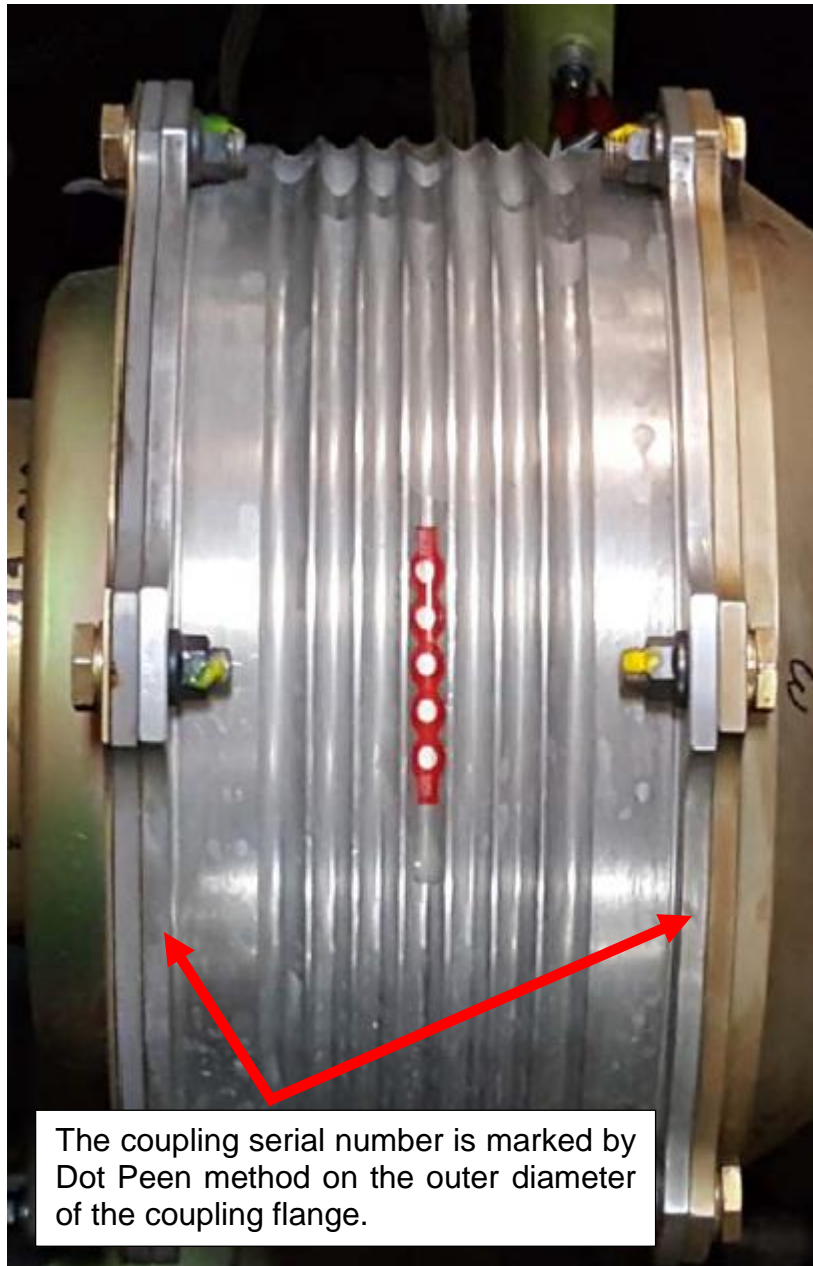
Figure 2.  
Serial Number marking location

The serial number is marked by Dot Peen method on the outer diameter of the coupling flange. (Figure 2)

2. Visually confirm the forward and aft 214-040-659-005 outer couplings' serial number.
  - a. If the coupling serial number is not listed in Table 1 or there are records showing that a MPI has previously been carried out with no crack indications, then no further action is required. Accomplish step 3.
  - b. If the coupling is affected and there are no records showing that a MPI has previously been carried out, then accomplish Part II within the specified compliance time.
