ALERT SERVICE BULLETIN

NO. 214ST-10-88

MODEL AFFECTED: 214ST

SUBJECT: ELEVATOR AND DIRECTIONAL FLIGHT CONTROL BEARINGS, P/N MS27643-4, INSPECTION AND REPLACEMENT OF

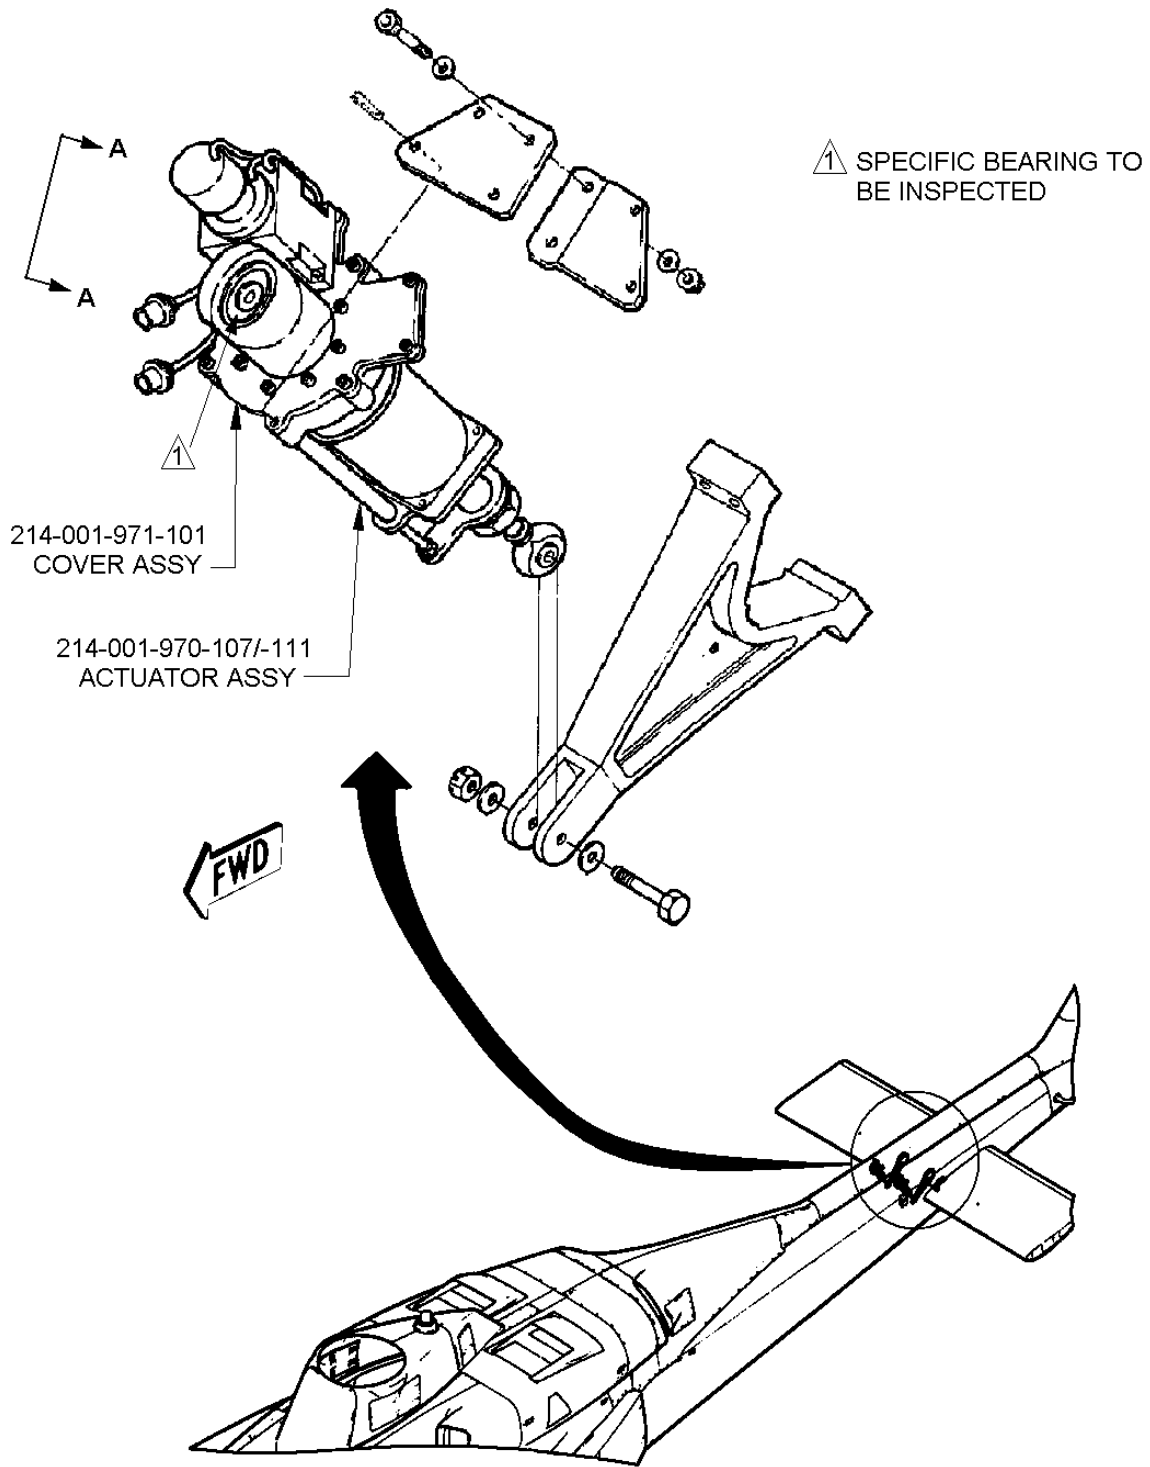
ELEVATOR CONTROLS
FIGURE 1

- The Elevator Actuator Assembly P/N 214-001-970-107/-111 (two per helicopter) has 1 P/N MS27643-4 Bearing installed (Figure 1).

- c. Inspect each MS27643-4 bearing, regardless of manufacturer, for serviceability paying particular attention to smooth rotation.
 - 1) Bearings found to be rough, ratchety, or otherwise not meeting serviceability criteria must be replaced immediately as follows:
 - a) Remove the actuator assembly to a suitable workspace and secure in a vertical position with the motor assembly at the top.

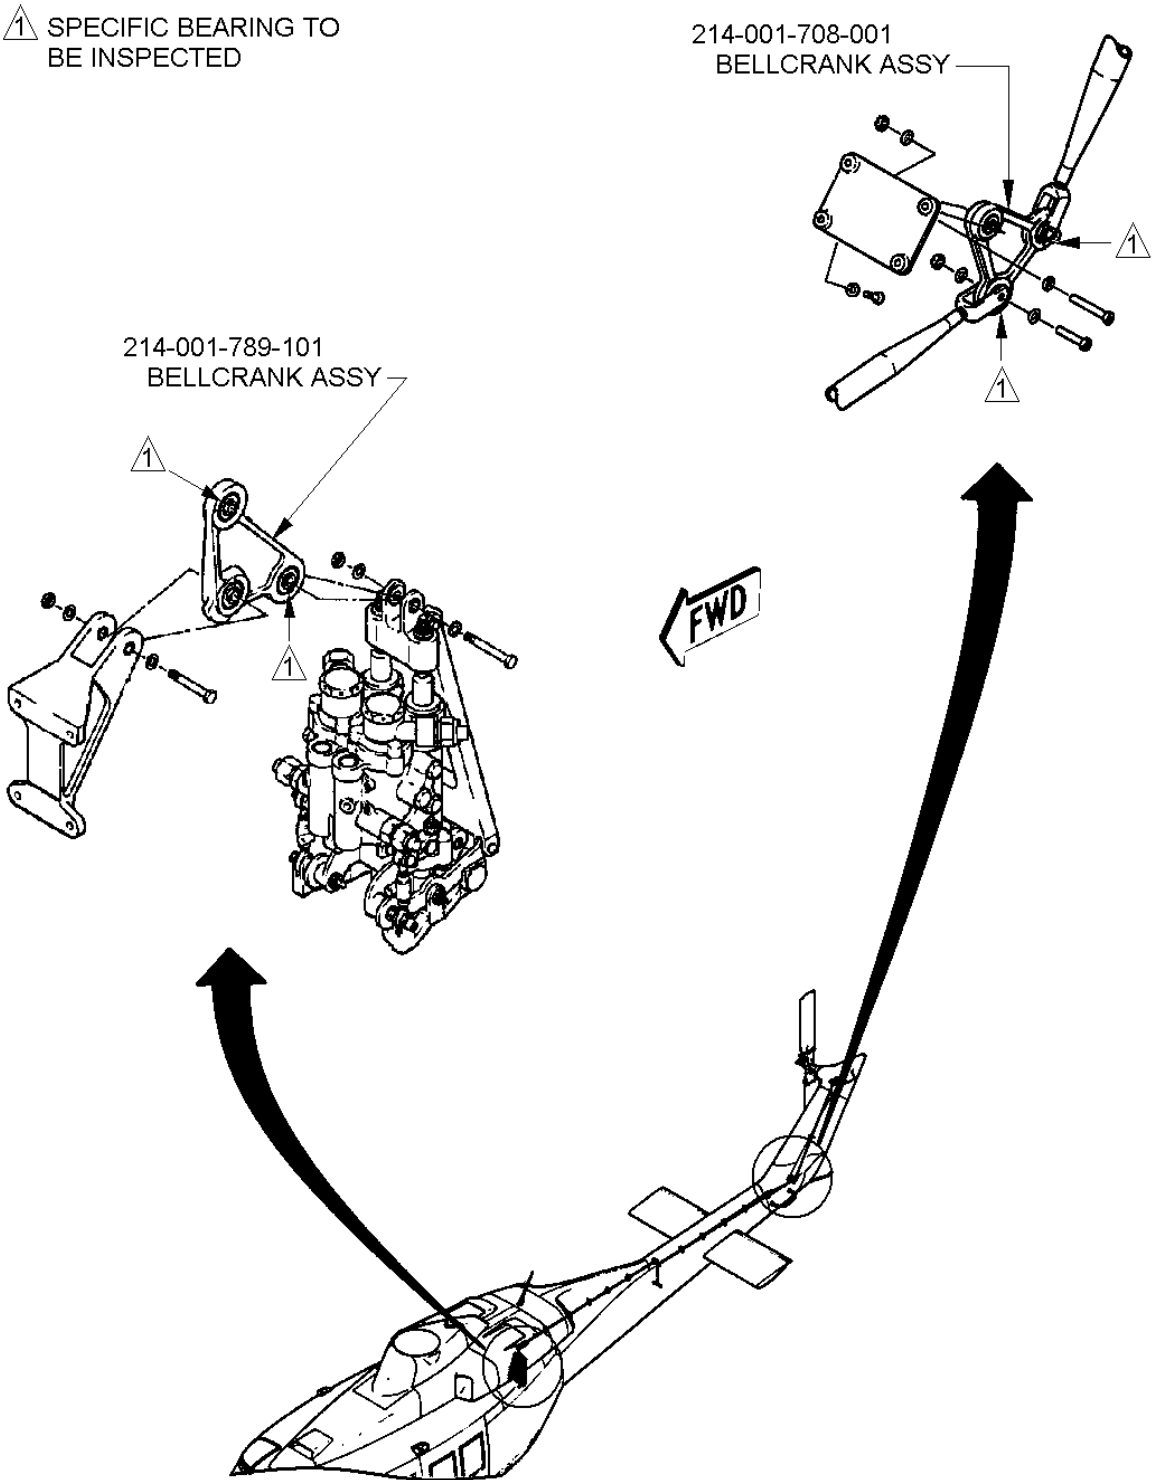
DIRECTIONAL CONTROLS
FIGURE 3

- The Bellcrank Assembly P/N 214-001-708-001 has 2 P/N MS27643-4 Bearings installed (Figure 3).

- The Bellcrank Assembly P/N 214-001-789-101 has 2 P/N MS27643-4 Bearings installed (Figure 3).

- a. Disconnect control tubes at each bellcrank location to be inspected; refer to BHT-214ST-MM. Specific bearings to be inspected are identified on Figure 3.

- 1) Bearings found to be rough, ratchety, or otherwise not meeting serviceability criteria must be replaced immediately. Refer to BHT-214ST-MM and BHT-ALL-SPM, as applicable, for bellcrank removal and installation and bearing replacement procedures except do not use zinc chromate or water borne (Mil-P-85582) primer, use Mil-P-23377 primer (C-204) only when installing the sleeve and bearing.

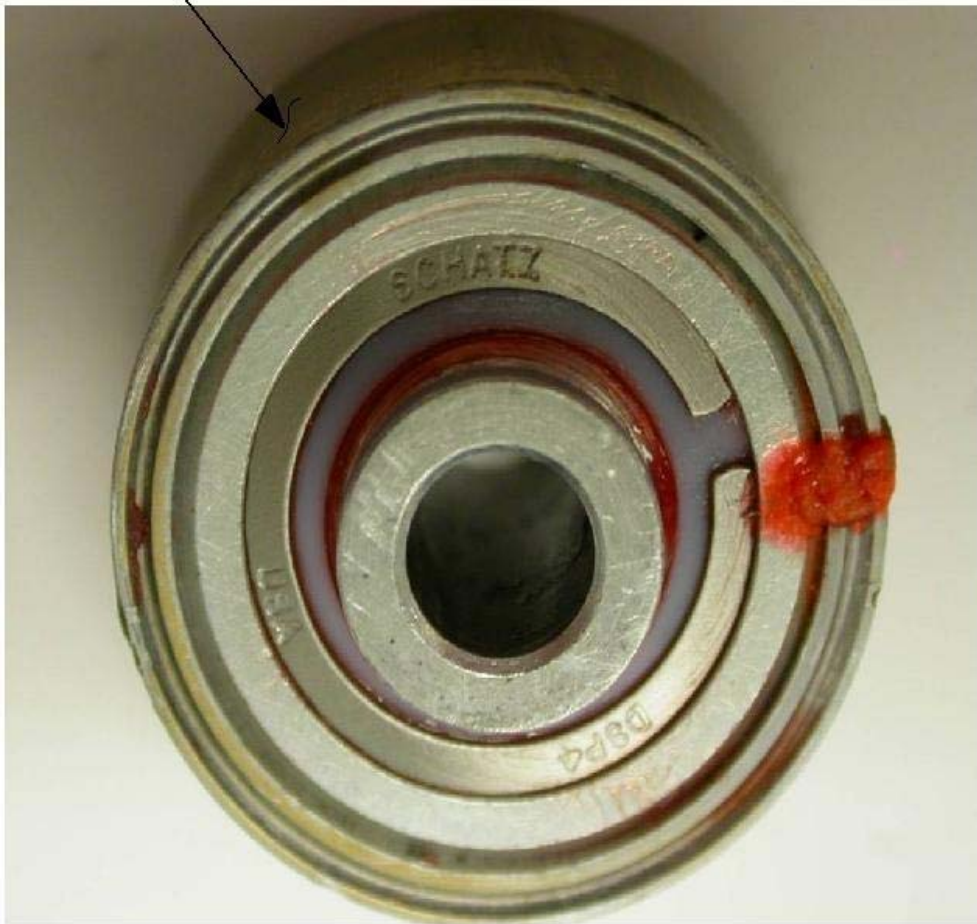
FIGURE 4

2. Installed MS27643-4 bearings manufactured by Schatz Bearing Corporation can be identified by the word **SCHATZ** and **DSP4** imprinted on the bearing seal retainer on at least one side of the bearing (Figure 4). Uninstalled MS27643-4 bearings will have a Schatz manufacturing lot number marked on the outer race (Figure 4) with MS27643-4 and DSP4-H or L identified on the packaging.

LOT NUMBER MARKED ON OUTER RACE
