OPERATIONS SAFETY NOTICE

**OSN 206-10-39
OSN 206L-10-47
OSN 407-10-16**

SUBJECT: 206-001-397-XXX CYCLIC SUPPORT ASSEMBLY; MAINTENANCE AND INSPECTION OF.

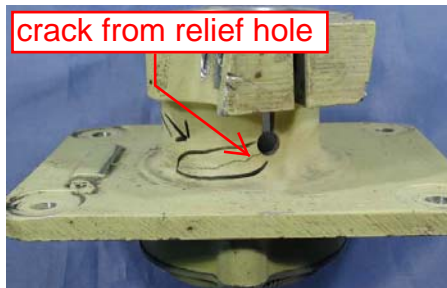
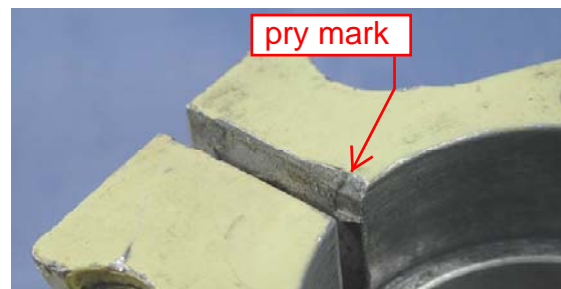
This Operation Safety Notice is issued to emphasize the importance of using the correct procedure while removing or installing parts on helicopters. Based on recent reports where cracks were found on Cyclic Pivot Support (all made from 206-001-360 casting), Bell Helicopter would like to remind owners/operators to pay particular attention to the note written in the applicable section of the maintenance manual specifying “not to use a screwdriver or wedge of any type to spread the slot in the pivot support to aid in the installation/removal of the split friction bearing. Spreading the slot results in excessive stress in relief hole of the slot which could cause overload cracks.” Supports exhibiting cracks are determined unserviceable.
