OPERATION SAFETY NOTICE

206L-17-52

SUBJECT: HIGH ALTITUDE TAIL ROTOR BLADE EXTERIOR CHECK

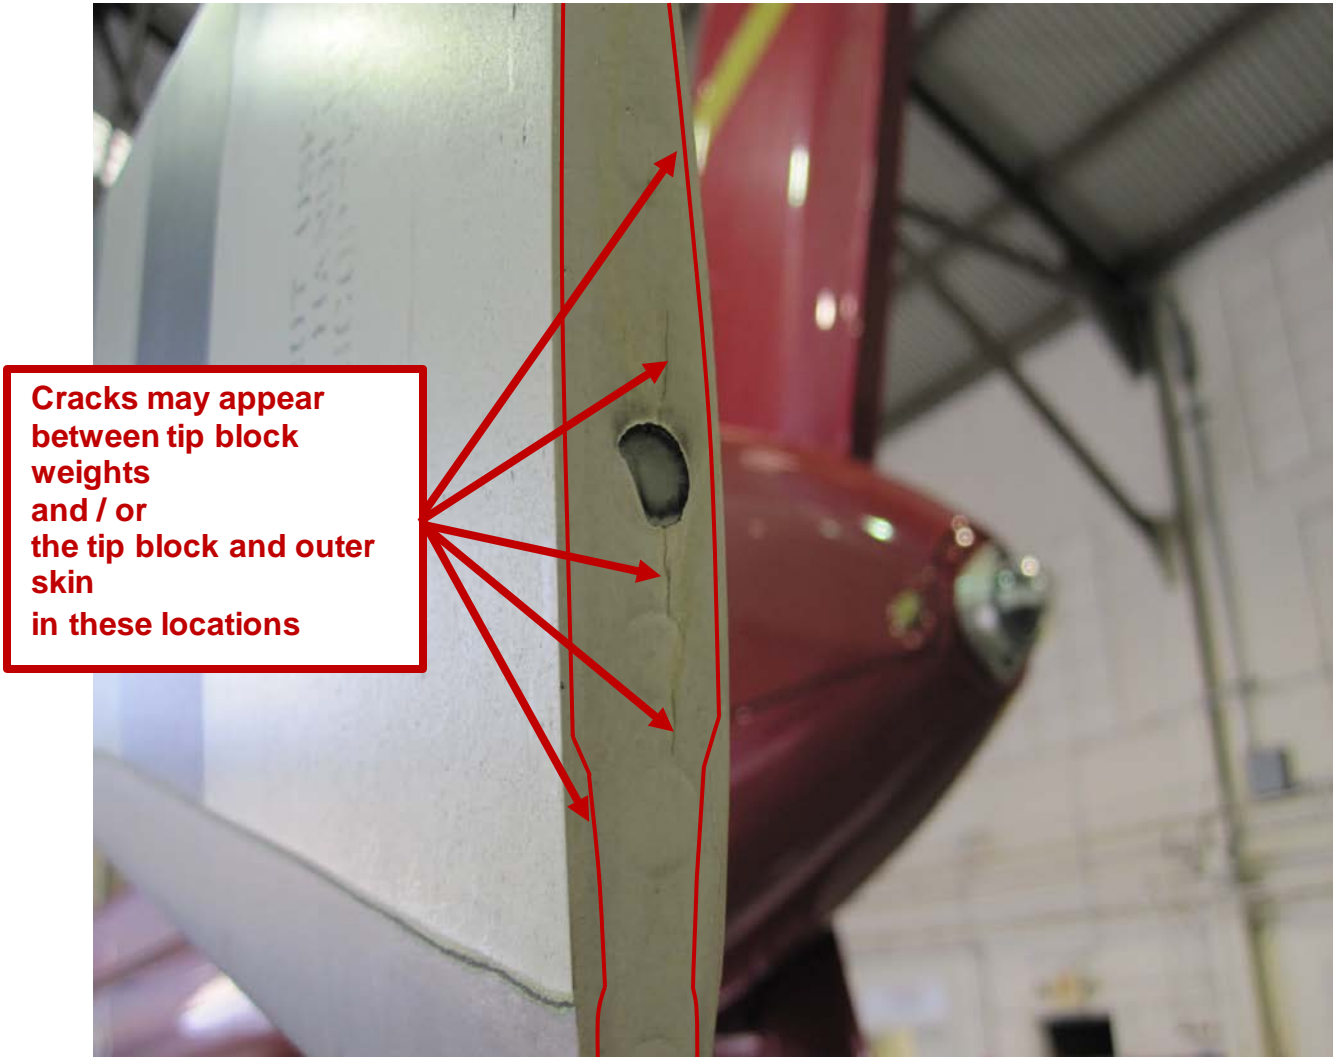
Figure 1 – Tail Rotor Blade Tip Block Area

This OSN is being published to emphasize the importance of the EXTERIOR CHECK requirements contained in the BHT-206L4-FM-1 and BHT-206L4T-FM-1 Flight Manuals, specifically the Section 2 for FUSELAGE – FULL AFT, and the tail rotor blades. For clarification, “tip block seal integrity” or “tip block seal condition” referenced in these procedures is explained as any anomalies (i.e. cracks, dents, damage, etc...), that might indicate degradation of the tip block bond.

If any cracks are suspected in the bond lines, or anywhere else, on the tail rotor blade assembly it should be investigated further prior to flight. If a crack exists in any location, the blade is not acceptable and must be removed from service. Detailed tail rotor blade assembly inspection criteria can be found in the Service Instruction BHT-206SI-2054 or BHT-206-SI-2057, as applicable. Refer to the Figure 1 below and the Figure 2-11 (extracted from the Service Instruction BHT-206-SI-2054) of this OSN, to identify the areas to pay particular attention.

Please note that wiping dirt and soot from the blade tip will increase visibility of cracks and other conditions in the area.
