## **ALERT SERVICE BULLETIN**

**205-20-116**

**MODEL AFFECTED:** 205A/205A-1

**SUBJECT:** TAILBOOM LEFT HAND FIN SPAR CAP P/N 212-030-447-117, INSPECTION OF.

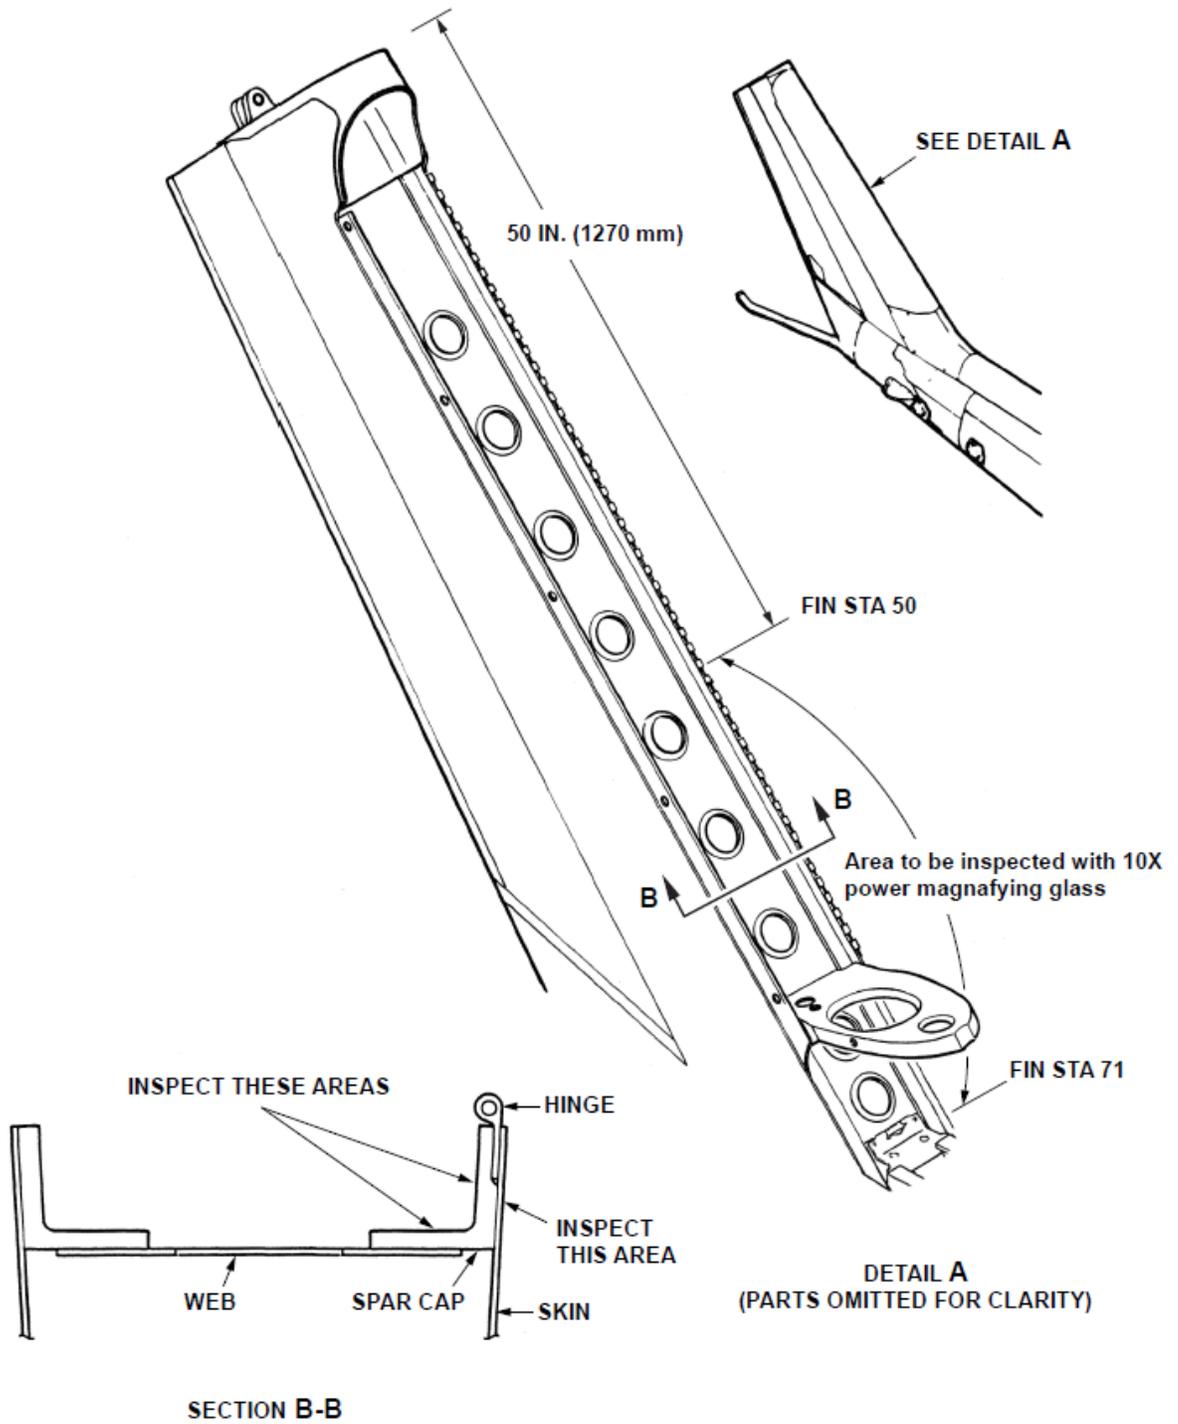
**Figure 1. Spar cap inspection.**

Bell has received a report of a fractured fin spar cap P/N 212-030-447-117. The crack occurred at vertical fin station (F.S.) 71 through the first rivet hole attaching the skin 212-030-099-105 to the spar cap. If undetected, the fin spar cap cracking may lead to additional structural damage. This bulletin introduces a 100 flight-hour inspection of the affected area of the fin spar cap using 10X magnifying glass.

1. Prepare the helicopter for maintenance.
2. Gain access to the spar cap angle by removing the 42-degree gearbox cover and opening the vertical fin driveshaft cover.
3. Clean exposed surfaces of spar cap to facilitate inspection.
4. Inspect both flanges of the spar cap between F.S. 50 and F.S. 71 using 10x magnifying glass and a bright light for cracks, loose rivets and other damage (Figure 1).
5. Inspect the exterior of the fin skin in the area in contact with the spar cap for cracks, loose rivets and/or distortion.
6. If no cracks or other damage is found, close the driveshaft cover, reinstall the 42-degree gearbox cover and return the helicopter to service.
7. If a crack or other damage is found, contact Product Support Engineering before further flight:
