ALERT SERVICE BULLETIN

205-23-120

MODEL AFFECTED: 205A/205A-1

SUBJECT: TENSION ROD ASSEMBLY P/N 205-030-249-009 OR 205-030-249-013, INSPECTION OF.

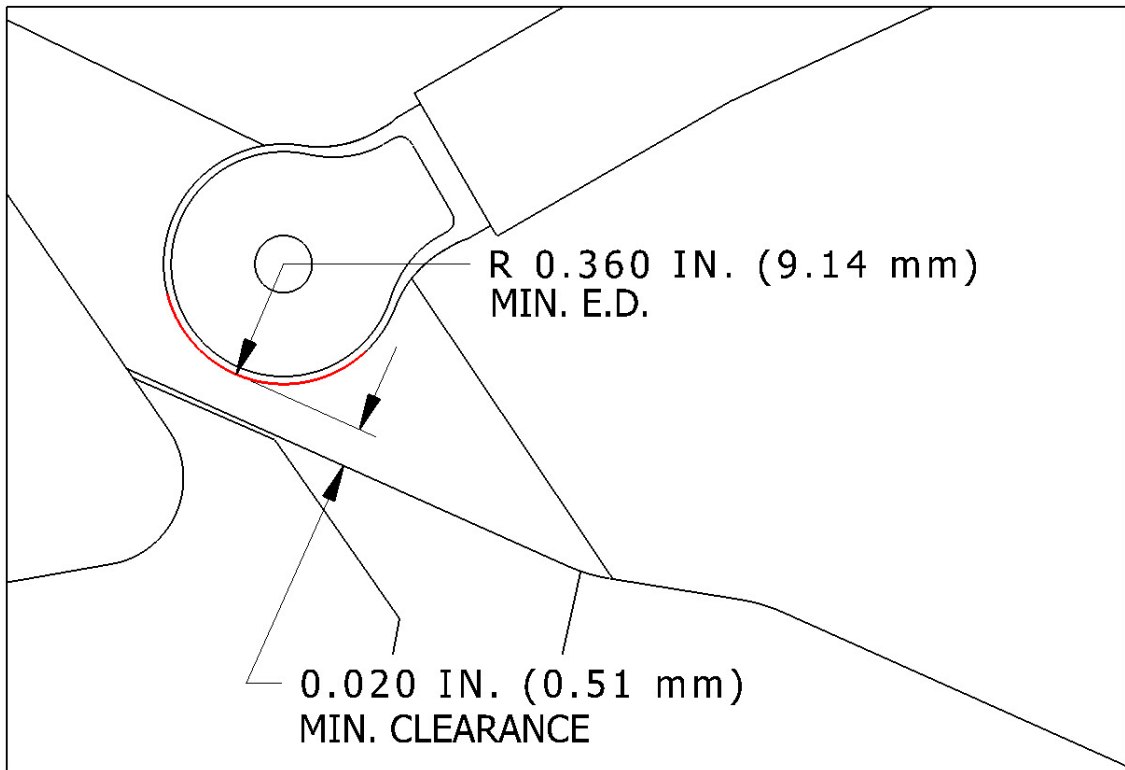
Figure 2. Inspection requirements

- a. Inspect both sides of the tension rod assembly rod end for a possible over trimmed condition. Minimum acceptable radius dimension measured from the bolt hole center is 0.360 inch (9.14 mm) edge distance (E.D.) (Figure 2 and 3). Removal of the attachment bolt may be required to perform this measurement. Record findings.

- b. Check for fouling or low clearance conditions between the rod end and the structure (cap, web) on the outboard side and the fillet radius on the inboard side of the fitting. Minimum acceptable clearance is 0.020 inch (0.51 mm) (Figures 2 and 3). Record findings.
