ALERT SERVICE BULLETIN

NO. 222-09-107

MODEL AFFECTED: 222 and 222B

SUBJECT: STAKED BEARINGS, ONE-TIME INSPECTION OF.

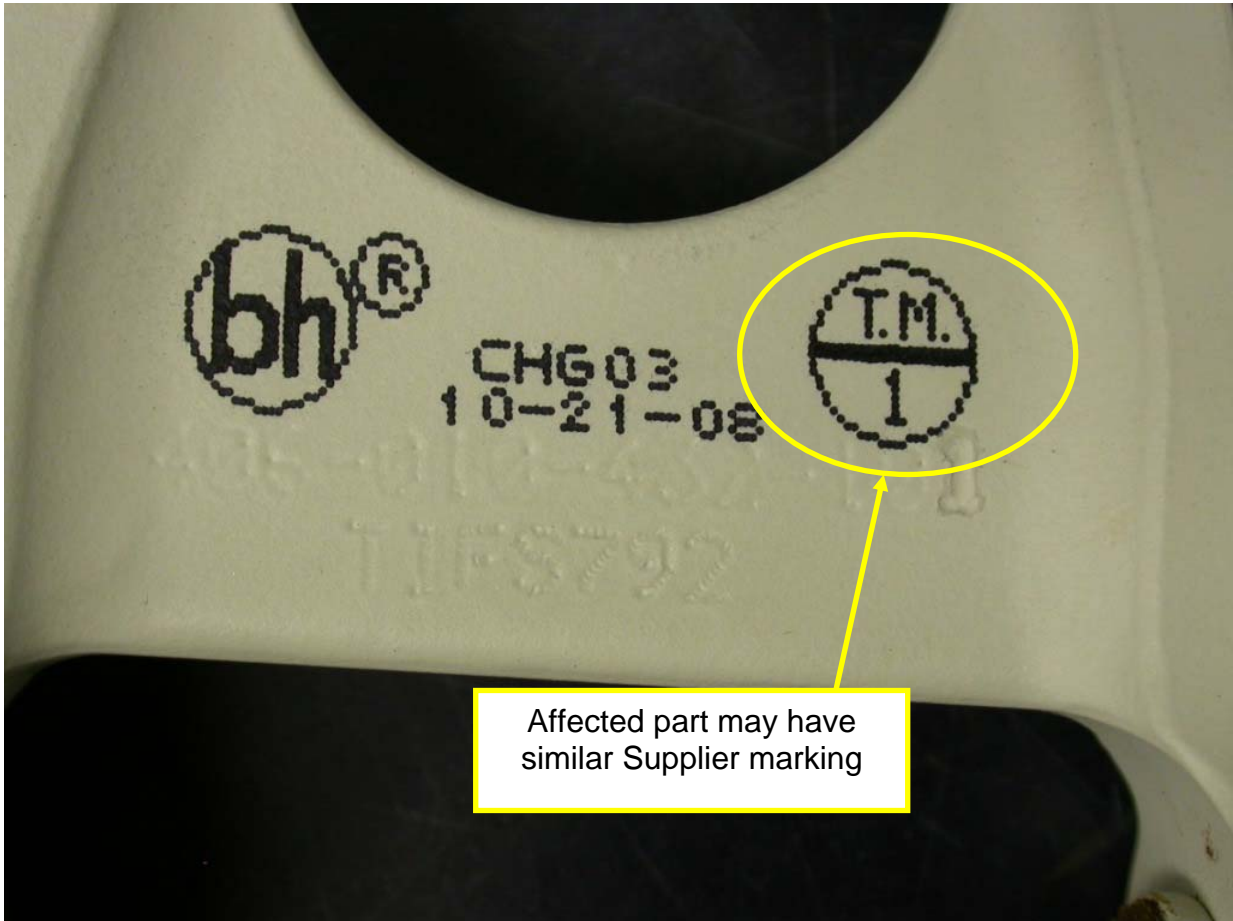
Bell Helicopter issues this bulletin to accomplish a one-time inspection of various parts that could potentially exhibit the same defect. The affected parts are separated in Table 1 and Table 2 based on installation characteristics and criticality. Parts in service and all spare parts are affected. When serialized, only parts with serial number prefix TI or TIFS are affected. However, affected part not serialized, may have Supplier marking as shown on Figure 1.

Figure 1. Affected part Supplier marking.
