**SUBJECT: REVISION A TO ALERT SERVICE BULLETIN 222-10-110:
DIRECTIONAL FLIGHT CONTROL BEARING P/N MS27643-4;
INSPECTION AND REPLACEMENT OF.**

NO. 222-10-110

MODEL AFFECTED: 222 and 222B

SUBJECT: DIRECTIONAL FLIGHT CONTROL BEARING P/N MS27643-4; INSPECTION AND REPLACEMENT OF.

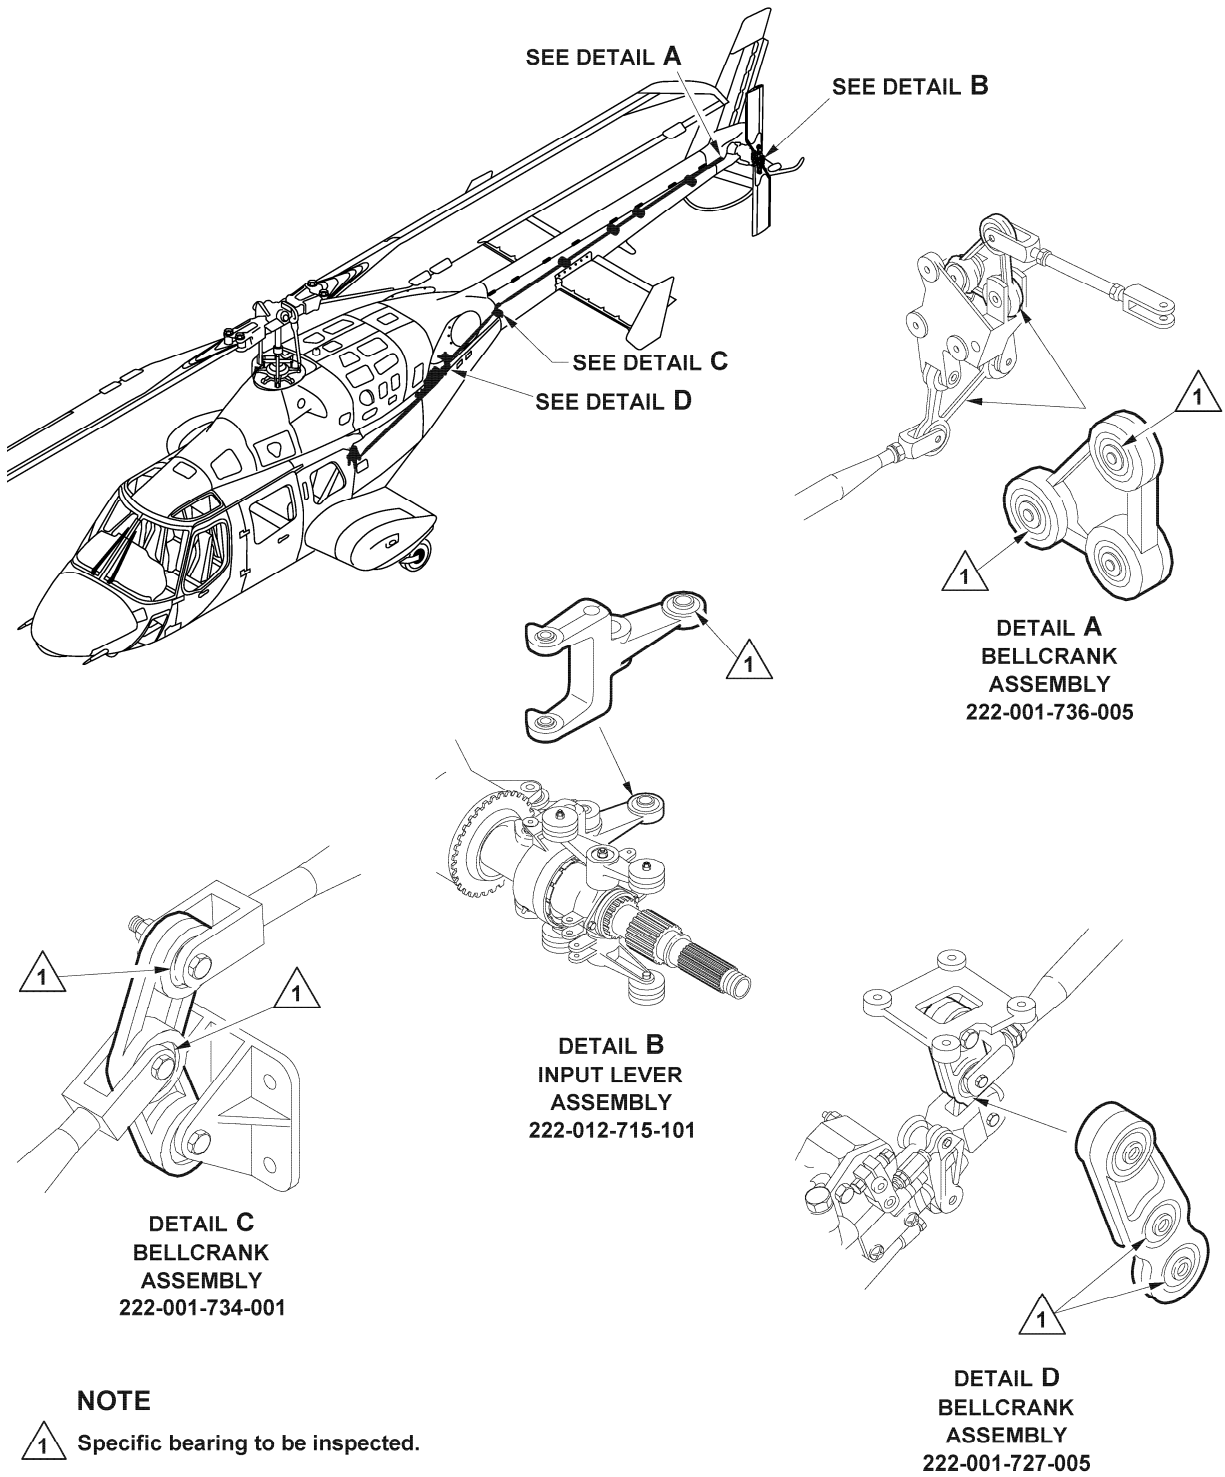
Figure 1

1. On the model 222 and 222B, Bell Helicopter has identified 4 locations in the boosted directional flight controls where a degraded P/N MS27643-4 bearing can affect proper control operation.

Input lever Assembly P/N 222-012-715-001 and/or -101 contains 1 P/N MS27643-4 Bearing (Figure 1).

Bellcrank Assembly P/N 222-001-736-005 (QTY2) contains 2 P/N MS27643-4 Bearings (Figure 1).

Bellcrank Assembly P/N 222-001-734-001 contains 2 P/N MS27643-4 Bearing (Figure 1).

Bellcrank Assembly P/N 222-001-727-001 and/or -005 contains 2 P/N MS27643-4 Bearing (Figure 1).

- a. Disconnect directional control tubes at each location to be inspected. Specific bearings to be inspected are identified on Figure 1. Refer to BHT-222/222B-MM-1 as necessary.

- 1) Bearings found to be rough, binding, or otherwise not meeting serviceability criteria must be replaced immediately. Refer to BHT-222/222B-MM-1 and BHT-ALL-SPM, as applicable, for replacement procedures.

- 2) Schatz manufactured bearings installed after Sep 2006 and found serviceable remain susceptible to degradation and therefore must be replaced at the next 150 hour inspection but no later than one year after release date of this bulletin, which ever occurs first.

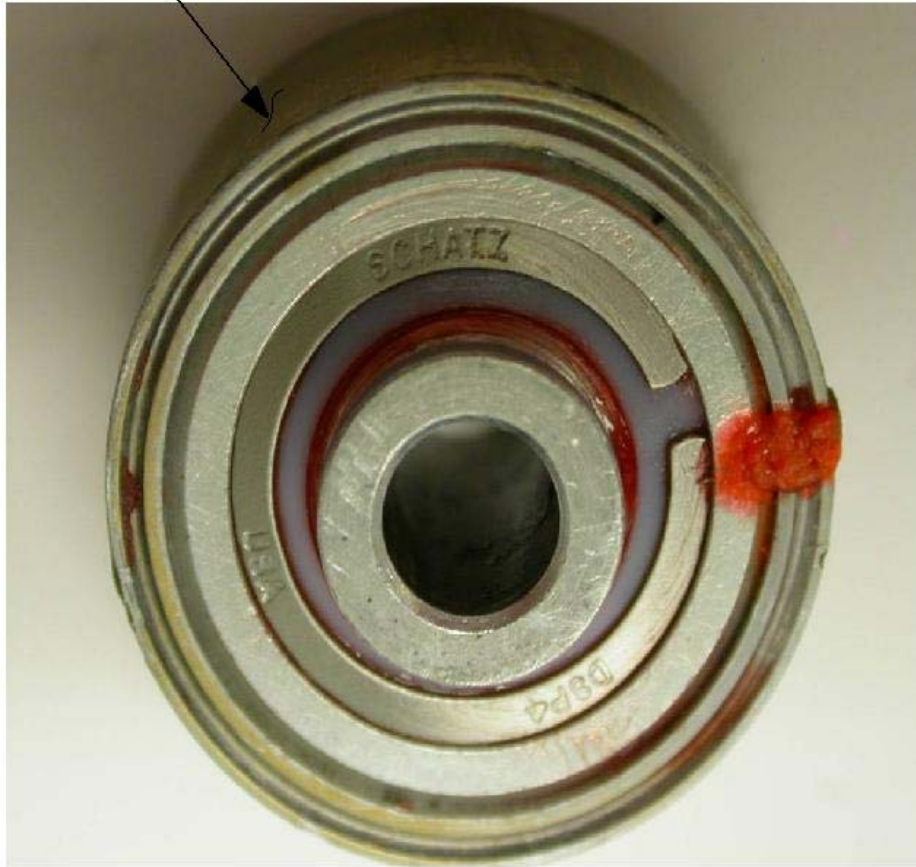
Figure 2

2. Installed MS27643-4 bearings manufactured by Schatz Bearing Corporation can be identified by the word **SCHATZ** and **DSP4** imprinted on the bearing seal retainer on at least one side of the bearing (Figure 2).
3. Uninstalled MS27643-4 bearings will expose a Schatz manufacturing lot number marked on the outer race, with MS27643-4 and DSP4-H or (L) identified on the packaging (Figure 2).

LOT NUMBER MARKED ON OUTER RACE
