## ALERT SERVICE BULLETIN

**206-16-134**

**MODEL AFFECTED:** 206A/B and TH-67

**SUBJECT:** AIR CONDITIONER BLOWER MOTOR  
CONNECTOR, INSPECTION OF

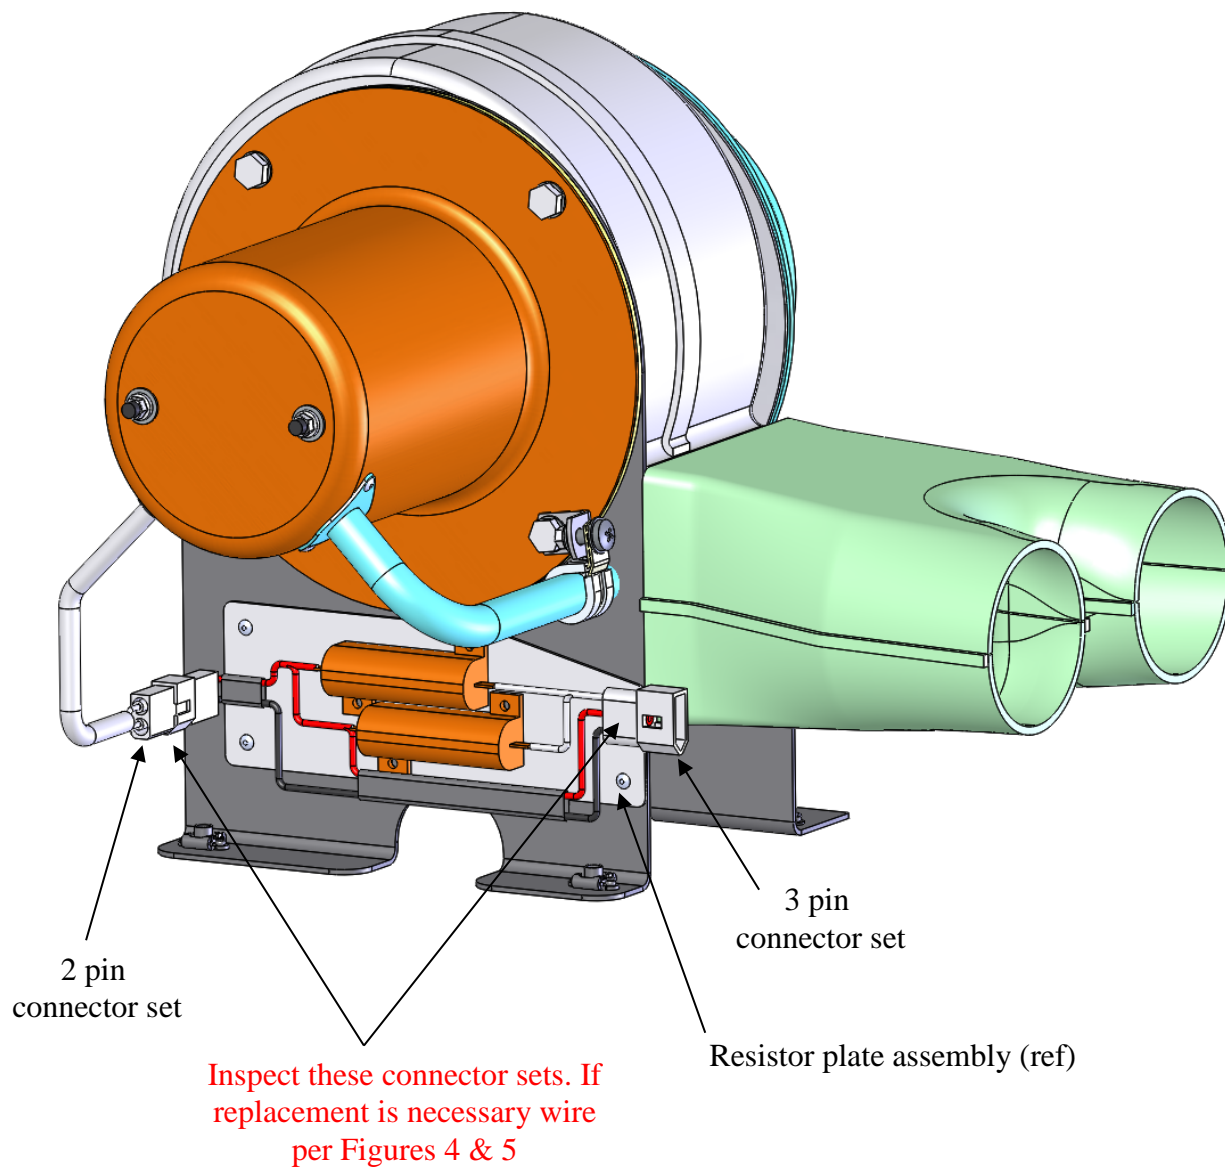
**Figure 1** Aft Evaporator Blower Assembly S-6102EC-3 used in 206EC-200-9,-10,-11 AC kits

Locate each connector shown in Figures 1, 2, and 3. De-mate each connector and inspect both mates for signs of overheating, discoloration or plastic deformation. Gently pull (estimated 5-7 lb force) on each wire to verify the integrity of the contact's crimp. The contacts should be fully seated and locked in the housing so pulling gently on the wires will not dislodge the contacts from the housings.

If any signs of overheating of the housing are present or if the pull test fails, the system must be rendered inoperative and the connector housings and contacts replaced with new replacement connectors using Deutsch HDT-48-00 Crimping tool or equivalent MIL-DTL22520 Type 1 crimping tool before further operation. See Section B for information on how to contact Air Comm Corporation.

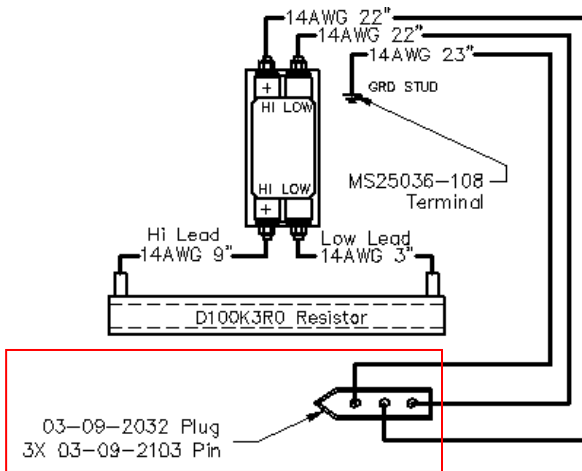
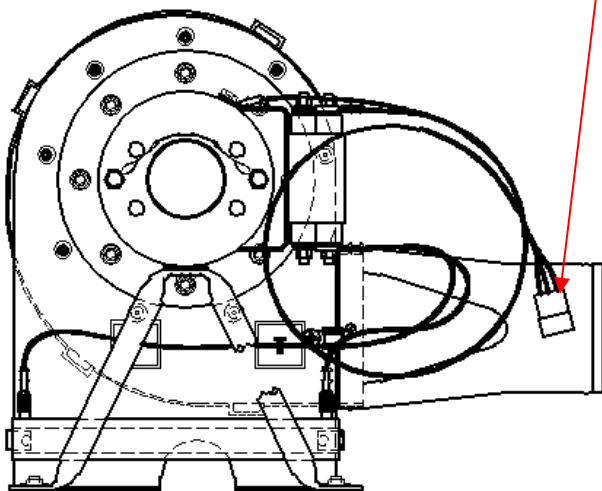
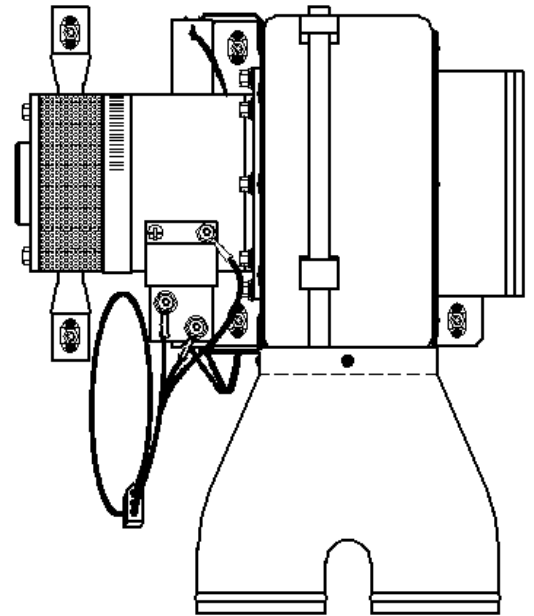
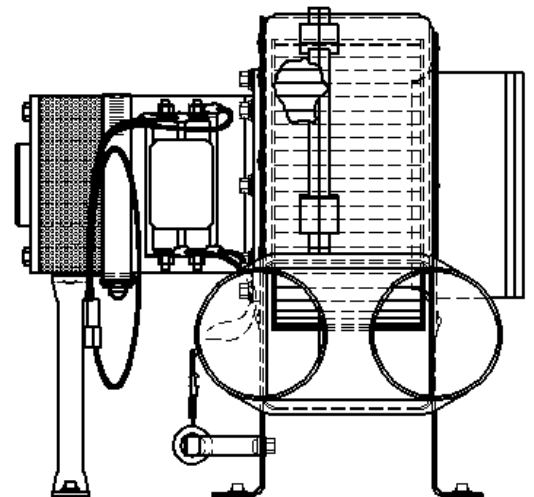
**Figure 2** Aft Evaporator Blower Assembly S-6078EC-15 used in 206EC-212-3,-4 AC kits

Inspect this connector.  
If replacement is necessary  
wire per Figure 6

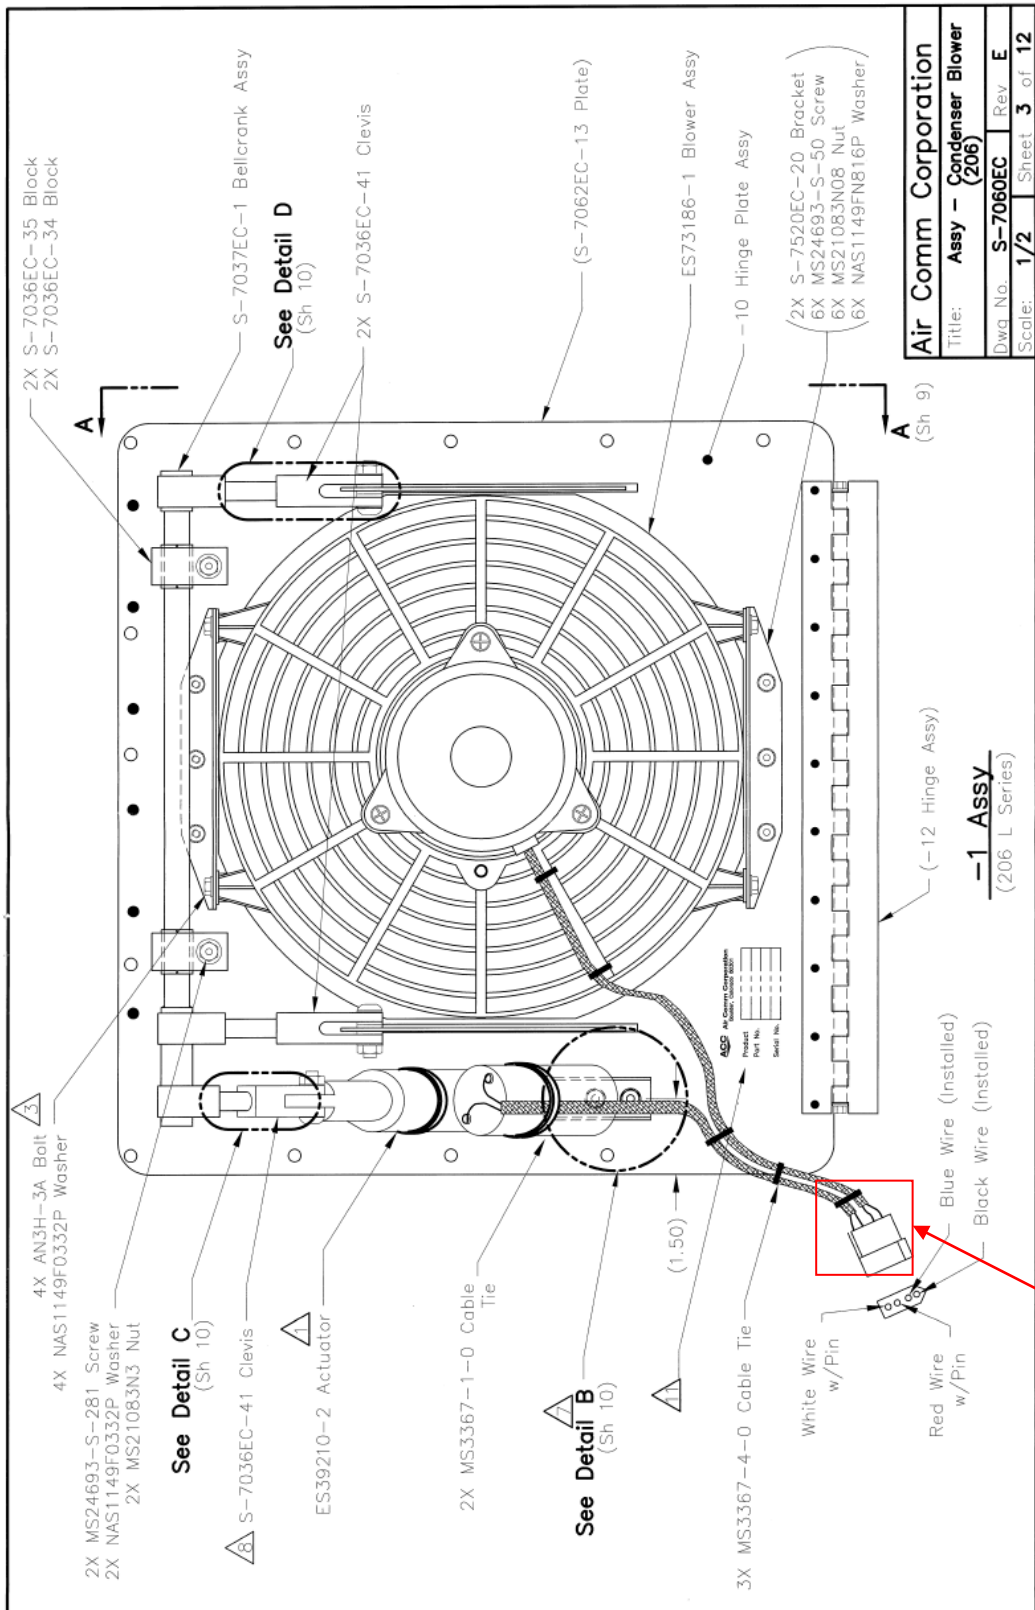
Figure 3. Condenser Blower S-7060EC -1, -2 used on 206EC-200-212 Systems

Inspect this connector

Note that the pinout of the replacement connector set is defined by the installer, however the wire alignment across the connector set must remain unchanged.
