A Textron Company

ALERT SERVICE BULLETIN

206-19-136

SUBJECT: TAIL ROTOR DRIVESHAFT DISC PACK COUPLING NUTS, REPLACEMENT OF

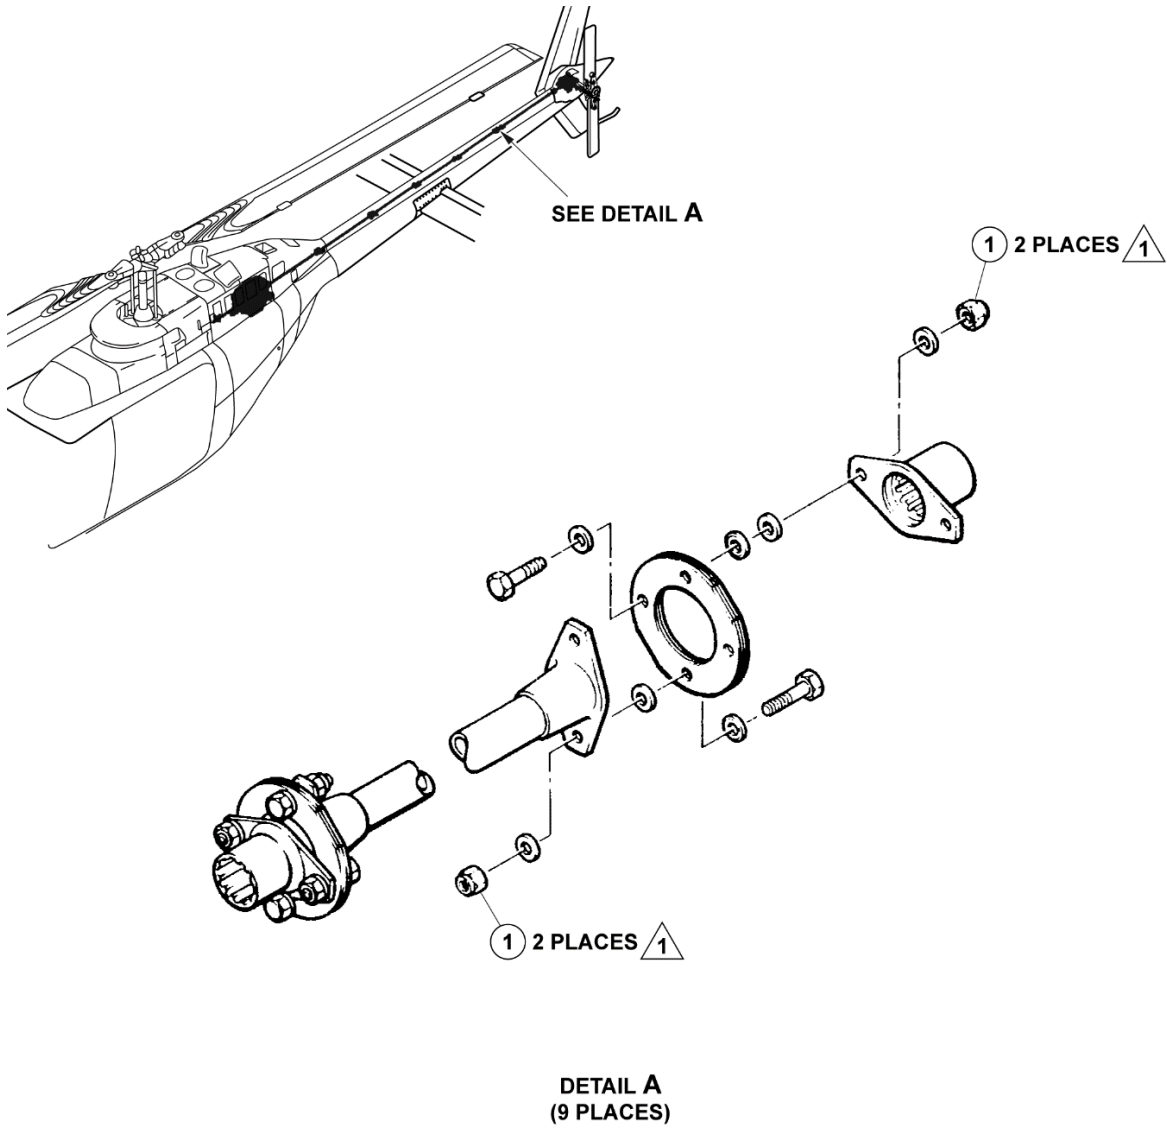
Figure 1 - Typical Tail Rotor Driveshaft Disc Pack Coupling Attachments

Bell has received reports of cracked or missing MS21042 series nuts. Conditions leading to the cracking or loss of MS21042 nuts may be attributed to improper torque applied, low tare torque, or hydrogen embrittlement. A review of several Service Difficulty Reports has concluded that the events were related to the loss of hardware from tail rotor disc pack (Thomas) couplings.

The Model 206 series helicopters use four (4) MS21042 nuts at each tail rotor driveshaft disc pack coupling attachment. Depending on the model and configuration, as many as twenty (20) or thirty-six (36) MS21042L4 nuts are used in the tail rotor driveshaft installations.

This Alert Service Bulletin (ASB) mandates the replacement of the MS21042L4 nuts with the 12-point NAS9926-4L corrosion resistant steel nuts.

1. Prepare the helicopter for maintenance.
2. Remove and replace the MS21042L4 nuts at each tail rotor driveshaft disc pack coupling with the 12-point NAS9926-4L nuts (BHT-206A/B-SERIES-MM, Chapter 65). There are four (4) nuts at each disc pack coupling attachment (Figure 1).
3. After torquing of the nuts, apply a torque stripe (witness mark) to each nut using the torque seal lacquer (C-049), or equivalent (Figure 2). Application of the torque seal lacquer (C-049) is used to mark the nuts that have been torqued to visually identify movement of the nuts. Torque seal is brittle and will crack if the fastener moves.
