OPERATIONS SAFETY NOTICE

OSN 206-99-36
OSN 206L-99-41

- TO:** **ALL BELL 206A/B/B3 OPERATORS** -- SERIAL NUMBER 4 THROUGH 4004, HAVING TAIL ROTOR PITCH CHANGE LINK 206-010-793-101 INSTALLED
ALL BELL 206L/L1 OPERATORS -- SERIAL NUMBER 45001 THROUGH 45790, HAVING TAIL ROTOR PITCH CHANGE LINK 206-010-793-101 INSTALLED
- SUBJECT:** **ASB 206-87-39**, DATED 9-17-87, TAIL ROTOR PITCH LINK P/N 206-010-793-101, INSPECTION OF
ASB 206L-87-48, DATED 9-17-87, TAIL ROTOR PITCH LINK P/N 206-010-793-101 AND 206-010-792-105, INSPECTION OF

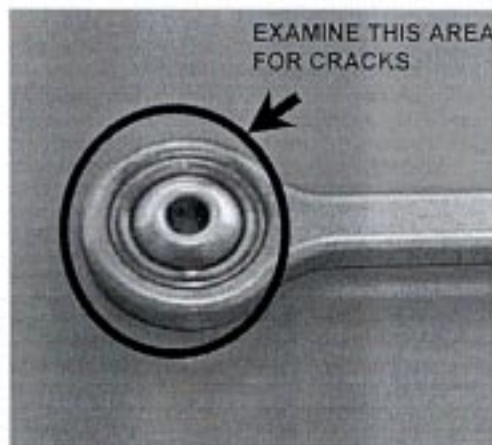
Since issuance of subject Alert Service Bulletins, Bell Helicopter has received additional reports of stress corrosion cracking of the 206-010-793-101 tail rotor pitch link in the area that houses the spherical bearing.

Particular attention should be given to the area that houses the spherical bearing as shown below:

This OSN is issued to stress the importance of adhering to the requirements of the subject Alert Service Bulletins, and the Flight Manual Preflight Check.
