# OPERATIONS SAFETY NOTICE

**OSN 205-10-44**  
**OSN 205B-10-16**  
**OSN 212-10-48**  
**OSN 412-10-38**  
**OSN 412CF-10-11**

**TO: All Owners/Operators of Bell 205/212 and 412 series Helicopters**

**SUBJECT: Tailboom Longerons Inspection Requirements**

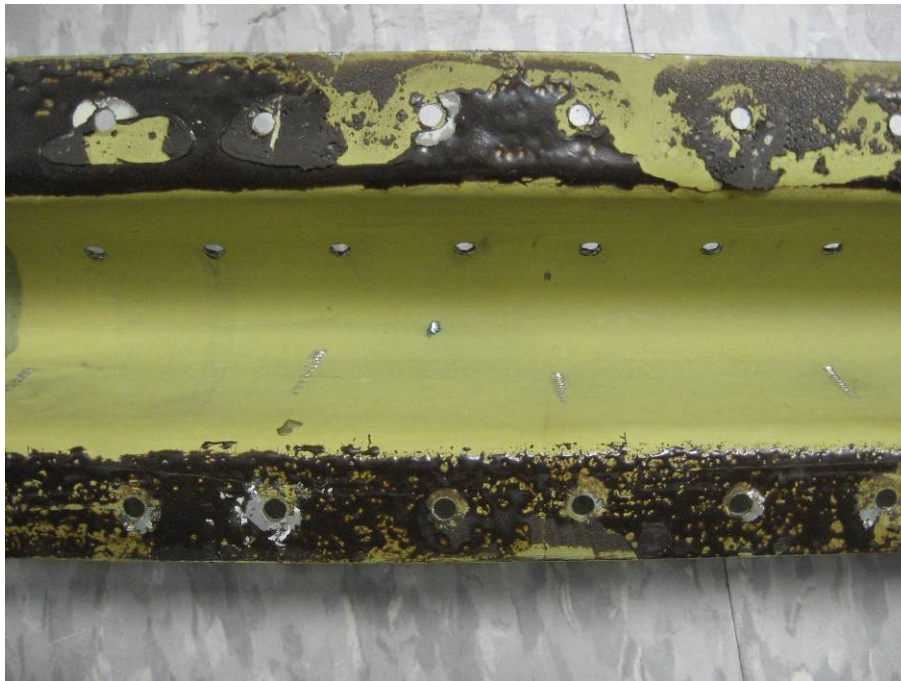
1. Score marks in the interior of the upper longerons caused by drilling operations. Bell Helicopter is not aware of any cracks or failures caused by these score marks. See Figure 1.
2. Cracking of upper and lower left longerons in the area aft of B.S.194.30 bulkhead. See Figure 2

**Figure 1**  
Drill damage to inside of Longeron (Longeron removed)

When carrying out drilling operations where the possibility of damage to underlying surfaces or components exists, a suitable drill stop should be used.

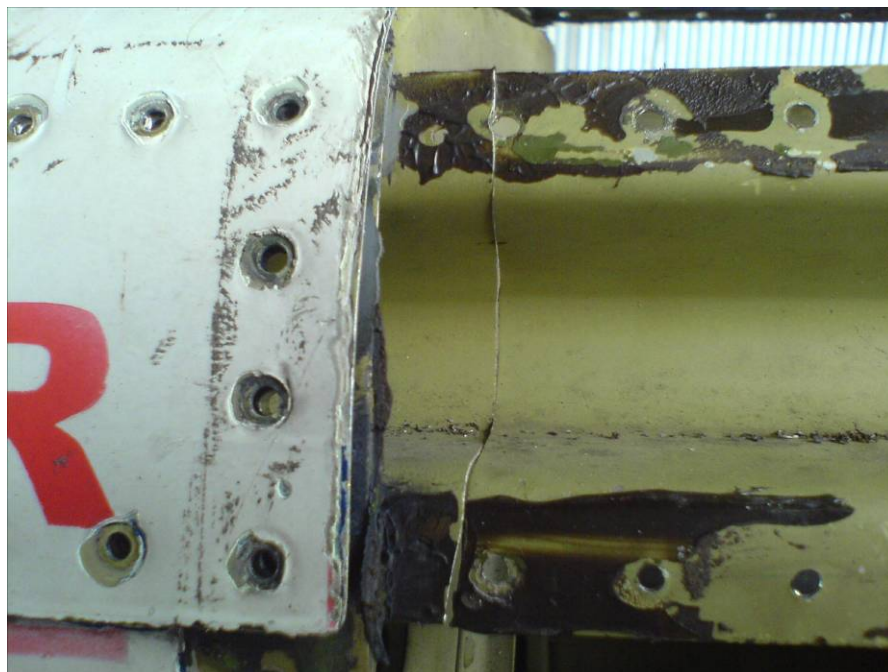
**Figure 2**  
Cracked Longeron (upper skin removed) Aft of B.S.194.30

When carrying out the required Maintenance Manual inspections, ensure adequate bright lighting, mirror and borescope as required are used. Cracked longerons must be repaired or replaced in accordance with the Structural Repair Manual (BHT-MED-SRM-1).
