OPERATIONS SAFETY NOTICE

**OSN 205-10-44
OSN 205B-10-16
OSN 212-10-48
OSN 412-10-38
OSN 412CF-10-11**

SUBJECT: Tailboom Longerons Inspection Requirements

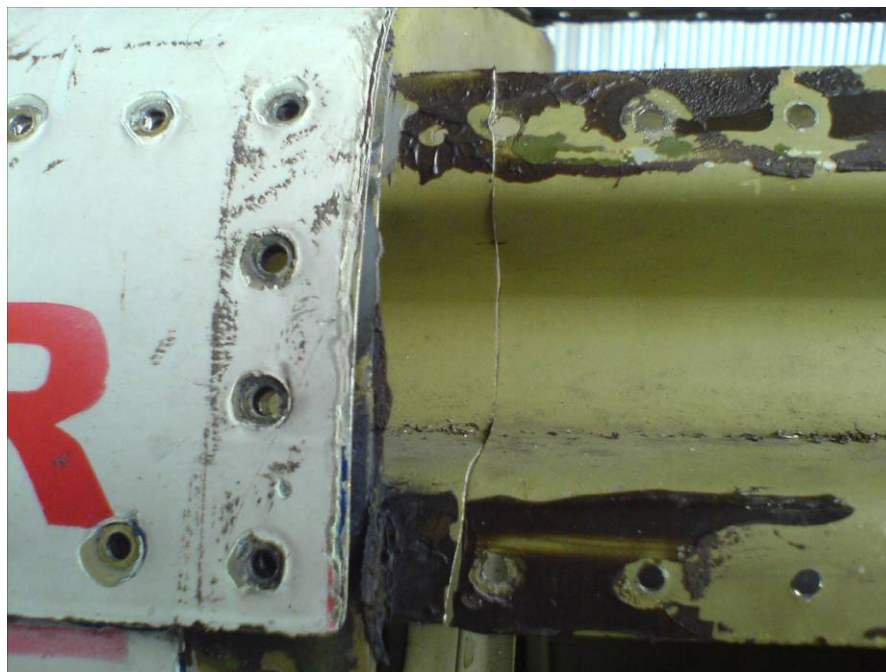
1. Score marks in the interior of the upper longerons caused by drilling operations. Bell Helicopter is not aware of any cracks or failures caused by these score marks. See Figure 1.
2. Cracking of upper and lower left longerons in the area aft of B.S.194.30 bulkhead. See Figure 2

Figure 2
Cracked Longeron (upper skin removed) Aft of B.S.194.30

When carrying out the required Maintenance Manual inspections, ensure adequate bright lighting, mirror and borescope as required are used. Cracked longerons must be repaired or replaced in accordance with the Structural Repair Manual (BHT-MED-SRM-1).
