ALERT SERVICE BULLETIN

204B-15-69

MODEL AFFECTED: 204B

SUBJECT: MAIN ROTOR BLADE BOLT 204-011-151-001
INSPECTION, REWORK AND REPLACEMENT OF

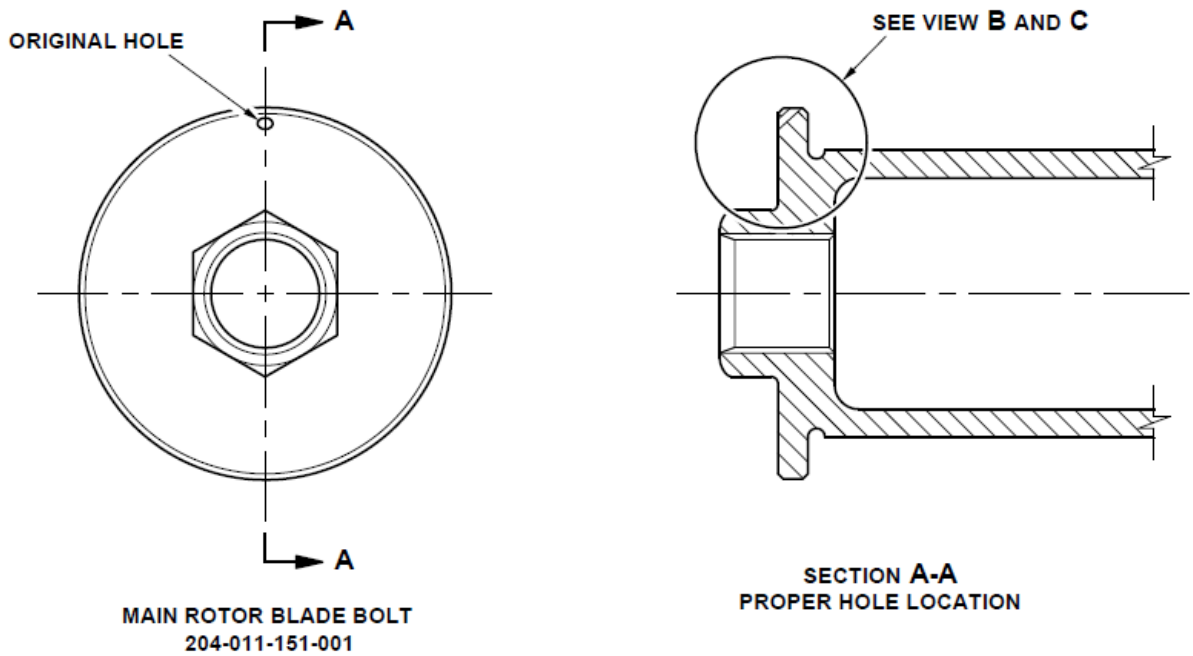
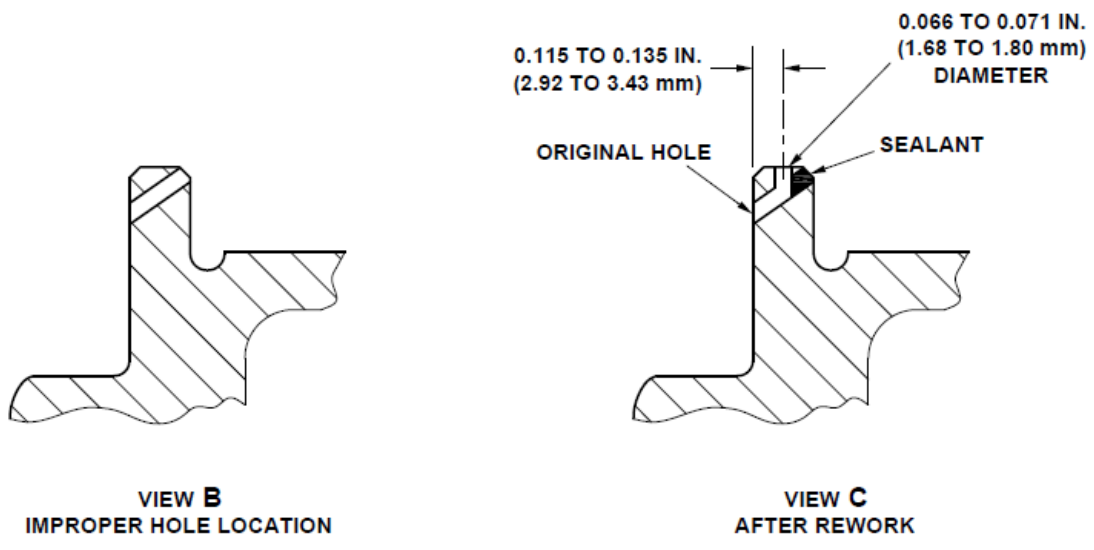
Figure 1. Main Rotor Blade Bolt Inspection and Rework

Main rotor blade bolts listed in Table 1 of the Accomplishment Instructions are suspected to have the lockwire hole for the lead weight plug incorrectly drilled. This non-conformity may prevent installation of the lockwire and lead to incorrect installation of the blade bolt. This bulletin mandates a one-time inspection for conformity of the affected blade bolts listed in Table 1 and provides rework instructions allowing the use of these blade bolts. After rework, affected blade bolts will require a repetitive 300 flight hours inspection of the reworked area. As a terminating action to this repetitive inspection, the reworked blade bolts will require replacement. As an alternative option to the rework, defective blade bolts that have not been installed and/or reworked can be returned to Bell Helicopter as "new part return" and a credit will be offered. Applicability of this bulletin to any spare part shall be determined prior to its installation on an affected helicopter.

1. Verify if any of the blade bolts listed in Table 1 are installed on a helicopter or in spare stock. If none of the blade bolts listed in Table 1 are found installed or in spares stock, go to step 3.
2. Blade bolts listed in Table 1 that have the safety wire hole drilled as shown in Figure 1, Section A-A, conform to the approved engineering. Go to step 3.
3. Make an entry in the helicopter logbook and historical service records indicating findings and compliance with this Alert Service Bulletin.
4. Blade bolts listed in Table 1 that have the safety wire hole drilled incorrectly as shown in Detail B, can either be returned to Bell Helicopter as “new part return”, or reworked as follows:

- a. Radially mark the location of the existing lockwire hole on the flange with a marker (Figure 1).
- b. Drill a 0.066 to 0.071 inch (1.68 to 1.80 mm) diameter hole in the center of the flange, as shown, to break into the existing safety wire hole.

- c. Break edges 0.0005 to 0.015 inch (0.013 to 0.38 mm) radius or 0.0005 to 0.015 inch (0.013 to 0.38 mm) x 40-50°.
- d. Verify the intersection of the two bolt holes with a 10X magnifying glass to ensure it is free of burrs or knife edges and that the opposing hole has no damage.
- e. Insert a piece of safety wire in the new hole that exits the upper surface of the flange and fill the lower end of the original safety wire hole with sealant (C-251). Make sure the sealant is flush with the end of the hole and the flange.
- f. Remove the piece of safety wire prior to sealant curing. Once the sealant has cured, fill and drain the new safety wire hole with primer (C-204).
- g. Reidentify the part number on the blade bolt assembly by adding the letter "R" after the last three digits using a permanent marker (i.e., 204-011-151-001R).

After final installation of the blade bolt on a hub assembly and installation of the safety wire, seal safety wire hole with sealant (C-251) or sealant (C-308).
