ALERT SERVICE BULLETIN

204B-16-71  
PSL 7000000201  
14 December 2016

**MODEL AFFECTED:** 204B

**SUBJECT:** TAIL ROTOR YOKE 204-011-722-005 CHROMATE CONVERSION COATING

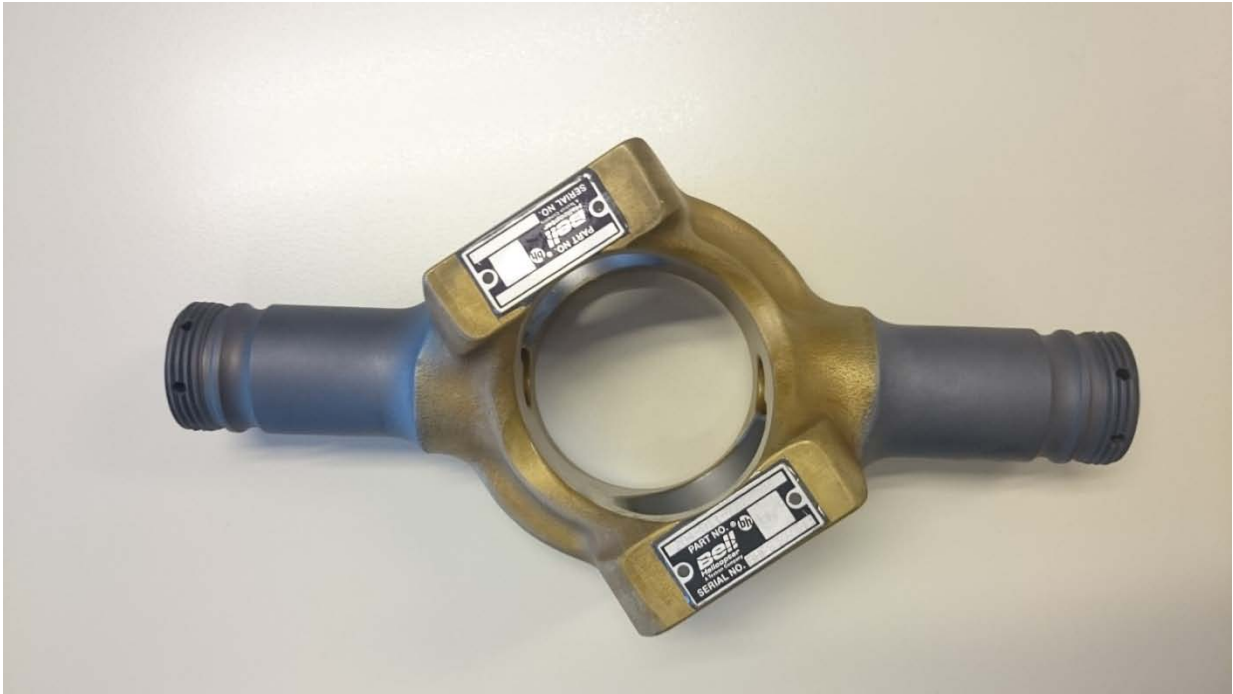
**Figure 1. Conversion Coating Application Areas**

Bell Helicopter found that the chromate conversion coating applied on some tail rotor yokes does not conform to the approved released Engineering. The affected tail rotor yokes are listed in Table 1 of the Accomplishment Instructions. Unless rectified, this non-conformity may diminish the corrosion protection. This ASB mandates that the affected yokes be visually inspected and the chromate conversion coating reapplied. Applicability of this bulletin to any spare part shall be determined prior to its installation on an affected helicopter.

7. Apply the chromate conversion coating (BHT-ALL-SPM, Chapter 3, Paragraph 3-18). Do not apply the chromate conversion coating in the trunnion bores or on the yoke spindles. For an example of the chromate conversion-coated areas, refer to Figures 1 and 2.
8. Once the chromate conversion coating has been reapplied successfully, the tail rotor hub and blade can be reassembled (BHT-204B-M&O, Section 6).
9. Make an entry in the helicopter and component historical service records to indicate that **Part II** of this bulletin has been accomplished as a terminating action to this bulletin.
