ALERT SERVICE BULLETIN

204B-17-73  
3 March 2017

**MODEL AFFECTED:** 204B

**SUBJECT:** MAGNETIC BRAKE ASSEMBLY 204-001-376-003,  
INSPECTION AND REPAIR OF.

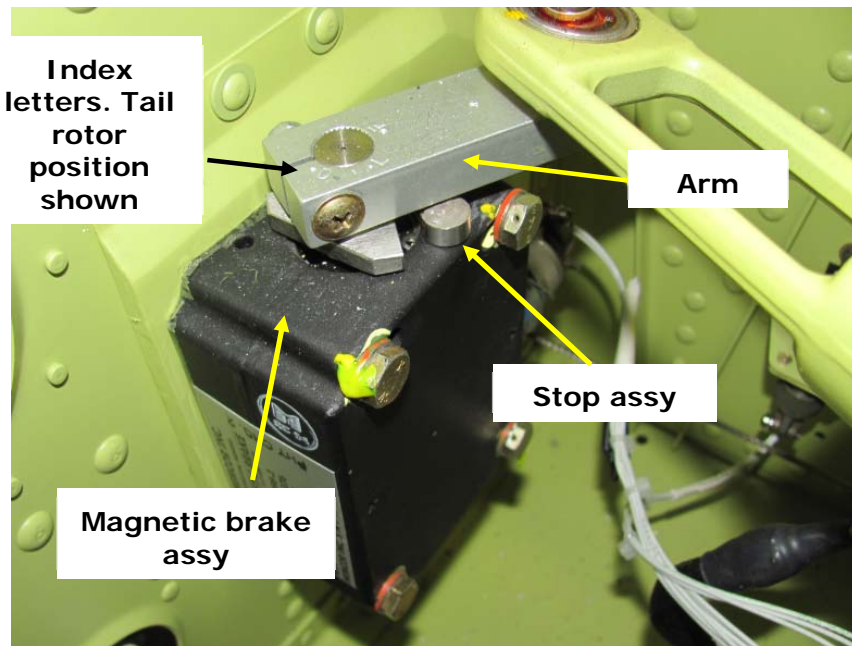
Figure 1. Magnetic brake assembly.

1. Prepare the helicopter for maintenance.
2. Gain access to the cyclic and tail rotor magnetic brake assembly (BHT-204B-M&O).
3. Perform a detailed visual inspection of the stop assemblies (Figures 1 and 2). Figures 3 and 4 show a stop assembly found disbonded.

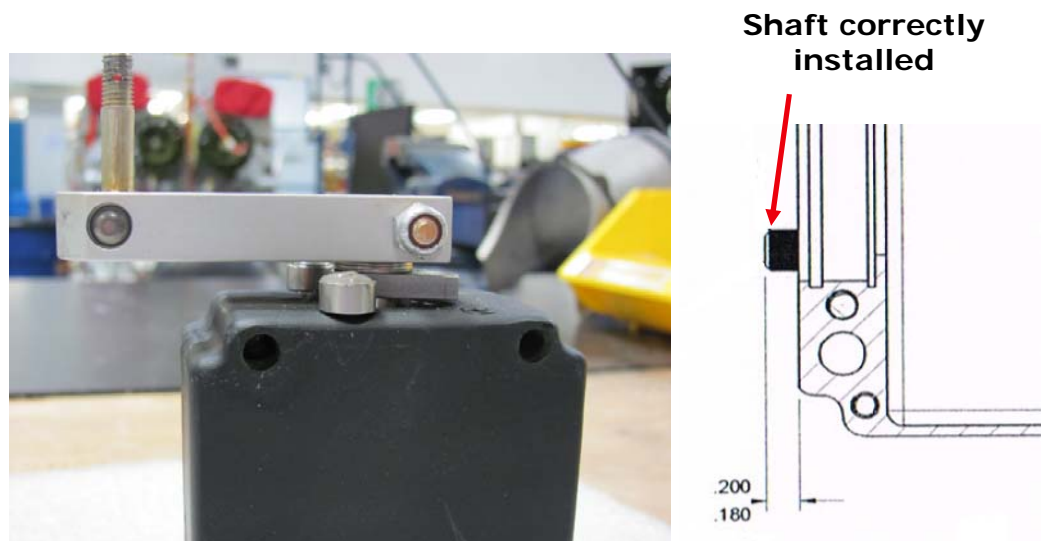
Figure 2. Magnetic brake assembly with stops correctly installed.

8. The shaft should protrude from the housing surface between 0.180 inch (4.57 mm) and 0.200 inch (5.08 mm) (Figure 2).
9. Allow sufficient time for the adhesive (C-317) to cure (24 hours at 21°C to 35°C (70°F to 95°F)) and return the magnetic brake assembly to service.

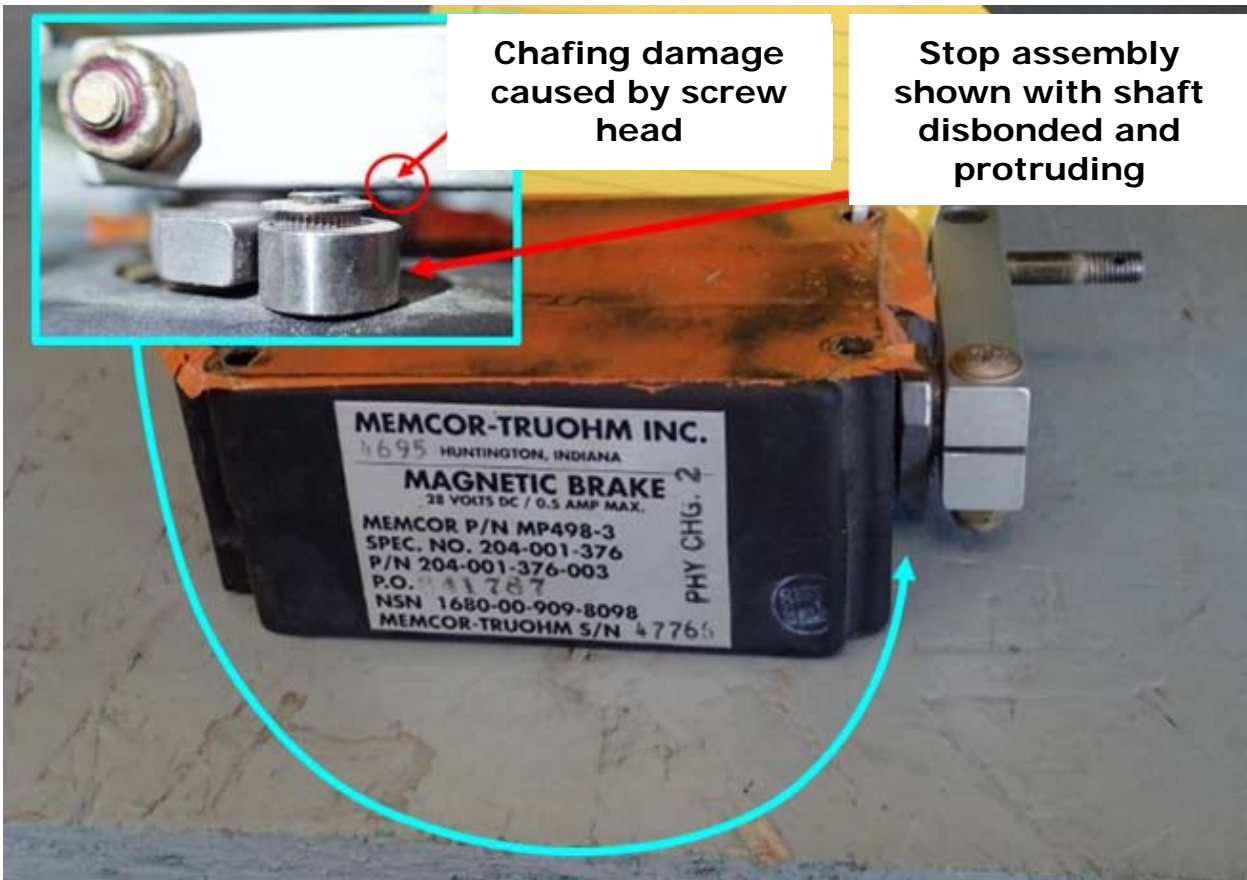
Bell Helicopter has received reports of magnetic brake assembly P/N 204-001-376-003 (Memcor-Truohm P/N MP498-3) adjustable stop assembly contacting the magnetic brake arm. With time in service, the stop assembly shaft may disbond from the housing, back out and cause interference or limit the magnetic brake arm range of motion. This condition, although not desirable, will not affect the proper function of the flight controls.

Figure 3. Stop assembly with disbonded shaft.

4. By hand, pull on the stop assembly to verify if the stop shaft is disbonded from the housing assembly.
5. If the shaft shows evidence of disbonding, inspect the lower side of the arm for possible chafing damage and accomplish Part II. The maximum allowable mechanical damage is 0.030 inch. (0.762 mm).

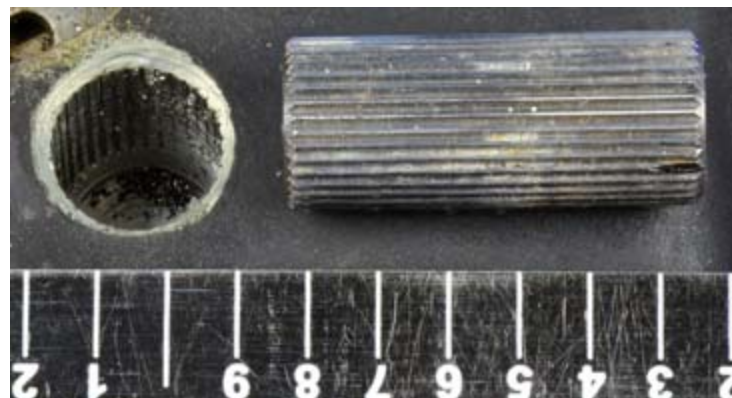
Figure 4. Shaft removed from housing.

5. Thoroughly clean adhesive residue from the shaft and the housing bore (BHT-ALL-SPM). If the splined stop requires removal from the shaft, index mark the stop, the shaft and the housing to ensure installation at the same location. If the screw is removed from the shaft, reinstall with Loctite (C-320) and torque to 5 to 10 inch-pounds (0.56 to 1.13 Newton-meters).

6. Apply adhesive (C-317) to the mating surfaces of the housing and the shaft.
7. Install the stop assembly in the housing bore and remove excess of adhesive (C-317).
