## **ALERT SERVICE BULLETIN**

**205B-23-74**

**MODEL AFFECTED:** 205B

**SUBJECT:** TENSION ROD ASSEMBLY P/N 205-030-249-009 OR 205-030-249-013, INSPECTION OF.

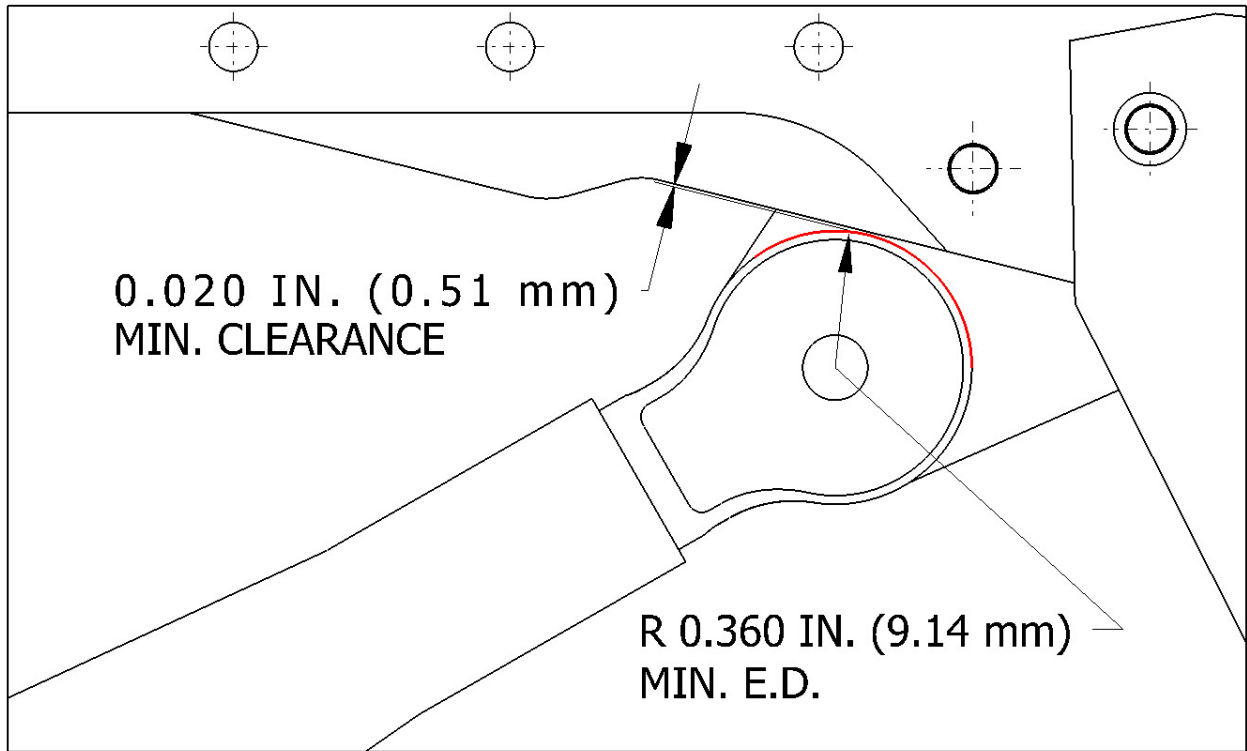
Figure 1. Inspection requirements.

2. Inspect the forward end (upper attachment location) of the tension rod assembly as follows:
  - a. Inspect the outboard side of the tension rod assembly rod end for a possible over trimmed condition. Minimum acceptable radius dimension measured from the bolt hole center is 0.360 inch (9.14 mm) edge distance (E.D.) (Figure 1). Removal of the attachment bolt may be required to perform this measurement. Record findings.
  - b. Check for fouling or low clearance conditions between the rod end and the structure (cap, web, angle). Minimum acceptable clearance is 0.020 inch (0.51 mm) (Figure 1). Record findings.
3. Inspect the aft end (lower attachment location) of the tension rod assembly as follows:

LOOKING INBOARD ON UPPER ATTACHMENT

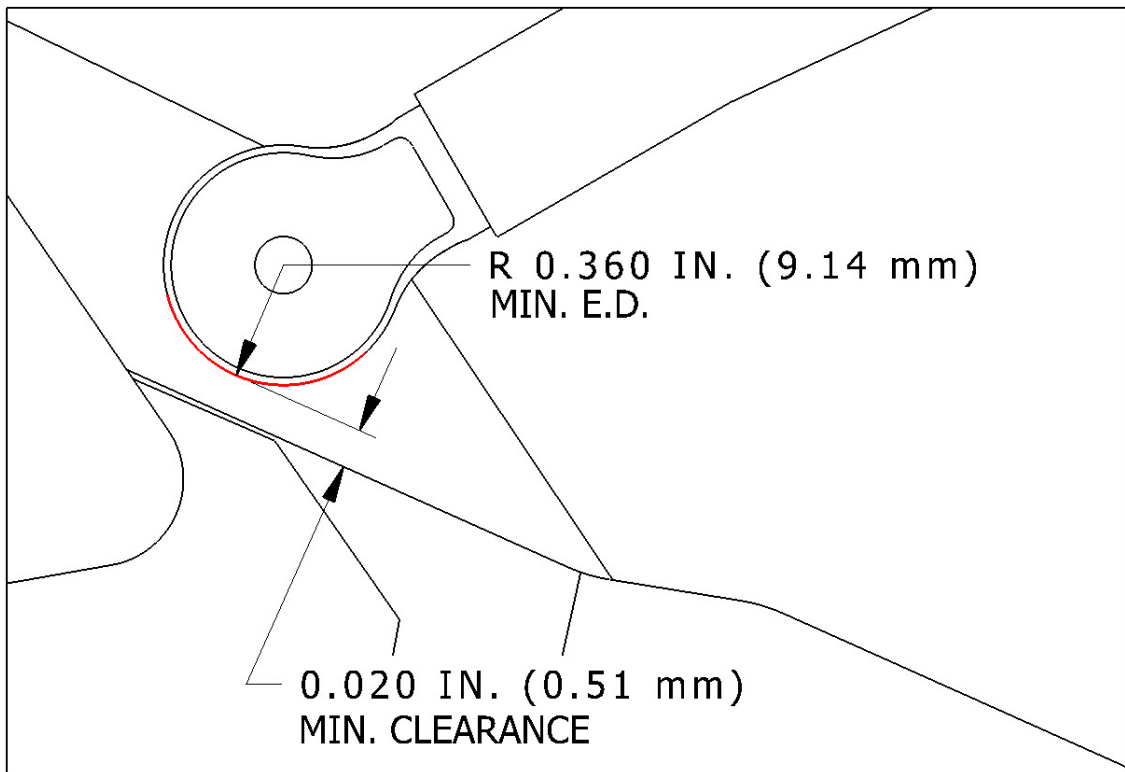
Figure 2. Inspection requirements

- a. Inspect both sides of the tension rod assembly rod end for a possible over trimmed condition. Minimum acceptable radius dimension measured from the bolt hole center is 0.360 inch (9.14 mm) edge distance (E.D.) (Figure 2 and 3). Removal of the attachment bolt may be required to perform this measurement. Record findings.

- b. Check for fouling or low clearance conditions between the rod end and the structure (cap, web) on the outboard side and the fillet radius on the inboard side of the fitting. Minimum acceptable clearance is 0.020 inch (0.51 mm) (Figures 2 and 3). Record findings.

LOOKING INBOARD ON LOWER ATTACHMENT

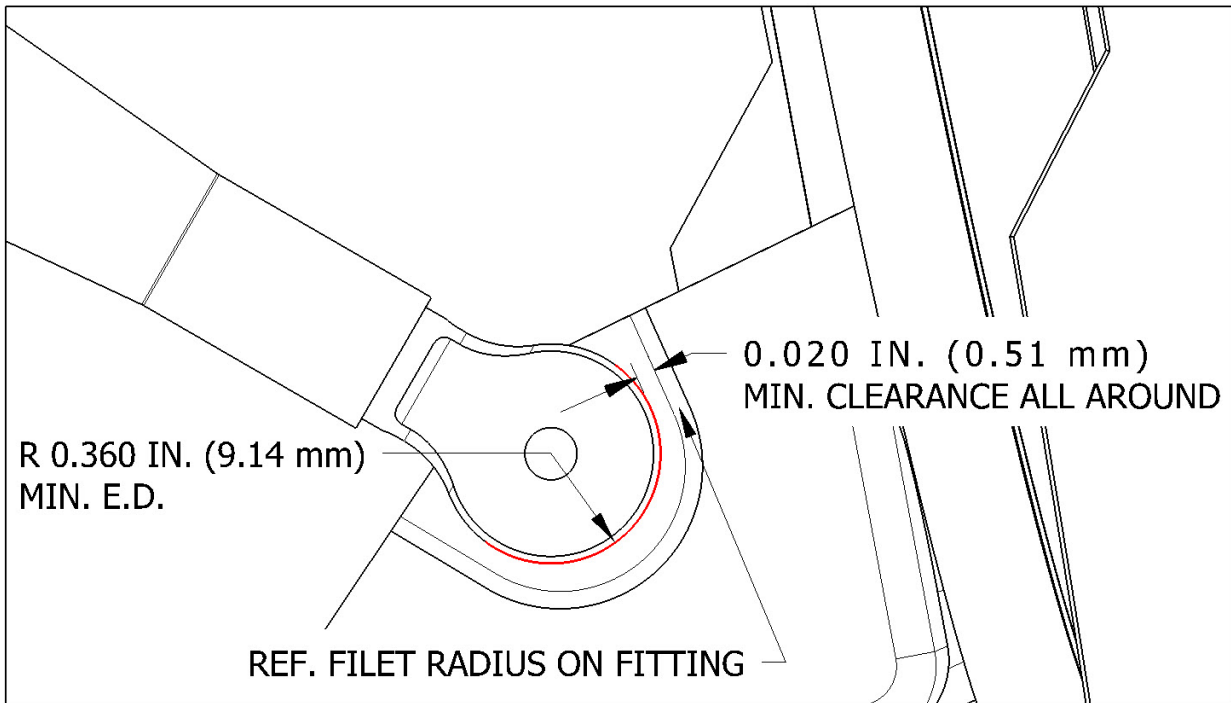
Figure 3. Inspection requirements

LOOKING OUTBOARD ON LOWER ATTACHMENT

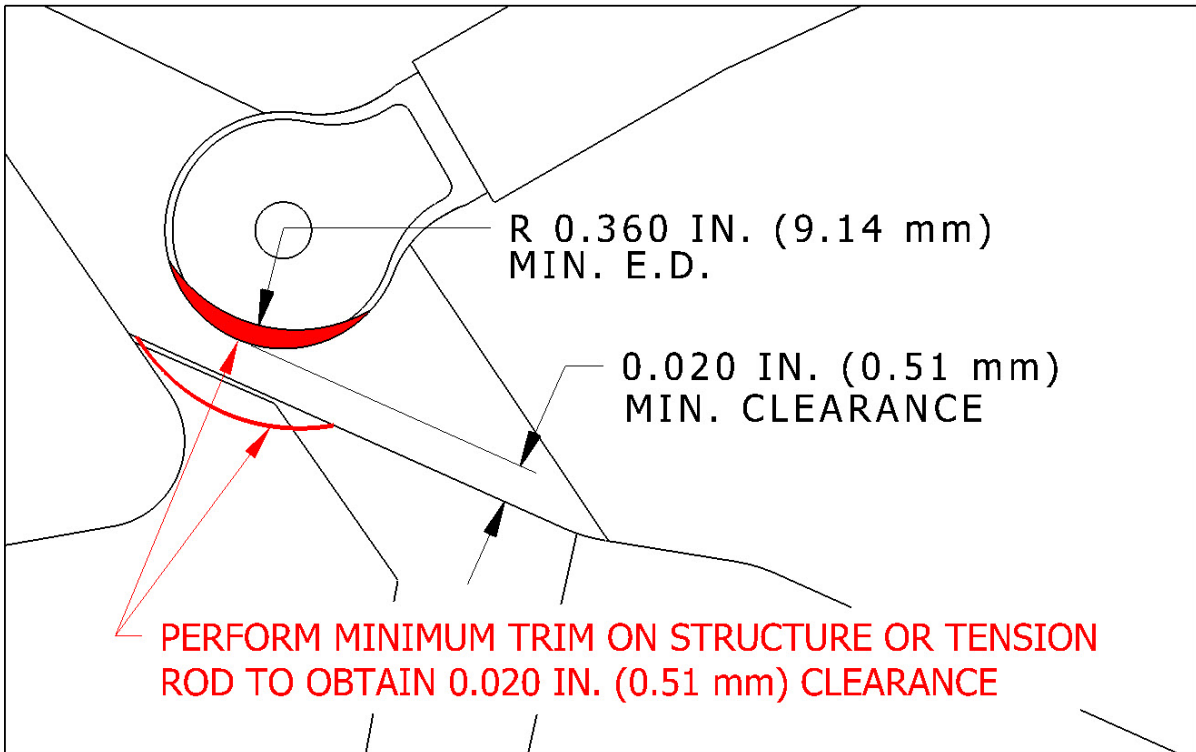
Figure 4. Rework requirements

LOOKING INBOARD ON LOWER ATTACHMENT

It is acceptable to remove material from the rod ends and/or the structure attachment fittings provided the inspection criteria defined in **PART I** are respected (Figures 4,5 and 6).

5. Trim and deburr previously marked material on the affected rod end and/or structure attachment fitting. Ensure the inspection criteria defined in **PART I** are respected (Figures 4,5 and 6).

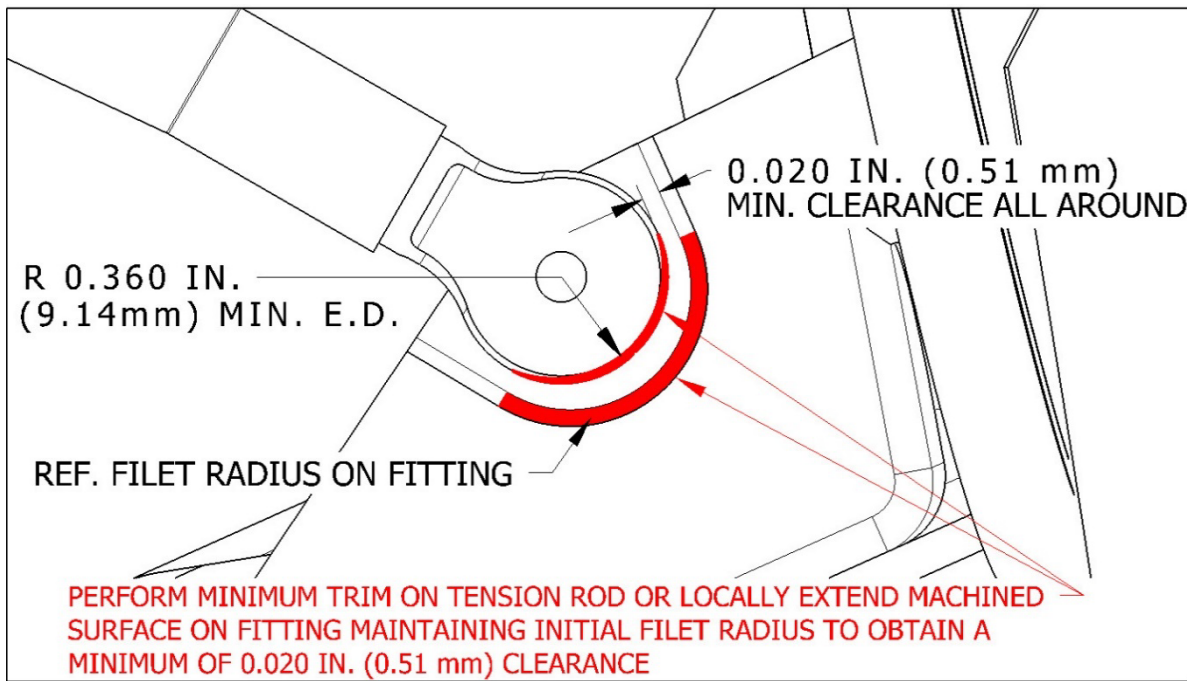
LOOKING OUTBOARD ON LOWER ATTACHMENT  
Figure 5. Rework requirements

KEEP 0.280 IN. (7.11 mm) MIN. E.D.  
FOR FASTENERS (CAP, WEB, ANGLE)
