## **ALERT SERVICE BULLETIN**

**205B-23-76**  
20 October 2023

**MODEL AFFECTED:** 205B

**SUBJECT:** INBOARD STRAP FITTING 212-010-103-101,  
RECALL OF

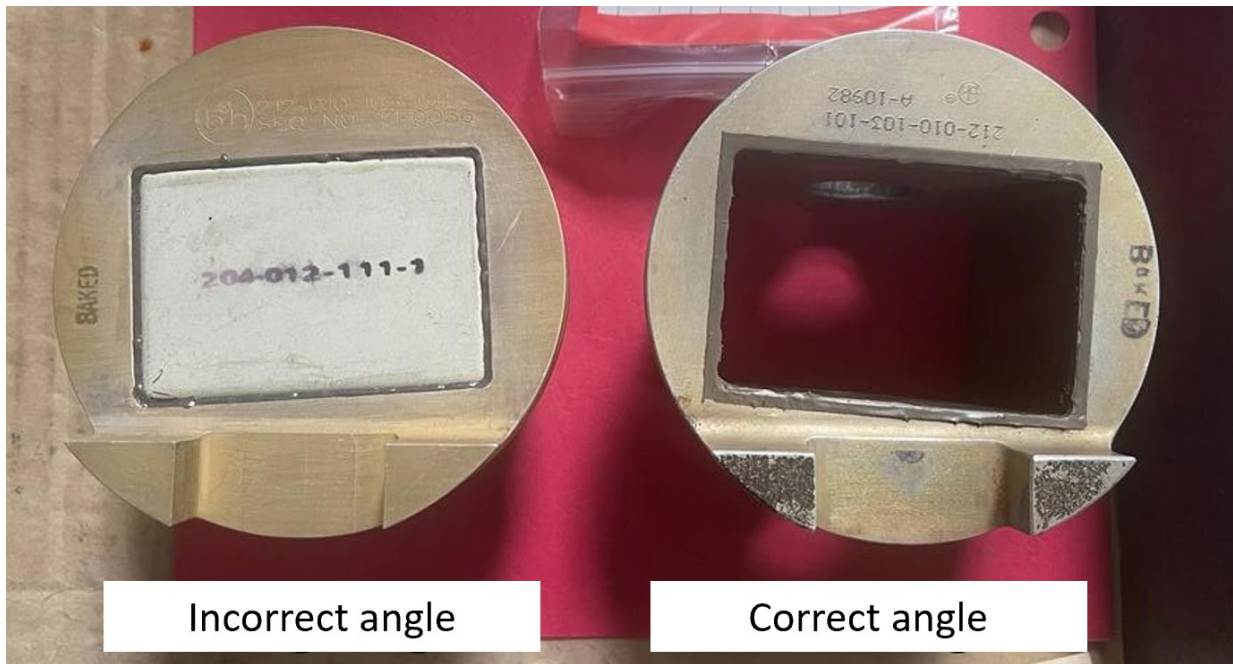
Bell has been informed that some 212-010-103-101 inboard fittings have been incorrectly manufactured with the static stop lugs at an incorrect angle as shown in Figure 1. This ASB requires that the affected fittings be returned to Bell.

**Figure 1. Inboard strap fitting 212-010-103-101.**

1. Review helicopter records and current spare inventory for inboard strap fittings 212-010-103-101 with a serial number ranging from FF0002 through FF0047 inclusively.
2. If affected strap fittings have been installed, replace in accordance with the BHT-212-CR&O chapter 62.
3. Return all defective inboard strap fittings to Bell using the instructions detailed in the WARRANTY section.
4. If an affected inboard strap fitting had to be removed from a main rotor hub assembly, make an entry in the helicopter logbook (if applicable) and historical service records indicating compliance with this Alert Service Bulletin.
