ALERT SERVICE BULLETIN

212-18-160  
25 September 2018

**MODEL AFFECTED:** 212

**SUBJECT:** HANGER BEARING SUPPORT BRACE ASSY 205-030-831-015 INSTALLATION, VERIFICATION OF

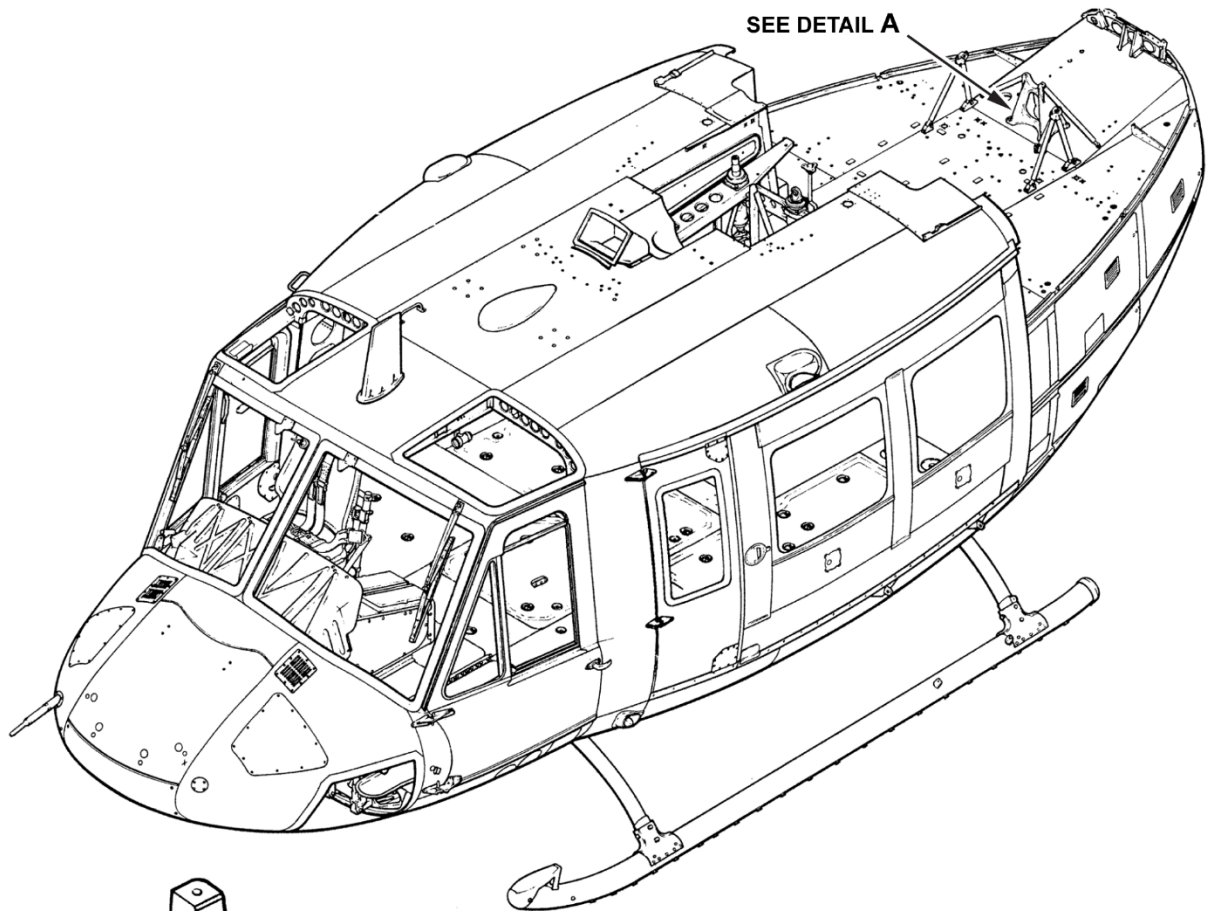
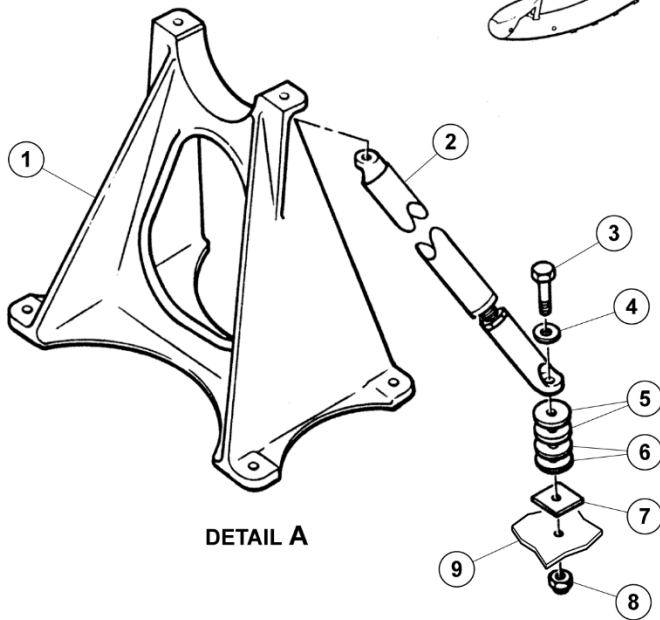
Figure 1.

Bell has received reports of the tail rotor driveshaft hanger bearing support brace assemblies 205-030-831-015 being installed incorrectly. The braces may not have been adjusted or shimmed correctly during manufacturing. Bell found that in some cases, the spot face on the support 205-030-236-009, where the upper end of the brace assembly attaches, may not be perpendicular with the bolt hole. This condition may also contribute to the incorrect installation. The spot face anomaly is considered negligible, and all supports in this condition can remain in service as is.

3. Check installed brace assemblies (2) for preload condition. Remove Sealant. Remove bolts (3) attaching brace assemblies (2) to service deck (9). If brace assembly (2) is properly adjusted, there will be no spring-back or hard contact with

the service deck (9) when bolts (3) are removed. If spring-back is in excess of 0.020 in., or hard contact is evident, adjust brace assemblies (2) as follows:

- a. Adjust overall length of brace assembly (2) so that the bolt holes in the brace lower fitting and service deck (9) are aligned.
- b. Adjust thickness of peel shims (5 and 6) between lower ends of brace assemblies (2) and service deck (9), so there is no excessive spring-back or hard contact (preload).

Maximum amount of laminated shim permitted is 0.374 inch. If more shim is required, an aluminum block that can be locally fabricated and bonded to the service deck will be required. Do not exceed a total of 0.500 inch, combined laminated shim and aluminum shim block.

- c. If required, fabricate and bond aluminum block (7) as follows:
  - (1) Fabricate shim block from aluminum with dimensions as follows:
    - (a) 1.0" wide by 1.0" long by 0.250" thick
    - (b) Drill a 9/32" inch hole in center of block, deburr.
  - (2) Remove paint, dirt and primer from service deck and clean for bonding. Bond to service deck using adhesive C-317 and remove excessive squeeze-out. Allow to cure for 24 hours.
  - (3) Prime all bare metal surfaces using C-204 and allow to dry.
4. After proper brace assembly (2) adjustment and shimming have been achieved, install bolts (3) attaching brace assemblies (2) to service deck (9). Torque nuts (8) to 50-70 in.-lbs. Seal all edges using sealant C-251.
5. Make an entry in the helicopter logbook and historical service records indicating compliance with this Alert Service Bulletin.
