ALERT SERVICE BULLETIN

212-19-161

MODEL AFFECTED: 212

SUBJECT: REDUCTION GEARBOX OIL TUBE ASSEMBLY
P/N 212-061-533-001, INSPECTION OF.

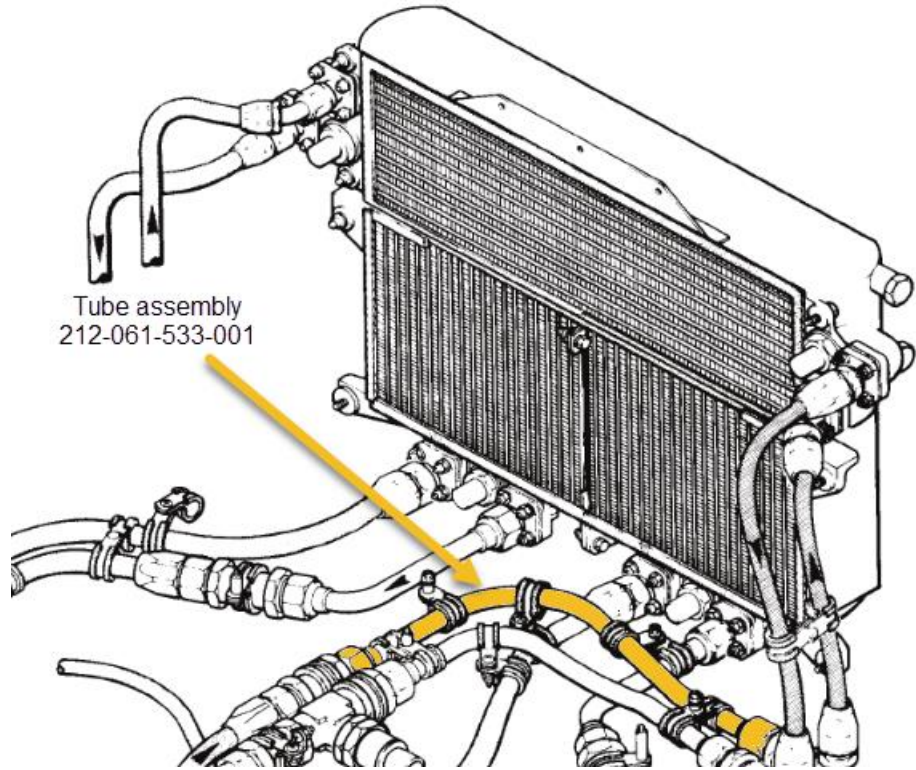
1. Prepare the helicopter for maintenance and gain access to the tube assembly 212-061-533-001 located under the oil cooler blowers in the aft engine compartment (Figure 1).

Figure 1. Tube assembly 212-061-533-001 location.

1. If not previously accomplished, prepare the helicopter for maintenance and gain access to the tube assembly 212-061-533-001 located under the oil cooler blowers in the aft engine compartment (Figure 1).
2. As required, reposition the clamping and the tube assembly to obtain proper clearance. The screw length may be reduced if required and washers NAS1149D0332J or NAS1149D0363J can be installed between the structure and the attaching clamps to obtain proper clearance.
3. If new holes are required to relocate the clamps, the holes that are no longer required must be plugged with sealant (C-308). Changing the clamp locations will require removal of the exhaust ejectors and oil cooler blowers. (BHT-412-MM Chapters 71 and 79).
4. Make an entry in the helicopter logbook and historical service records indicating findings and compliance with **PART II** of this Alert Service Bulletin.

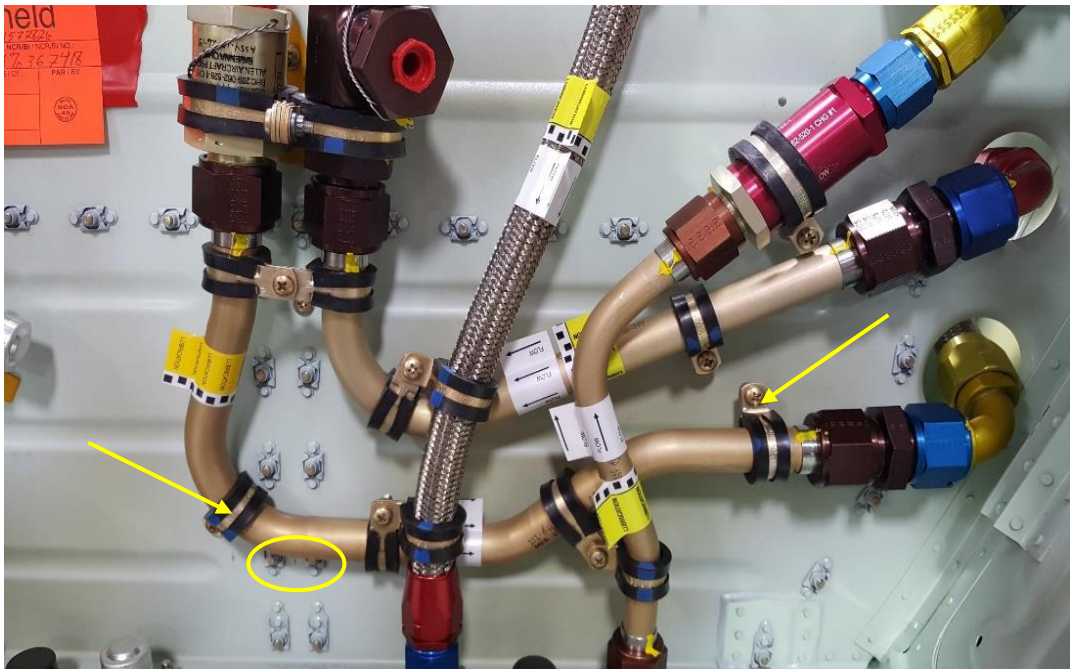
2. Using a bright light source and a feeler gauge, inspect the tube assembly for chafing damage and proper clearance between the tube assembly and the screw/nutplate (Figures 1 and 2). The maximum damage allowed is 0.003 inch (0.076 mm) and the minimum clearance required is 0.060 inch (1.52 mm).
 - a. If no chafing damage exists and the clearance meets the minimum required, no further action is required. Go to step 3.
 - b. If no chafing damage exists but the clearance is less than the minimum required, carry out **PART II** within the next 100 flight hours or 90 days whichever occurs first after the accomplishment of **PART I**.

Figure 2. Tube assembly supporting clamps and possible fouling area.

- c. For chafing damage less than or equal to 0.003 inch (0.076 mm), blend the damage smooth using an abrasive cloth or paper (C-406) 400 grit and apply chemical film treatment (C-100) as per BHT-ALL-SPM to the repaired area. Surface finish after repair should be restored to original.

- d. Install tube assembly in accordance with **PART II** before next flight.
 - e. For chafing damage greater than 0.003 inch (0.076 mm) but less than 0.010 inch (0.254 mm), replace the tube immediately in accordance with **PART II** or accomplish step f.

- f. Blend the damage smooth using an abrasive cloth or paper (C-406) 400 grit and apply chemical film treatment (C-100) as per BHT-ALL-SPM to the repaired area. Surface finish after repair should be restored to original. Replace the tube assembly in accordance with **PART II** within the next 100 flight hours or 90 days whichever occurs first after the accomplishment of **PART I**.

- g. If chafing damage exceeds 0.010 inch (0.254 mm), replace the tube assembly and install in accordance with **PART II** before next flight.
3. Make an entry in the helicopter logbook and historical records indicating findings and compliance with **PART I** of this Alert Service Bulletin.

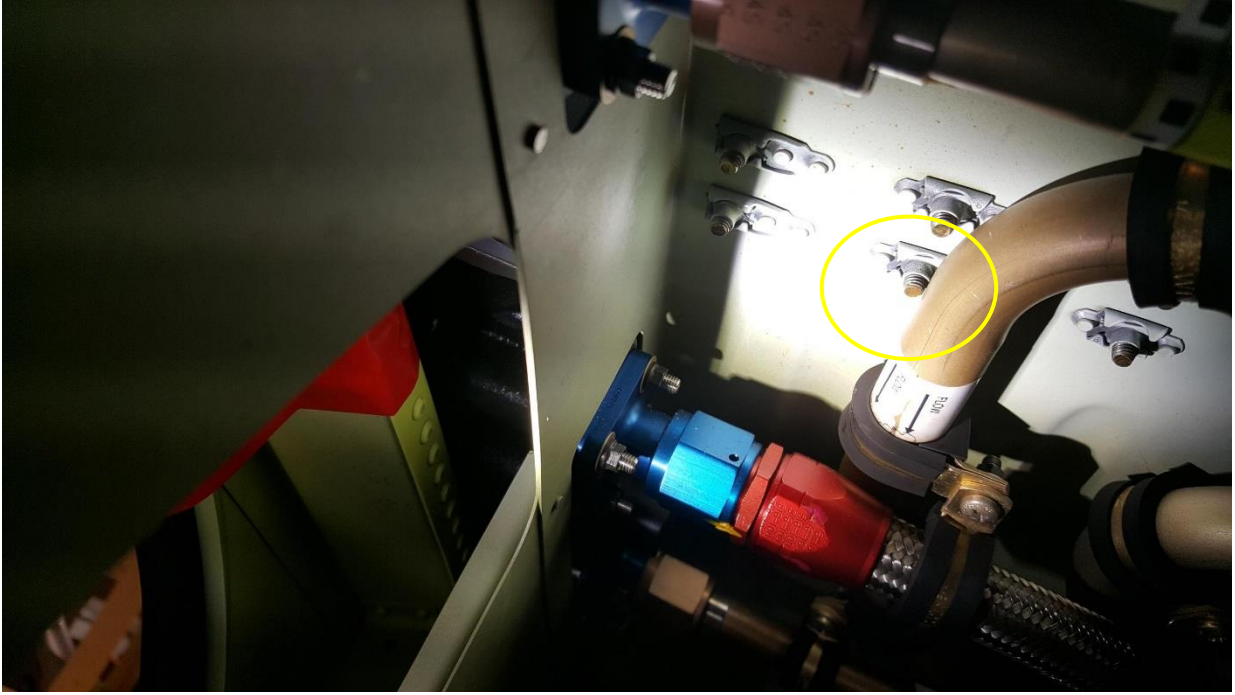
Bell has recently been made aware of a possible fouling condition between the Reduction Gearbox (RGB) oil tube assembly P/N 212-061-533-001 and a screw that secures the oil cooler blowers compartment divider. If not addressed, excessive chafing damage could lead to a loss of RGB oil pressure. This bulletin mandates a one-time inspection for chafing damage and proper installation of the affected tube assembly. Applicability of this bulletin to any spare part shall be determined prior to its installation on an affected helicopter.

Figure 3. Example of low clearance and fouling condition.
