ALERT SERVICE BULLETIN

212-23-168

MODEL AFFECTED: 212

SUBJECT: TENSION ROD ASSEMBLY P/N 212-030-170-007, INSPECTION OF.

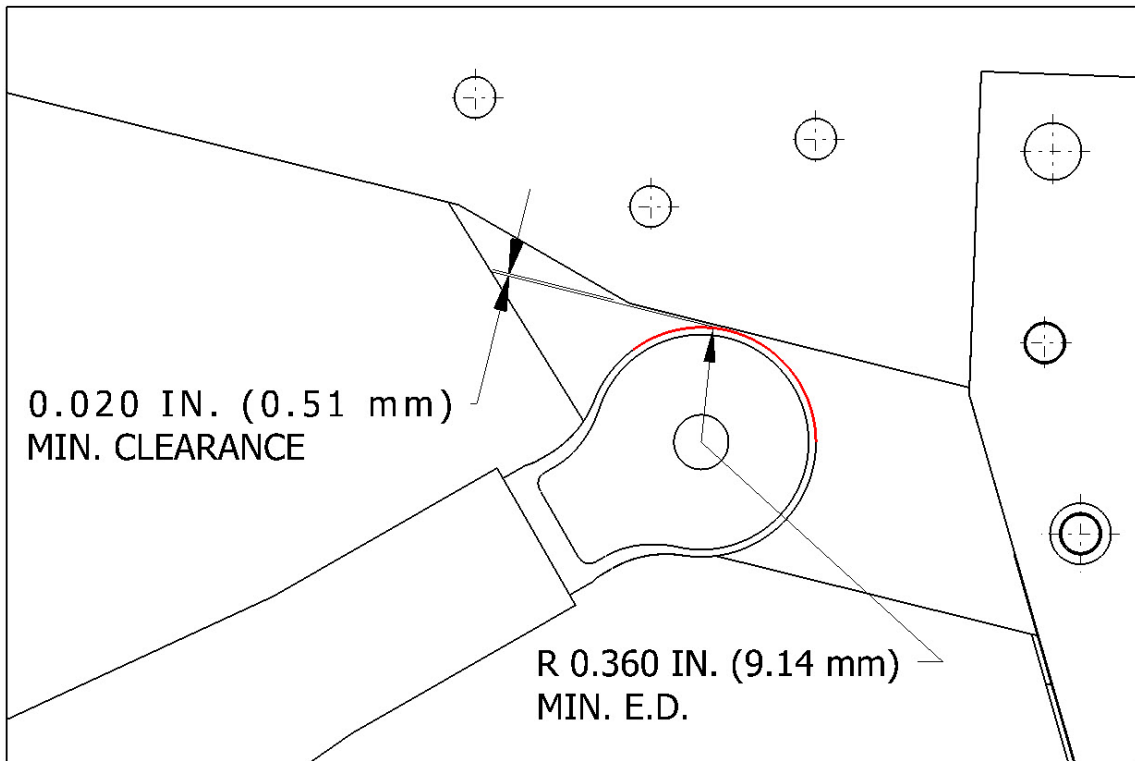
LOOKING INBOARD ON UPPER ATTACHMENT
Figure 1. Inspection requirements

2. Inspect the forward end (upper attachment location) of the tension rod assembly as follows:
 - a. Inspect the outboard side of the tension rod assembly rod end for a possible over trimmed condition. Minimum acceptable radius dimension measured from the bolt hole center is 0.360 inch (9.14 mm) edge distance (E.D.) (Figure 1). Removal of the attachment bolt may be required to perform this measurement. Record findings.
 - b. Check for fouling or low clearance conditions between the rod end and the structure (cap, web, angle). Minimum acceptable clearance is 0.020 inch (0.51 mm) (Figure 1). Record findings.

4. Following the inspections performed in steps 2 and 3, accomplish one of the following actions:
 - a. If no over trimmed conditions were found and there are no low clearance or fouling conditions, make an entry in the helicopter logbook and historical service records indicating findings and compliance with this Alert Service Bulletin.
 - b. If one or both rod ends have been over trimmed, accomplish **PART II**.
 - c. If no over trim conditions were found but there is a fouling or a low clearance condition, accomplish **PART III**.

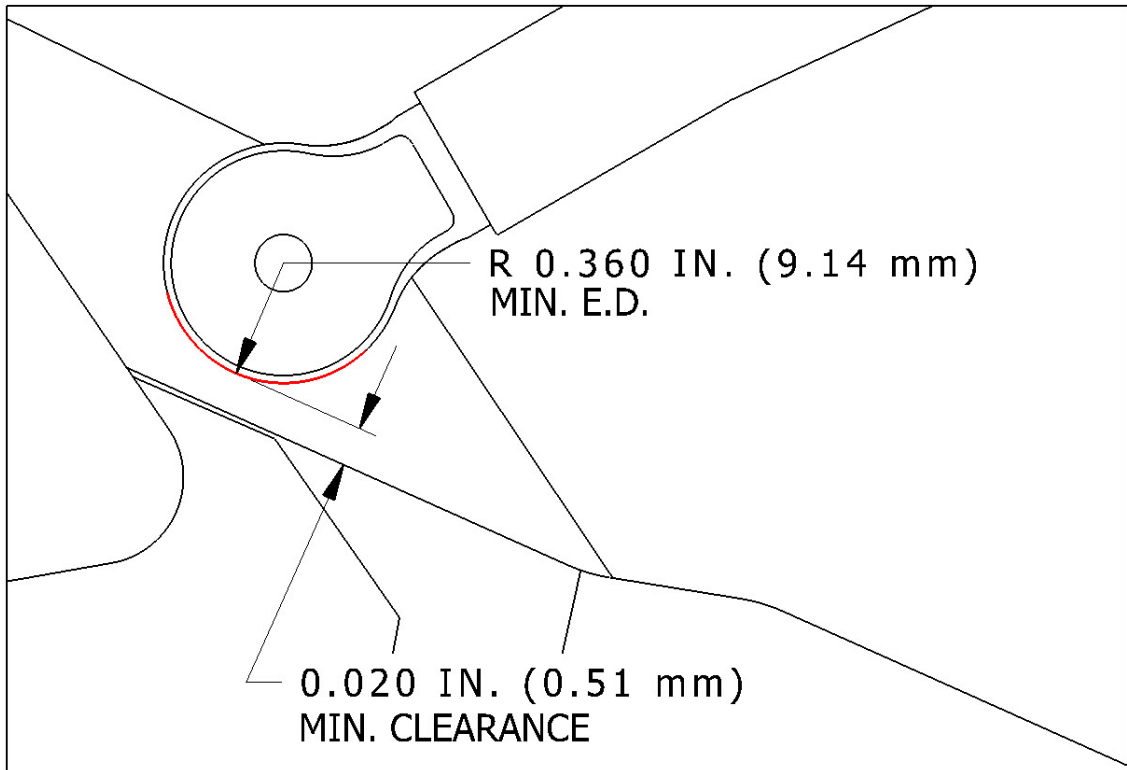
Figure 2. Inspection requirements

3. Inspect the aft end (lower attachment location) of the tension rod assembly as follows:
 - a. Inspect both sides of the tension rod assembly rod end for a possible over trimmed condition. Minimum acceptable radius dimension measured from the bolt hole center is 0.360 inch (9.14 mm) edge distance (E.D.) (Figure 2 and 3). Removal of the attachment bolt may be required to perform this measurement. Record findings.
 - b. Check for fouling or low clearance conditions between the rod end and the structure (cap, web) on the outboard side and the fillet radius on the inboard side of the fitting. Minimum acceptable clearance is 0.020 inch (0.51 mm) (Figures 2 and 3). Record findings.
