INFORMATION LETTER

206L-15-100

TO: All owners and operators of Model 206L-1, 206L-3 and 206L-4 helicopters

SUBJECT: ENGINE FOREIGN OBJECT DAMAGE (FOD), PREVENTION OF

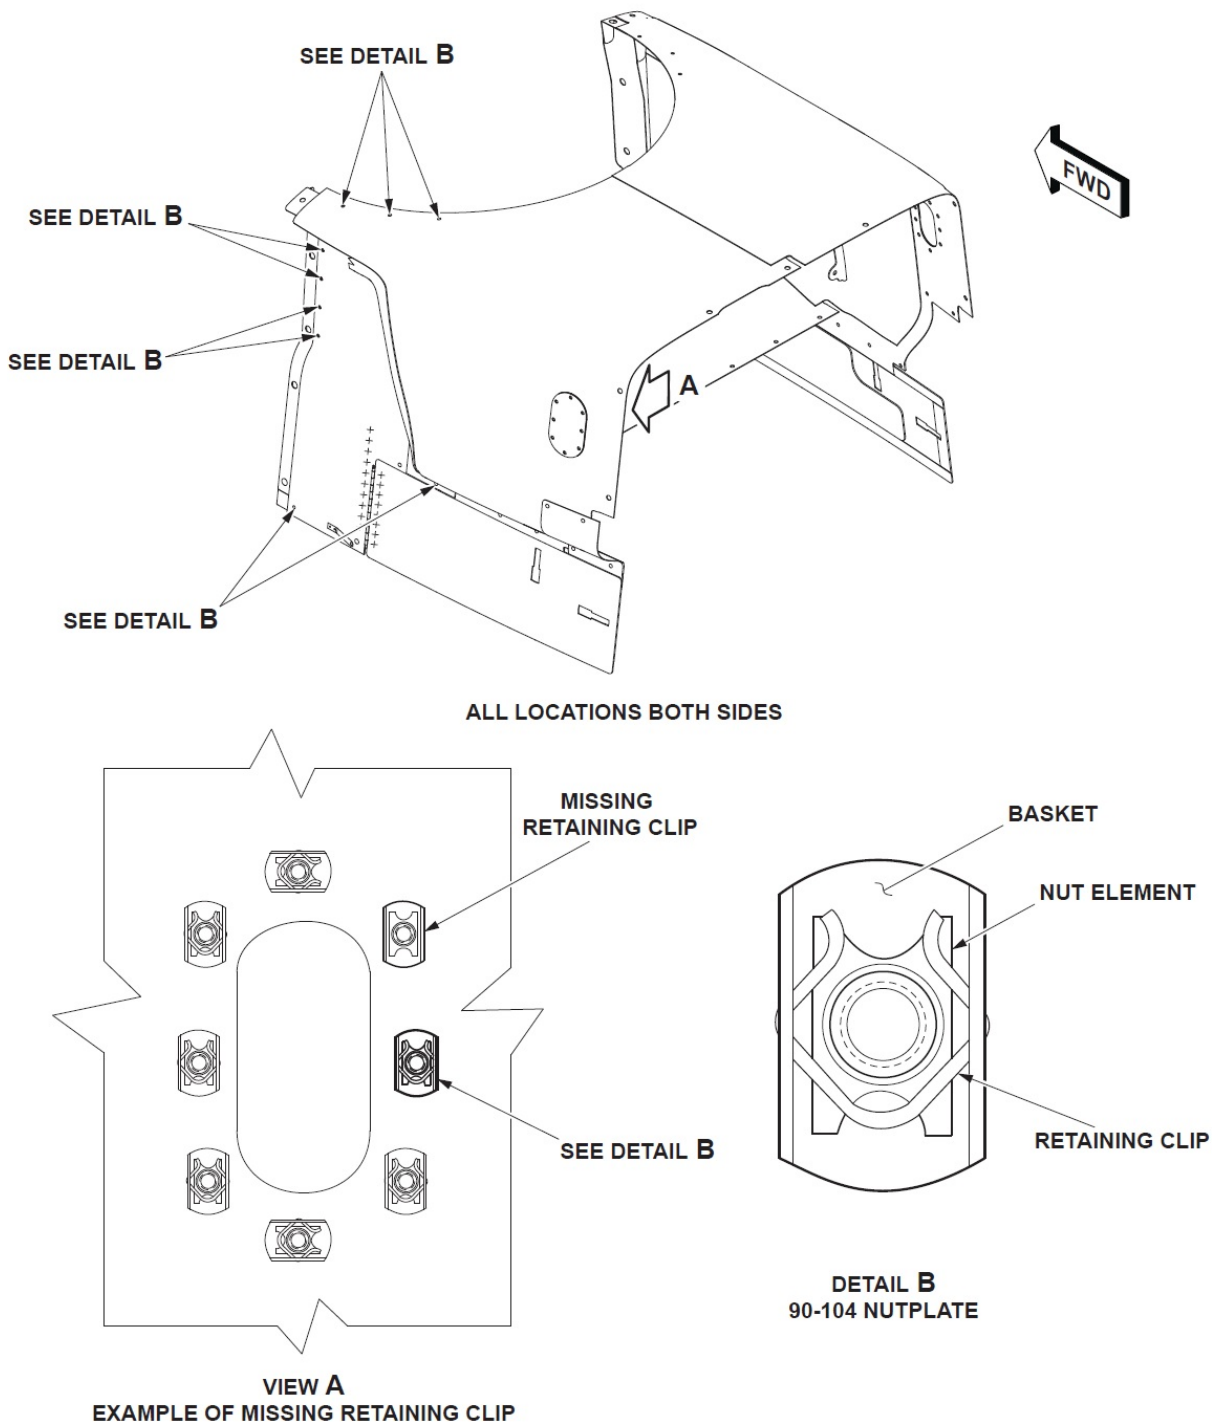
Figure 1 - Nutplate Locations and Retaining Clip Detail

The cowlings are configured with **90-104Cxx-x** nutplates that are bonded on the inner surface. This type of nutplate is designed with a replaceable nut element that is held in place by a retaining clip. The purpose of this revision is to highlight additional locations on the cowling where this type of nutplate is used in addition to the inspection windows (Figure 1, Detail B). All locations are on both sides of the cowling.

Bell Helicopter encourages maintainers to carefully inspect the nutplates for integrity when removing/reinstalling the inspection window, snow deflector, and/or the inlet cowling itself. This practice may prevent a broken nutplate causing FOD to the engine.
