ALERT SERVICE BULLETIN

NO. 210-08-03

MODEL AFFECTED: 210

SUBJECT: MAIN ROTOR BLADE P/N 210-015-001-001,
INSPECTION OF.

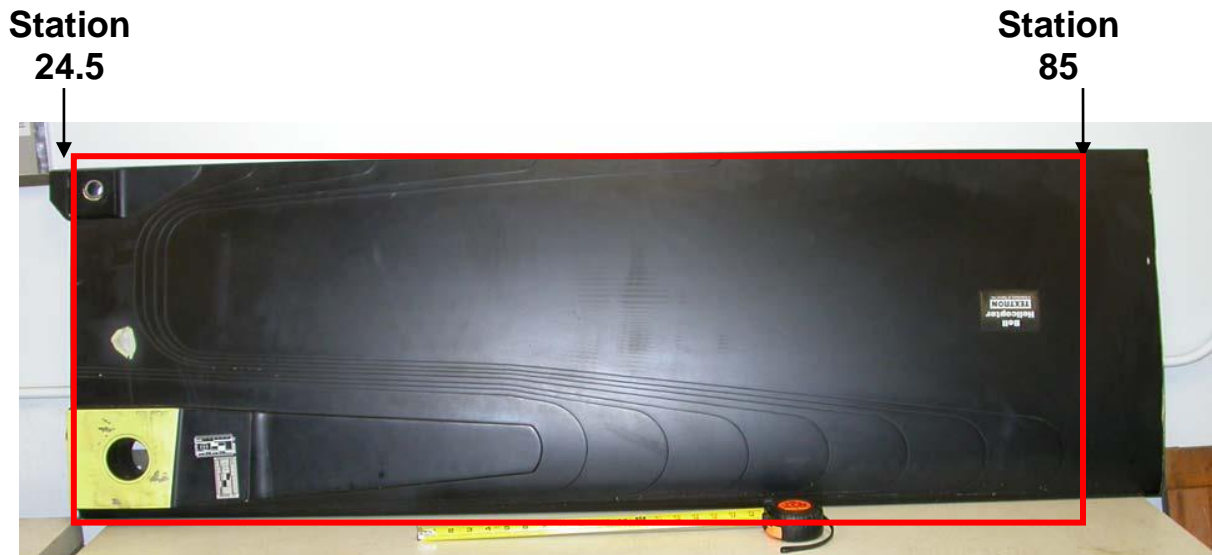
4. Carry out a detailed visual inspection of the top and bottom inspection areas of the blade using a 3X-power magnifying glass and a strong light source. Refer to Figure 1. Check for evidence of a dark line between doublers, grip plates and skin with excess alcohol bleeding out of the possible edge voids. Any cracks in the finish must be investigated further by removing paint in the affected areas (sand with 180-220 grit paper in a spanwise direction) to determine if the grip plate / doublers are cracked or voided. Any crack in paint finish which follows grip plate / doubler outline may indicate a possible edge void.

Figure 1. Area to be inspected with 3X-power magnifying glass (upper and lower surfaces)

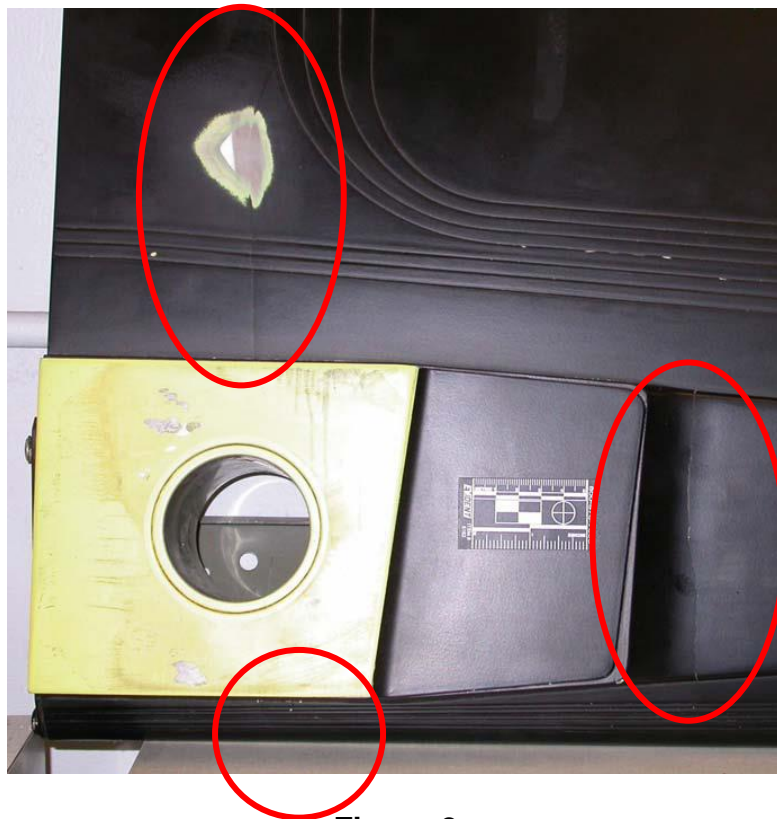
Figure 2
Crack Indications

6. If cracks in grip plate / doublers are found, the affected blade must be immediately removed from service. If no cracks are detected, continue with Step 7

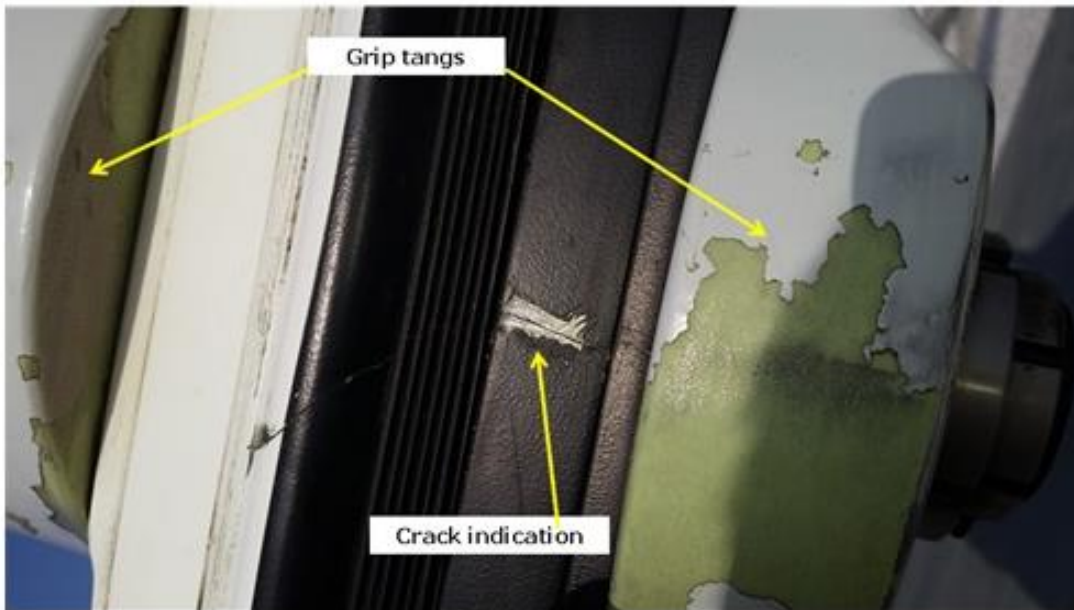
5. Carry out a detailed visual inspection of the top and bottom inspection areas in the blade bolt area using a 10X-power magnifying glass and a strong light source. Refer to Figure 4. Inspect the leading edge and the trailing edge sides of the blade across the doublers. Refer to Figure 3. Any cracks in the finish must be investigated further by removing paint in affected areas (sand with 180-220) grit paper in a spanwise direction) to determine if the grip plate / doublers are cracked or voided.

Figure 3 - Crack Indication

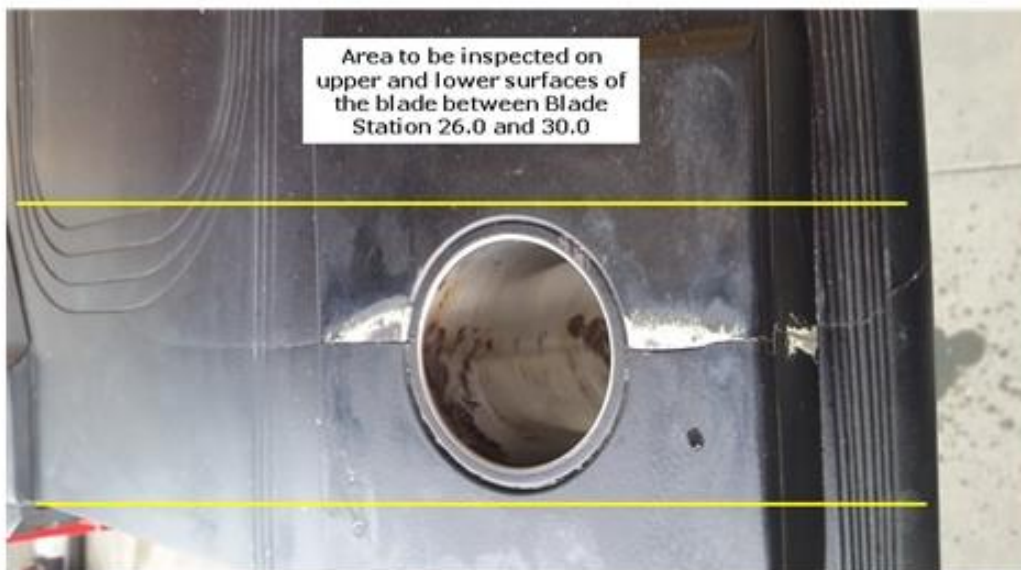
Figure 4 - Area to be Inspected with a 10X Power Magnifying Glass (Upper and Lower Surfaces)

Note: It is not required to remove the blade for inspection. The areas under the grip tangs will not be visible.
