ALERT SERVICE BULLETIN

210-17-12
21 March 2017

MODEL AFFECTED: 210

SUBJECT: **MAGNETIC BRAKE ASSEMBLY 204-001-376-003
INSPECTION AND REPAIR OF.**

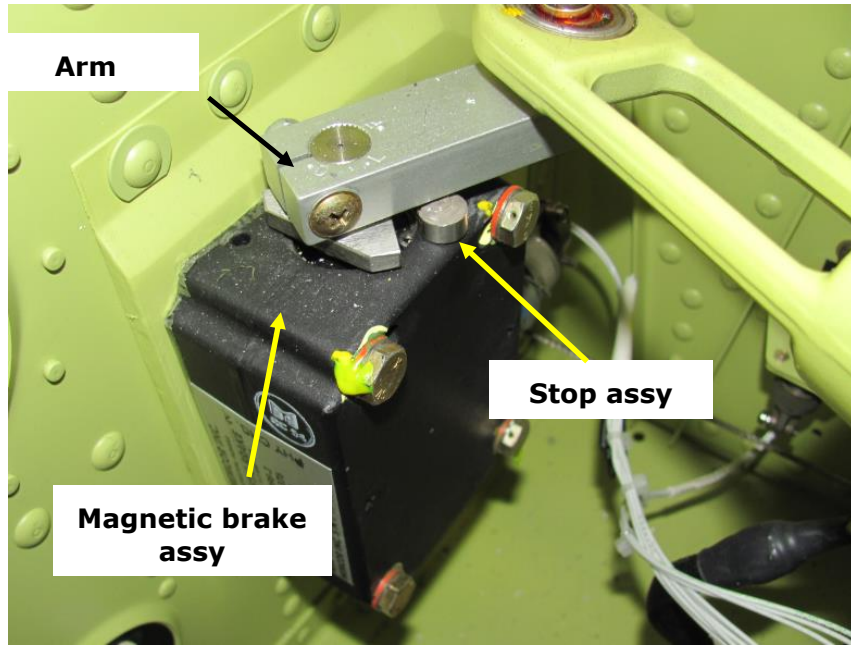
**Figure 1. Magnetic brake assembly.
(Magnetic brake 204-001-376-003 shown as an example Figures 1 to 4)**

1. Prepare the helicopter for maintenance.
2. Gain access to the cyclic and anti-torque magnetic brake assembly.
3. Perform a detailed visual inspection of the stop assemblies (Figures 1 and 2). Figures 3 and 4 show a stop assembly found debonded.

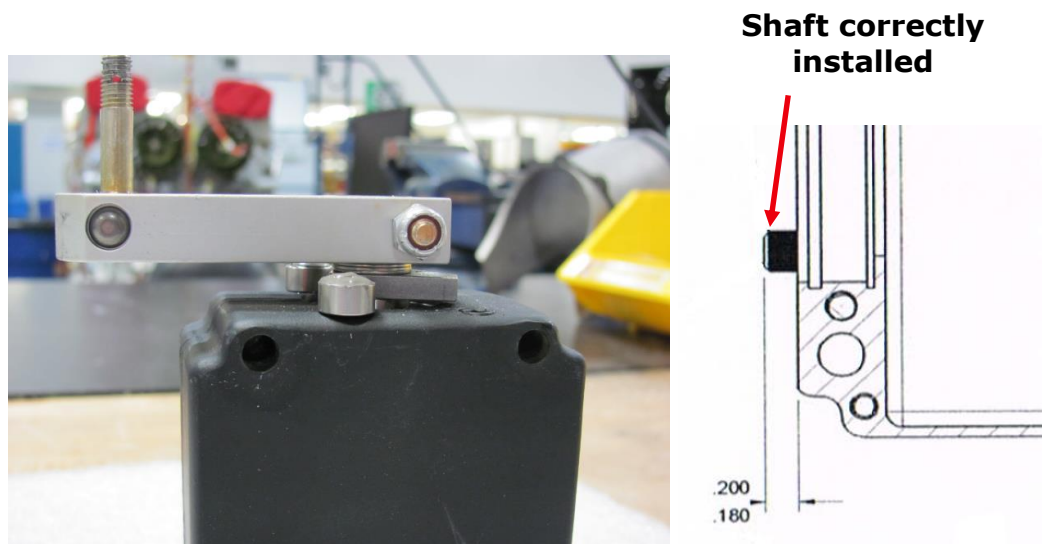
Figure 2. Magnetic brake assembly with stops properly installed.

8. The shaft should protrude from the housing surface between 0.180 inch and 0.200 inch. (Figure 2)
9. Allow sufficient time for the adhesive (C-317) to cure (24 hours at 70 to 95 °F).

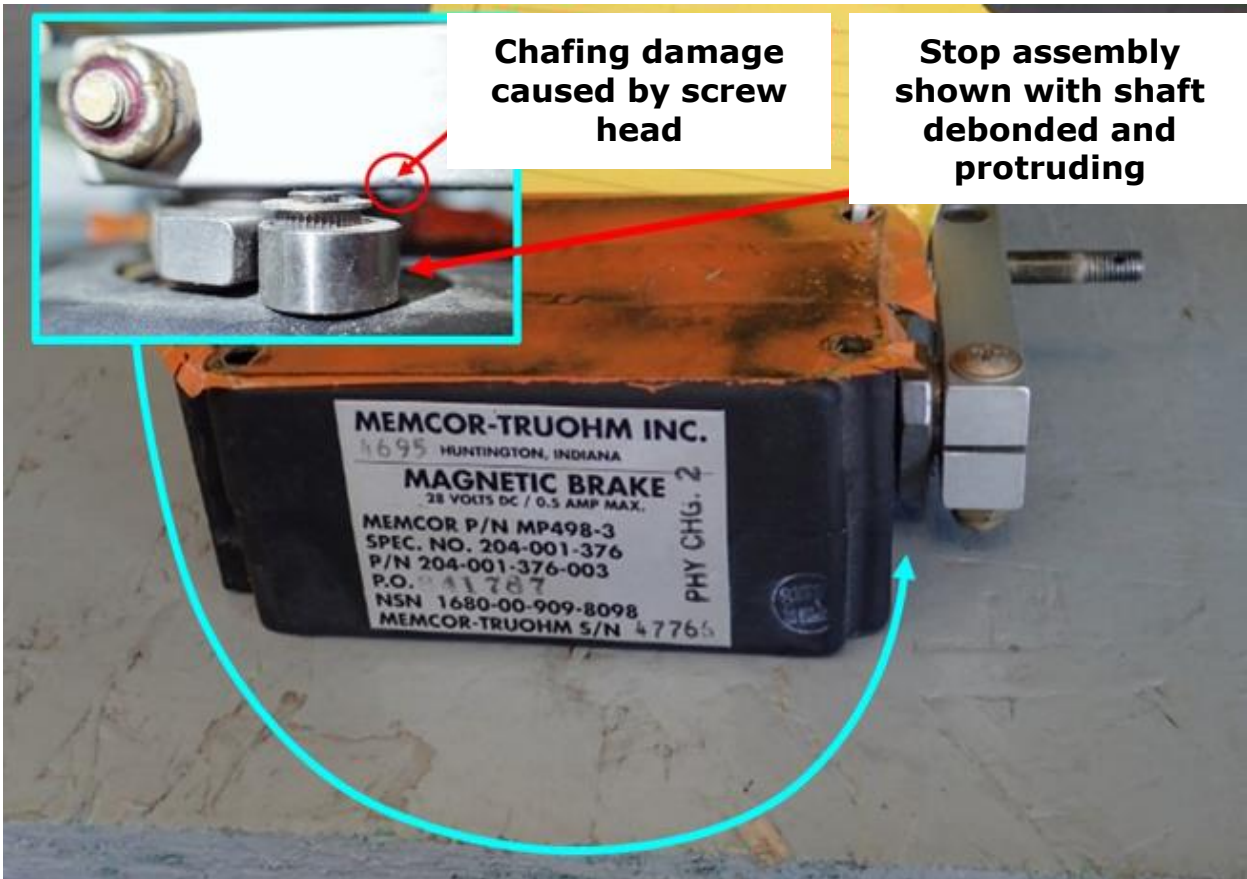
Bell Helicopter has received reports of magnetic brake assembly P/N 204-001-376-003 (Memcor-Truohm P/N MP498-3) adjustable stop assembly contacting the magnetic brake arm. With time in service, the stop assembly shaft may debond from the housing, back out and cause interference or limit the magnetic brake arm range of motion. This condition, although not desirable, will not affect the proper function of the flight controls.

Figure 3. Stop assembly with debonded shaft.

4. Pull on the stop assembly by hand to verify if the stop shaft is debonded from the housing assembly. If the shaft shows evidence of debonding, inspect the lower side of the arm for possible chafing damage. Repair allowable damage and then accomplish Part II. The maximum allowable mechanical damage is 0.030 inch. Repair allowable chafing damage as follows:

- a. Using 220 grit of finer abrasive cloth or aluminum oxide paper, polish out mechanical damage found within the allowable 0.030 inch.
 - b. Apply aluminum alloy chemical film treatment to the repaired area (BHT-ALL-SPM).

- c. If the mechanical damage exceeds the limitation contact Product Support Engineering.

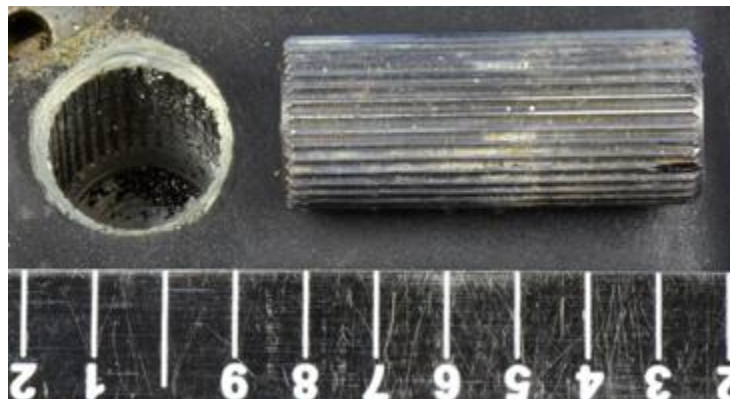
Figure 4. Shaft removed from housing.

4. Remove the stop assembly from the housing. (Figure 4)
5. Thoroughly clean adhesive residue from the shaft and the housing bore. If splined stop requires removal from the shaft, index mark the stop, the shaft and the housing to ensure stop installation at the same location.

6. Apply adhesive (C-317) to the mating surfaces of the housing and the shaft.
7. Install the stop assembly in the housing bore and remove excess adhesive.
