ALERT SERVICE BULLETIN

210-23-17

MODEL AFFECTED: 210

SUBJECT: INBOARD STRAP FITTING 212-010-103-101,
RECALL OF

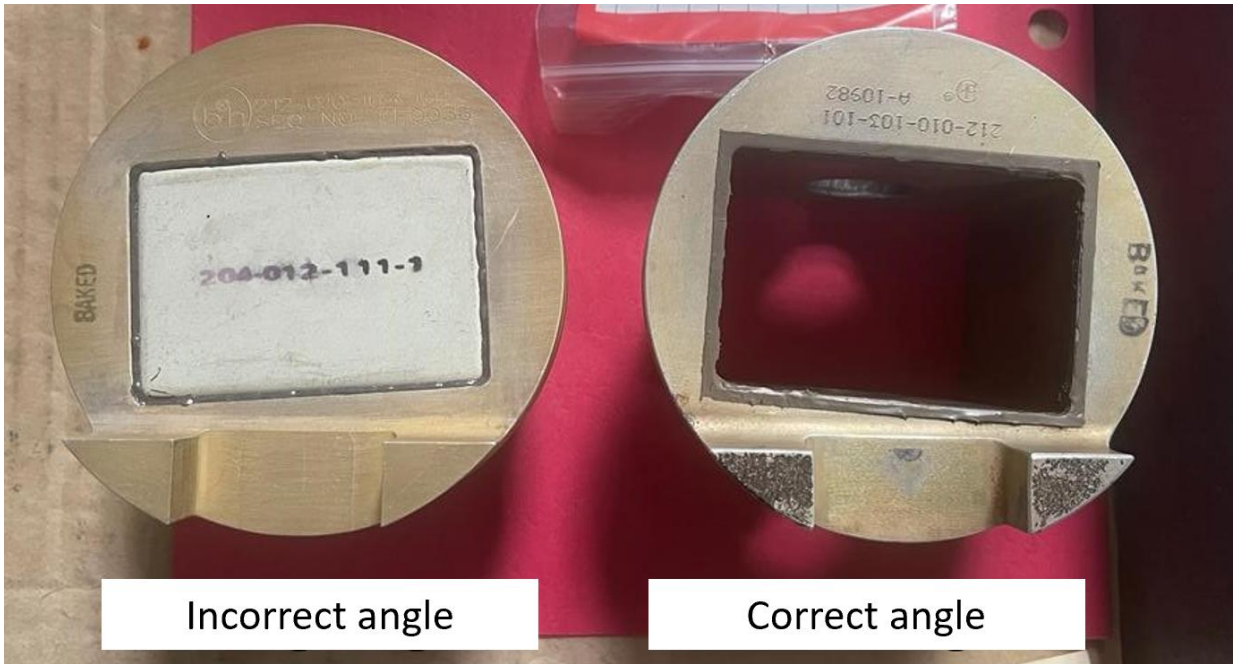
Figure 1. Inboard strap fitting 212-010-103-101.

Bell has been informed that some 212-010-103-101 inboard fittings have been incorrectly manufactured with the static stop lugs at an incorrect angle as shown in Figure 1. This ASB requires that the affected fittings be returned to Bell. Applicability of this bulletin to any spare part shall be determined prior to its installation on an affected helicopter.

1. Review helicopter records and current spare inventory for inboard strap fittings 212-010-103-101 with a serial number ranging from FF0002 through FF0047 inclusively.
2. If affected strap fittings have been installed, replace in accordance with the BHT-212-CR&O chapter 62.
3. Return all defective inboard strap fittings to Bell using the instructions detailed in the WARRANTY section.
4. If an affected inboard strap fitting had to be removed from a main rotor hub assembly, make an entry in the helicopter logbook (if applicable) and historical service records indicating compliance with this Alert Service Bulletin.
