ALERT SERVICE BULLETIN

NO. 205-00-79

MODEL AFFECTED: 205A1

SUBJECT: MAIN HYDRAULIC SERVO ACTUATOR ROD
END LOCK WASHER, INSPECTION AND
REPLACEMENT OF

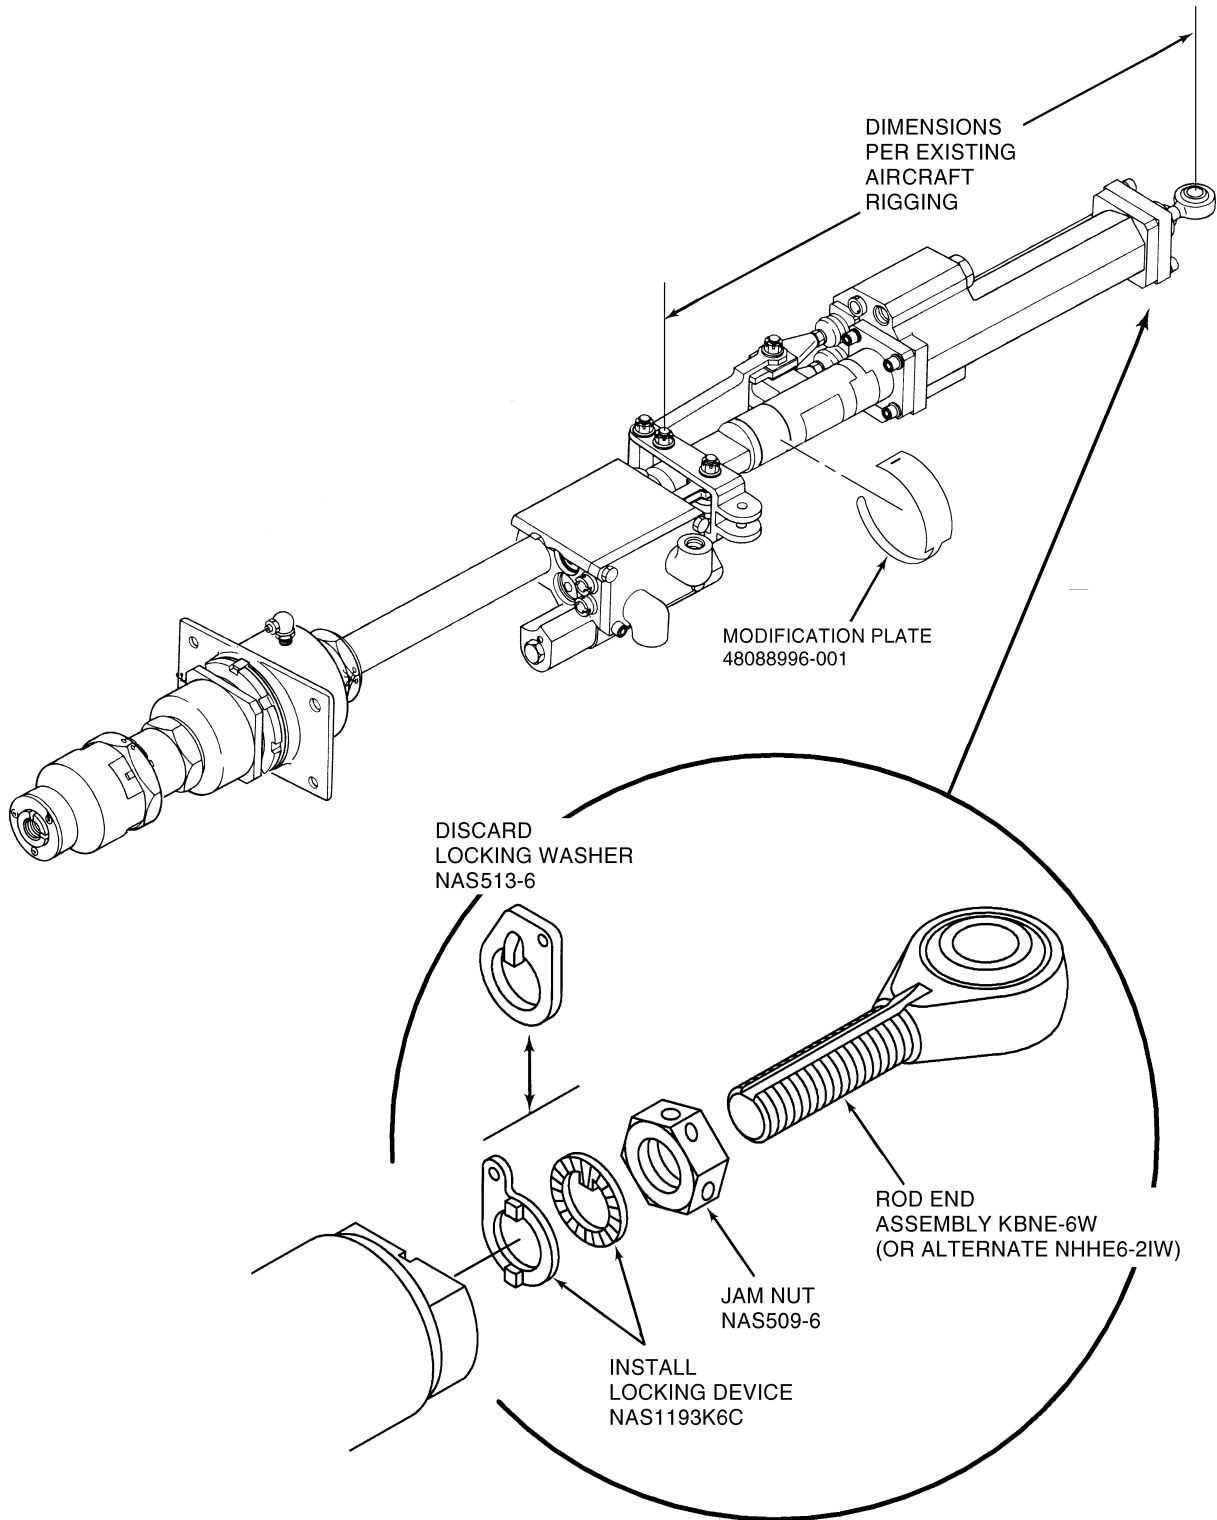
Locking Washer Inspection Area
Figure 1

On a similar actuator used on Bell 212/412 aircraft, a customer recently discovered a damaged locking washer that had allowed the piston to back itself out of the locking jam nut (Figure 1). This condition prevented the aircraft from taking off and presented a Safety of Flight condition. Bell Helicopter's subsequent investigation determined that existing locking washers NAS513-6 used on 212/412 actuators shall be replaced with new locking devices NAS1193K6C. The same locking washer NAS513-6 is used on 205 actuators, and also shall be replaced.

- (1) Without removing actuator from aircraft, gain access to locking washer (Figure 1).
- (2) Visually inspect locking washer to ensure it is not broken. Tab shall be in groove of rod end assembly. Immediately replace any locking washer whose tab is twisted or hanging askew.

- (3) Using two wrenches to protect locking washer from damage resulting from inadvertent rotation of rod end, verify torque of jam nut NAS509-6 as instructed below. Torque shall be 200 to 250 inch-pounds.

- (c) Use one wrench to hold and secure rod end assembly while using second wrench to tighten jam nut 200 to 250 inch-pounds. Do not use first wrench to hold piston assembly and turn jam nut with second wrench, as is the typical convention. This method may catch and turn the rod end, which strips the tab from the locking washer.

- (6) Remove rod end assembly from threads of piston assembly. Remove locking washer from rod end assembly and discard locking washer.
- (7) Carefully install new 2-piece locking device NAS1193K6C onto rod end assembly. Refer to Figure 1 and the following substeps:
 - (a) Install round ring onto threaded rod so that tab fits into groove on rod end and serrated side faces away from jam nut.
 - (b) Install oblong ring onto threaded rod so that serrated side will engage serrated side of round ring.
- (8) Install rod end assembly into threads of piston assembly. With piston assembly bottomed in cylinder assembly, establish the same dimension that was recorded in step 3.
- (9) Slide oblong ring (part of new locking device NAS1193K6C) so that two locking tabs fit into slots on end of piston assembly. Slide round ring (also part of new locking device NAS1193K6C) to engage oblong ring.

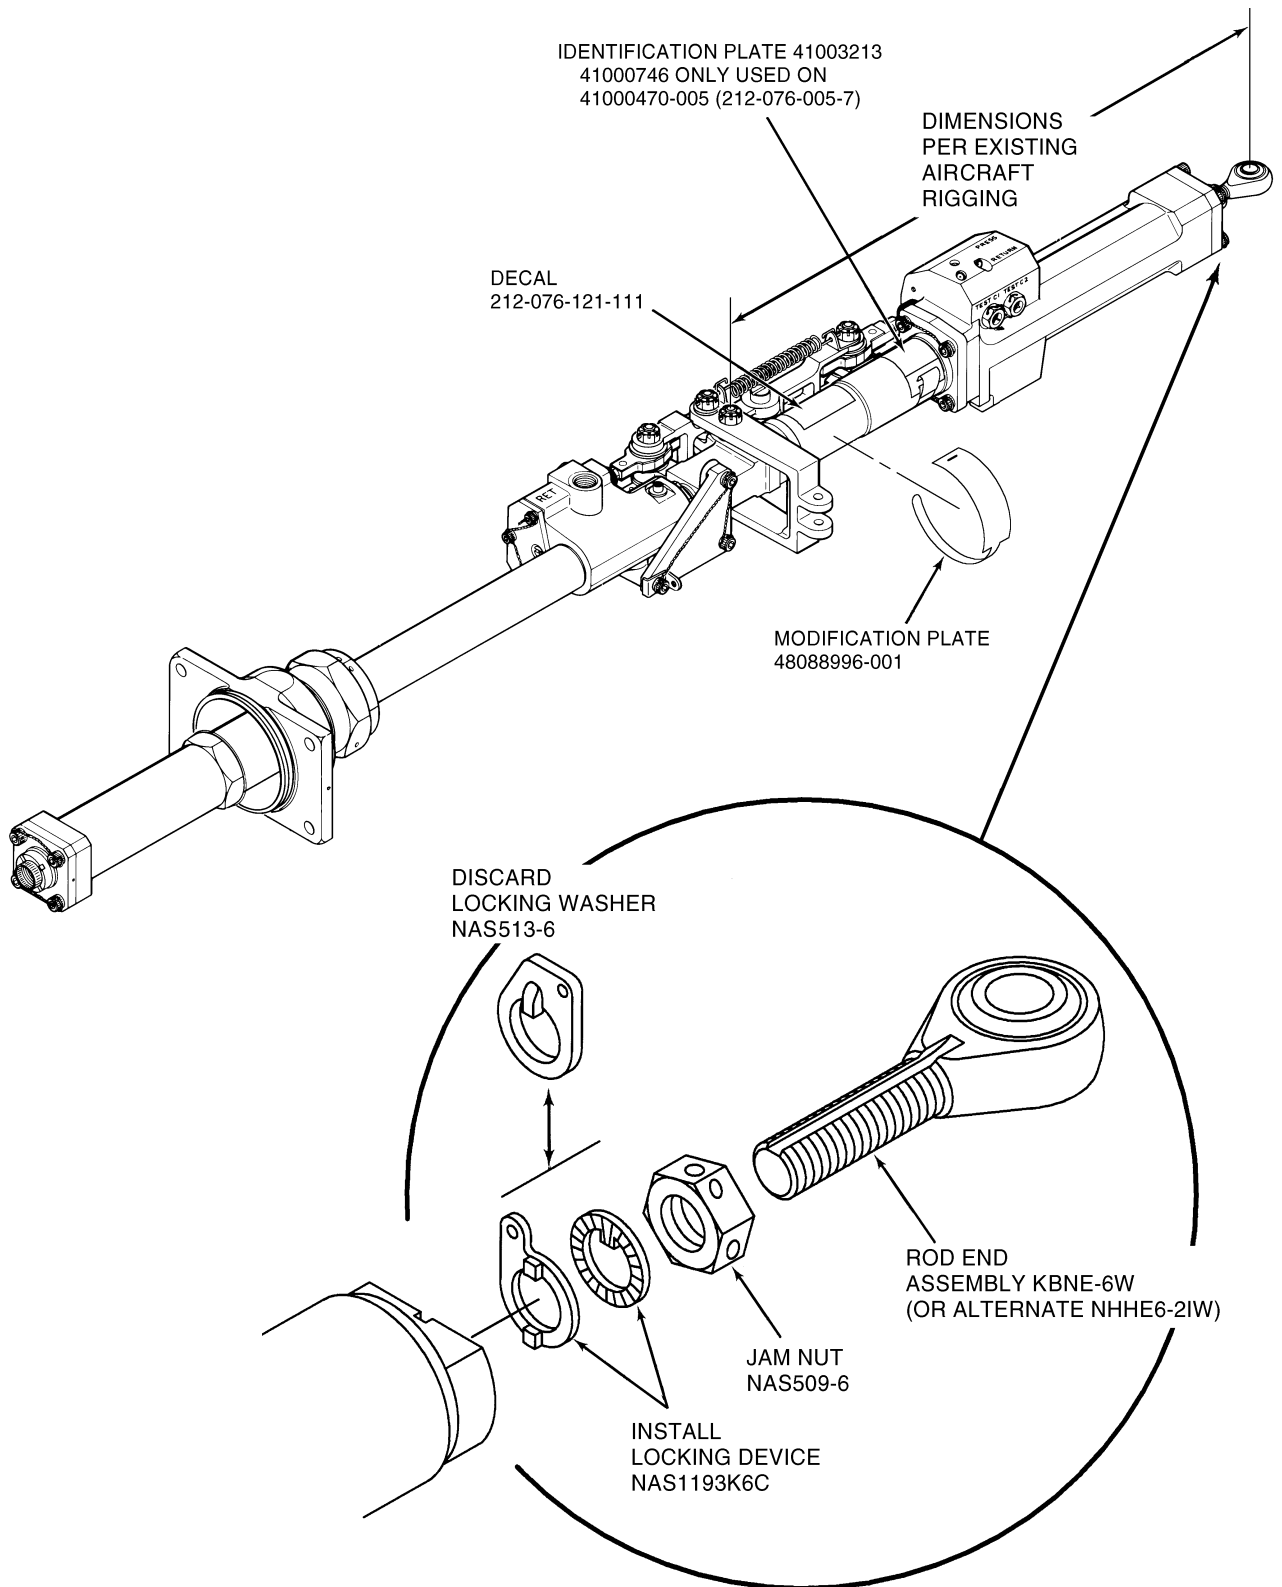
A customer recently discovered a damaged locking washer that had allowed the piston to back itself out of the locking jam nut (Figure 1). This condition prevented the aircraft from taking off and presented a Safety of Flight condition. Bell Helicopter's subsequent investigation determined that all existing locking washers NAS513-6 used on applicable actuators shall be replaced with new locking devices NAS1193K6C.

- (1) Without removing actuator from aircraft, gain access to locking washer (Figure 1).
- (2) Visually inspect locking washer to ensure it is not broken. Tab shall be in groove of rod end assembly. Immediately replace any locking washer whose tab is twisted or hanging askew.

- (3) Using two wrenches to protect locking washer from damage resulting from inadvertent rotation of rod end, verify torque of jam nut NAS509-6 as instructed below. Torque shall be 200 to 250 inch-pounds.

- (c) Use one wrench to hold and secure rod end assembly while using second wrench to tighten jam nut 200 to 250 inch-pounds. Do not use first wrench to hold piston assembly and turn jam nut with second wrench, as is the typical convention. This method may catch and turn the rod end, which strips the tab from the locking washer.

- (7) Carefully install new 2-piece locking device NAS1193K6C onto rod end assembly. Refer to Figure 1 and the following substeps:
 - (a) Install round ring onto threaded rod so that tab fits into groove on rod end and serrated side faces away from jam nut.

- (b) Install oblong ring onto threaded rod so that serrated side will engage serrated side of round ring.
- (8) Install rod end assembly into threads of piston assembly. With piston assembly bottomed in cylinder assembly, establish the same dimension that was recorded in step 3.

- (9) Slide oblong ring (part of new locking device NAS1193K6C) so that two locking tabs fit into slots on end of piston assembly. Slide round ring (also part of new locking device NAS1193K6C) to engage oblong ring.
