**SUBJECT: REVISION "D" TO ALERT SERVICE BULLETIN 205-00-80 (TAIL ROTOR BLADE 212-010-750-009 THROUGH -129 TIP BLOCK MODIFICATION)**

NO. 205-00-80

**MODEL AFFECTED:** 205A-1

**SUBJECT:** TAIL ROTOR BLADE P/N 212-010-750-009  
THROUGH -129, TIP BLOCK RETENTION  
MODIFICATION

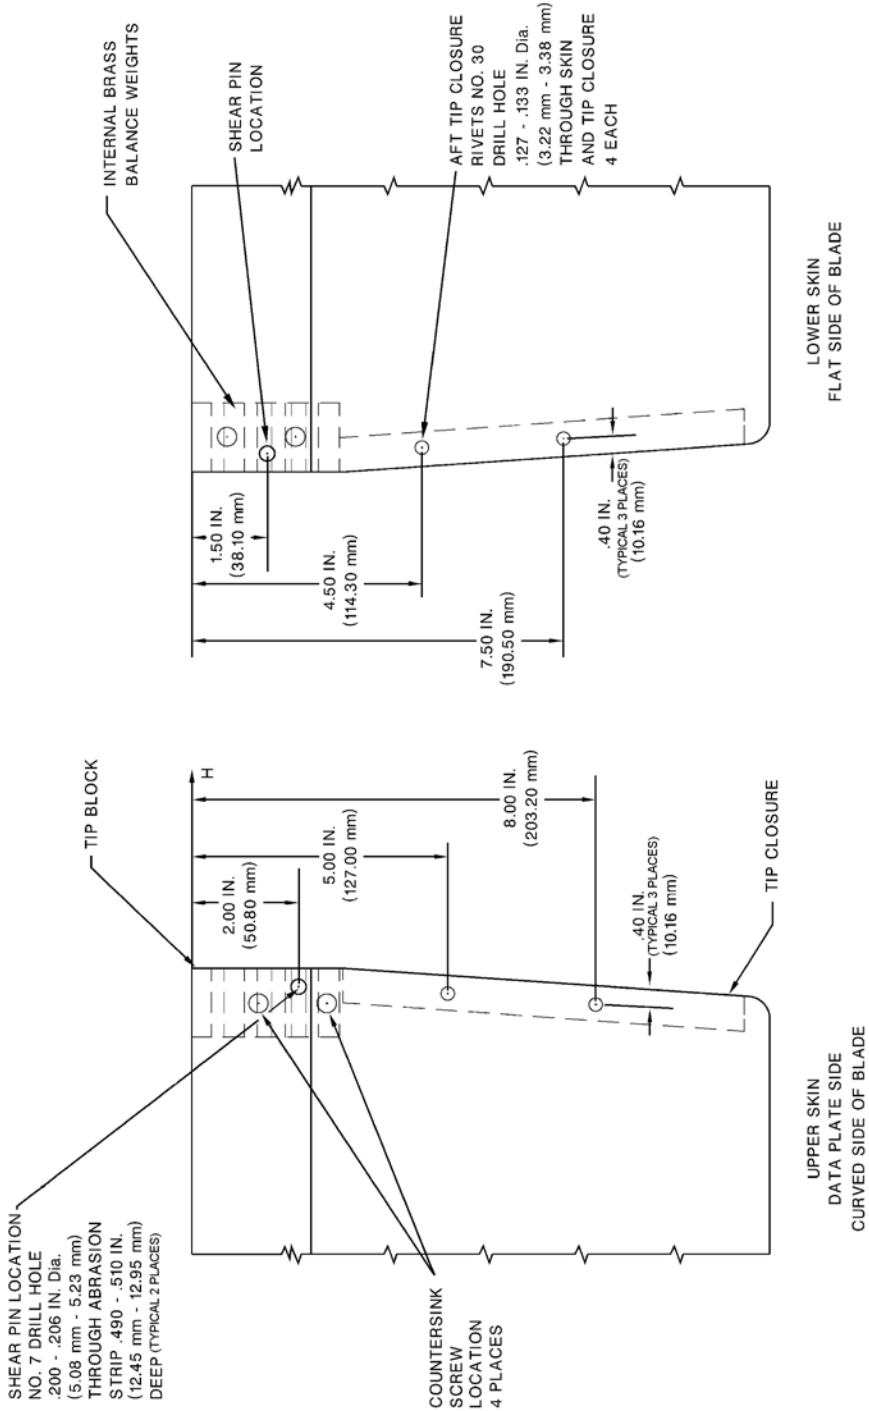
**Figure 1**  
**212-010-750 - ALL**  
**TAIL ROTOR TIP RETENTION MOD**

Bell Helicopter has recently investigated the in-flight loss of a 212-010-750-105 tail rotor blade tip block. Investigation has revealed that the countersunk screws retaining the tip block were installed incorrectly resulting in little or no tip block retention. Additionally reports have been submitted of the loss of the tail rotor tip closure. Investigation revealed that there is a possibility of a poor adhesive bond in this area allowing for voiding and eventual closure loss.

1. Deleted
2. Inspect forward tip weight retention block and aft tip closure for voids. Remove any blade from service that exhibits voids in excess of CR&O limitations.
3. Inspect forward tip block attachment countersink screws. 4 locations. See Figure 1. Inspect to insure that the head of the countersunk screw is flush with the surface of the abrasion strip.
4. T/R blades that have the screws flush with the surface of the abrasion strip in all 4 locations do not require shear pin installation. T/R blades with one or more of the screws that are set below the surface of the abrasion strip or are covered with filler material may not provide acceptable retention of the tip block in the event of adhesive failure and will require shear pin installation. The limit is flush to 0.010 inch (0.0254 mm) high.
5. The aft tip closure rivet installation must be accomplished on all tail rotor blades.

1. Using a clean, sharp No. 7 drill bit, drill a **.50** inch deep shear pin installation hole as shown on Figure 1. The upper surface of the blade can be identified as the curved side of the blade and is same side as the data plate. Likewise the lower surface of the blade is the most flat side of the blade. The shear pin installation holes are located at 2.0 inches (projected) aft of the leading edge on the upper surface and 1.5 inches (projected) aft of the leading edge on the lower surface.

1. Using a clean, sharp no.30 drill bit, drill two rivet installation holes on both the upper and lower surface of the blade tip as shown in Figure 1. It is not necessary to remove the paint in the area.
