**ALERT SERVICE BULLETIN**

**NO.** 205-01-81

**MODEL AFFECTED:** 205A/205A1

**SUBJECT:** MAGNETIC BRAKE P/N 204-001-376-003, ONE TIME INSPECTION OF.

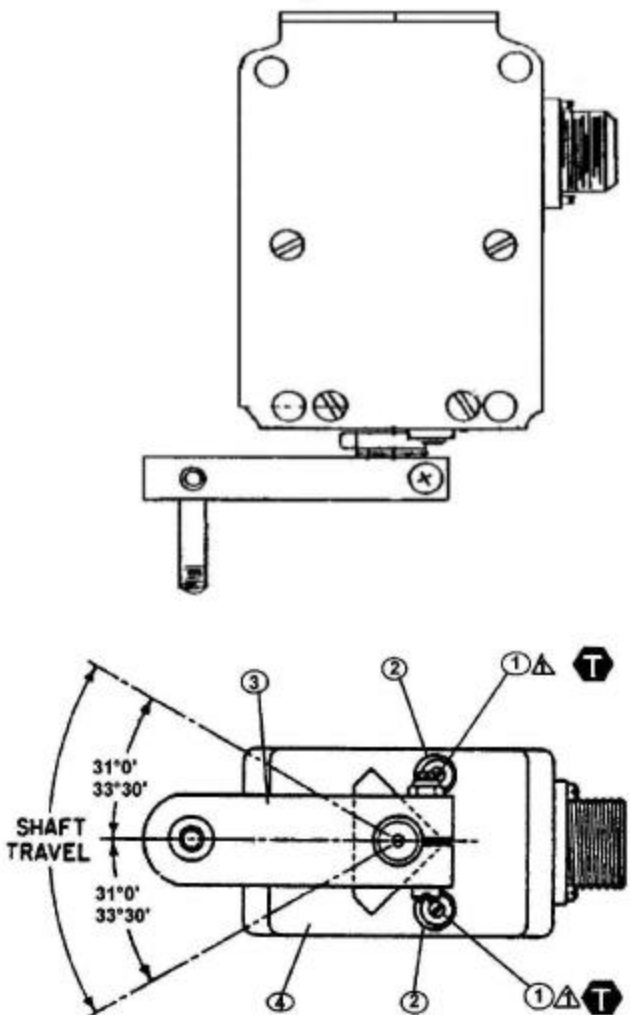
**FIGURE 1**

Bell Helicopter has recently received a report that magnetic brake P/N 204-001-376-003 adjustable stop screws P/N MS51959-3 had backed out which limited the travel of the arm assembly. Investigation revealed the stop screws had been installed without the proper adhesive. These Magnetic Brakes were manufactured by Memcor Truohm, Inc. under their P/N MP498-3. Magnetic Brakes P/N 204-001-376-003 made by other manufacturers are not affected by this bulletin.

6. Using a suitable torque wrench and screw driver bit apply 10 inch/lbs (1.12 Nm) force to screw(s) (1, figure 1) in a counterclockwise direction. If screw(s) (1) do not move, proceed to step 12. If any movement is found on screw(s) (1) proceed to the following steps.

If the inspection reveals that screw(s) (1) has disengaged, inspect arm assembly (4) for mechanical damage created by screw(s) (1). If mechanical damage is found, the depth shall not exceed 0.030 inch (0.762 mm). Acceptable damage may be smoothed and treated in accordance with the Standard Practice Manual Chapter 3 for Chemical Film. If damage is greater than 0.030 inch (0.762 mm) contact Product Support Engineering.

7. Remove screw(s) (1) and stop limit(s) (2) from magnetic brake (4).

8. Clean residue adhesive from magnetic brake (4) screw holes and screw(s) (1) with compressed air.
9. Apply adhesive (C-320) to screw (1) threads and install in magnetic brake (4) hand tight.
10. Adjust the stop limit(s) (3) to achieve the arm assembly shaft travel as per dimensions in BHT-205-MM Maintenance Manual, Chapter 27.
11. Once shaft travel is obtained, torque screws (1) 5 to 10 in-lbs (0.56 to 1.12 Nm).
12. Apply torque seal inspection ink to screws (1) and to stop limits (2).
13. Re-install cyclic fore & aft and lateral magnetic brakes into aircraft.
14. Re-install cyclic and anti-torque magnetic brake access panels.
15. Connect battery.
16. Make an entry in the helicopter historical records indicating compliance with this Alert Service Bulletin.

- Bond screw with adhesive C-320
- 5 to 10 IN-LBS  
(0.56 TO 1.12 Nm)
