ALERT SERVICE BULLETIN

NO. 205A1-01-82

MODEL AFFECTED: 205A-1

SUBJECT: CHIP DETECTOR ASSEMBLY, TEDECO B3703

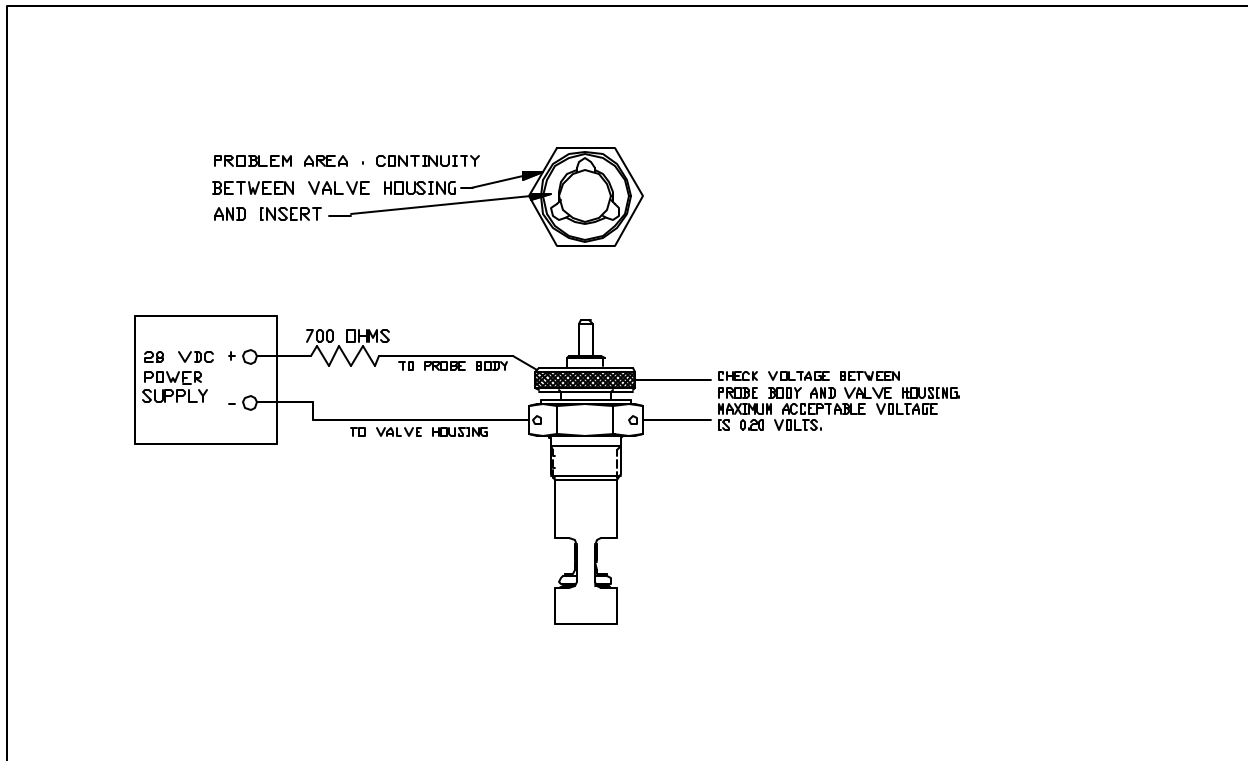
FIGURE 1

1. Connect the chip detector to a 28 Volt DC power supply using a 700 ohm, 2 watt resistor as shown in Figure 1.
2. Measure the voltage between the probe body and the valve body. The voltage drop must be 0.20 volts or less across the unit. If the voltage drop is larger than 0.20 volts, then return the unit to Tedeco (See 3. Part Replacement.)
