ALERT SERVICE BULLETIN

NO. 205-02-87

MODEL AFFECTED: 205A-1

SUBJECT: TAIL ROTOR BLADE ASSEMBLIES P/N 212-010-750-011 / -113 / -115, INSPECTION AND REWORK OF.

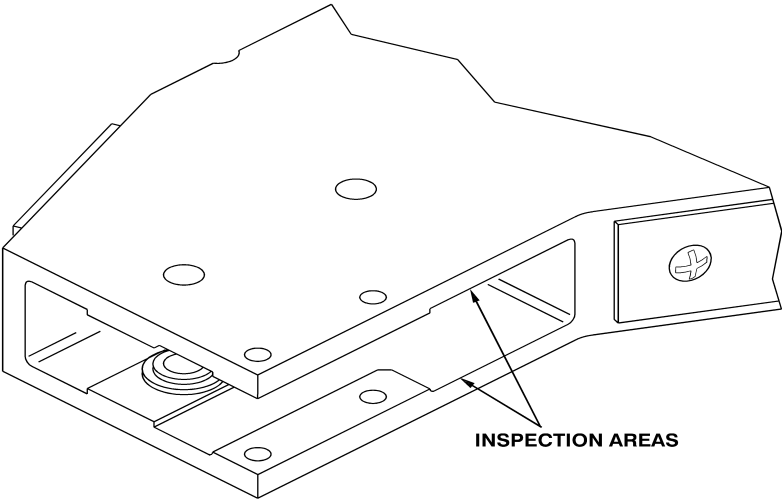
FIGURE 1

Bell Helicopter has discovered that certain serial number tail rotor blades may have been manufactured with mechanical damage located on the inside of the root cuff. The mechanical damage may be identified on the inside of the upper and lower grip plates. The exact location varies, but generally located outboard of the outboard blade bolt attachment hole. See figure 1 and 2.

Inspection Areas

1. Ensure that the location of each tail rotor blade is identified in relation to the hub assembly. Ensure that all hardware and balance weights are identified so they can be reinstall at the same location.
2. Remove tail rotor blades from helicopter. Refer to Bell-205A-1-MM for instruction.
3. Remove pitch horn from blade. Refer to Bell-205A-1-CR&O manual for instruction.
4. Clean off all paint inside blade cuff areas per figure 1 and 2.
 - a. Remove paint by sanding with 120 grit abrasive cloth or paper (C-423)
 - b. Clean residual paint with an abrasive pad (C-407) and Methyl-Ethyl-Ketone (C-309) or alternate.
 - c. Wipe area with a clean cloth dampened with alcohol (C-339)
5. Inspect area for mechanical damage.
6. If a defect is found, perform a penetrant inspection of the grip plates to ensure that no cracks are present.

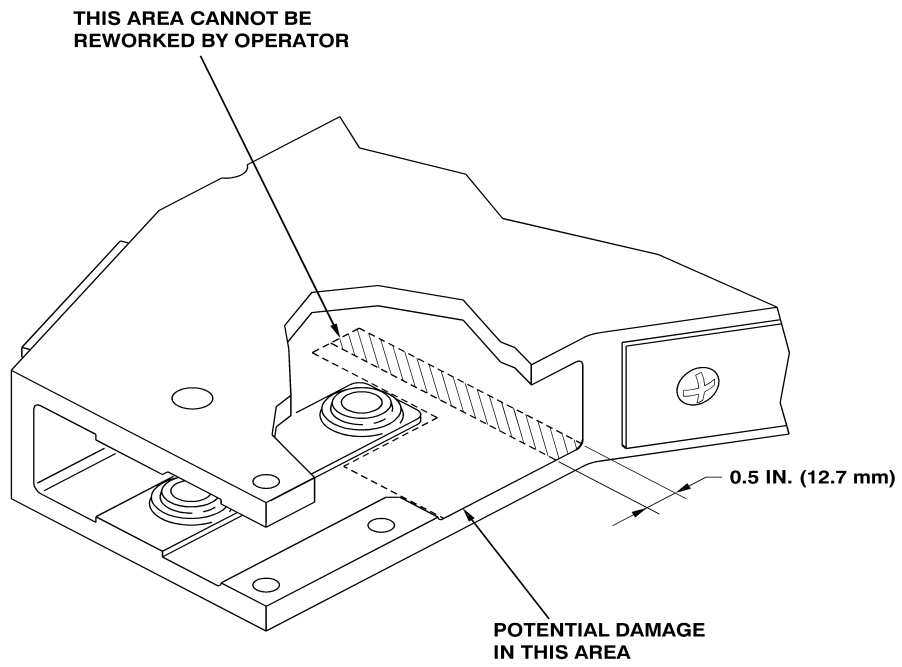
FIGURE 2

If the depth of the damage exceed 0.030 inch (0.762 mm) or the damage is located in the non-reparable area per figure 2, notify Product Support Engineering for further instruction.

Detailed Insection

7. Blend any damage found to a maximum depth of 0.030 inch (0.762 mm). Blend over a length of at least 10 times the depth on all edges of the damage.
8. Surface finish of repair shall be similar to surrounding area.
9. Apply chemical film (C-100) to reworked area.
10. Refinish tail rotor blade assembly per Bell-205A-1-CR&O.
11. Install pitch horn
12. Install tail rotor blade assemblies on aircraft.
13. Annotate records to indicate compliance with this bulletin.
