**ALERT SERVICE BULLETIN**  
**Bell Helicopter** **TEXTRON**

NO. 205-04-89

**MODEL AFFECTED:** 205A-1

**SUBJECT:** TAIL ROTOR PITCH HORN ASSEMBLY  
P/N 212-011-708-105, REPLACEMENT OF.

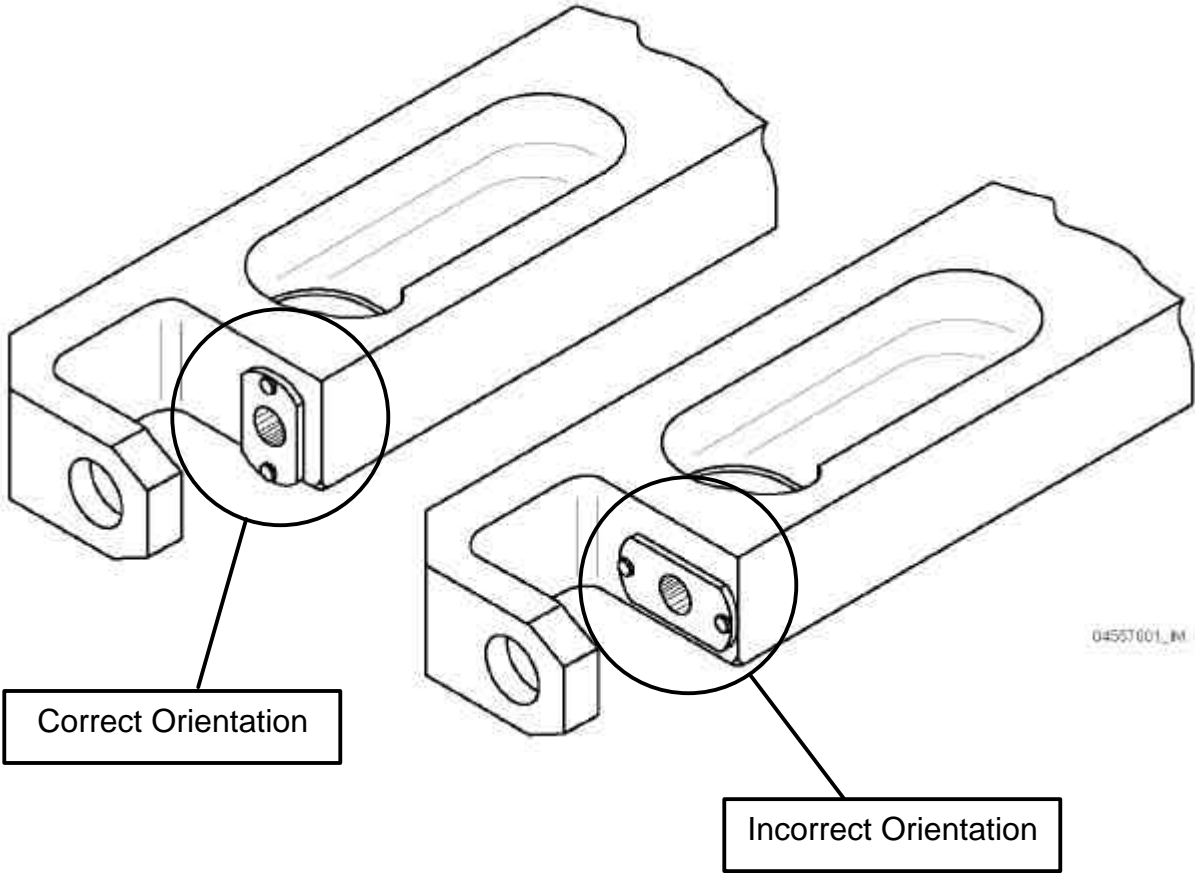
Bell Helicopter has found that subject Pitch Horns S/N TI-1 through S/N TI-113 may have incorrectly installed Bushings, which could cause the Pitch Links to contact the Bushings during Tail Rotor flapping. The resulting loads may cause excessive stress to the Pitch Horn, Pitch Link and attachment hardware between Pitch Links, Crosshead and Pitch Horn. Discrepant Pitch Horns shall be returned to Bell Helicopter, along with the mating Pitch Links and the attachment hardware. Any Pitch Horns bearing a letter "R" at the end of the affected serial number has been either reworked or found to conform, and therefore is not affected by this ASB.

**Figure 1**  
Correct Orientation of Pitch Horn Bushing

1. Review historical service records and physically identify T/R pitch horn serial numbers installed on aircraft and held in spares inventory.
2. For each horn found to be within the serial number block, verify position of bushing using Figure 1. If bushing is found properly positioned, add a letter "R" at the end of the serial number, using a vibrating stylus (For example: TI-113R).

3. If bushing is found incorrectly positioned in accordance with Figure 1, remove discrepant pitch horns, mating pitch links and attaching bolts (20-057-5-14D & NAS6605H20) and return to Bell Helicopter for credit. Remove any chordwise

4. Re-assemble Tail Rotor Hub & Blade Assembly as required by replacing discrepant parts with new and/or serviceable pitch horns, pitch links and attachment hardware between pitch horn and pitch link and crosshead to pitch link. Dynamic balance as required after installation.
5. All discrepant pitch horns serial number TI-1 through TI-113 that have never seen service on an aircraft may be reworked at Bell Helicopter. Reworked pitch horns will have a letter "R" at the end of the serial number.
6. Annotate historical records to show compliance with this bulletin.
