ALERT SERVICE BULLETIN

NO. 205B-01-36

MODEL AFFECTED: 205B

SUBJECT: CHIP DETECTOR ASSEMBLY, TEDECO B3703

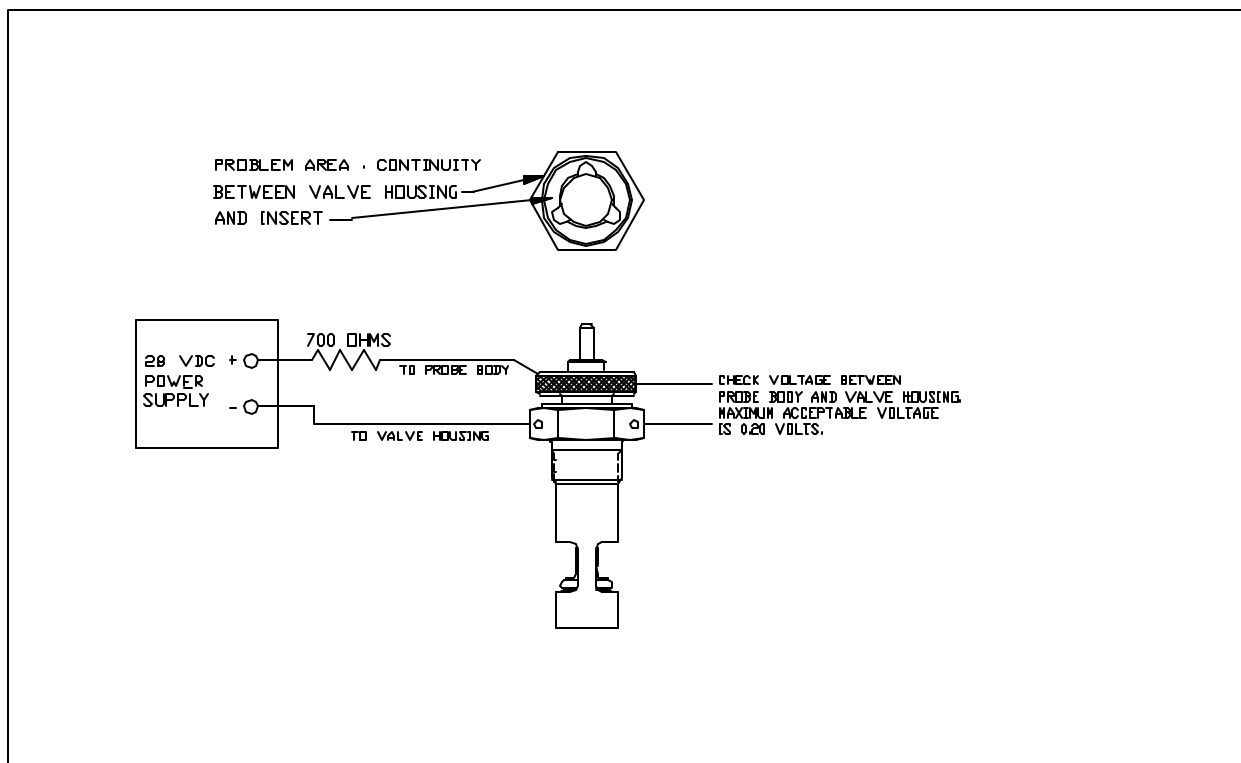
FIGURE 1

Units that are not installed in an aircraft should be tested per Procedure A. Units installed in aircraft should be tested per procedure B. These tests will determine if the unit is acceptable by verifying that the resistance between the probe body and the valve body is 5 ohms or less.

1. Connect the chip detector to a 28 Volt DC power supply using a 700 ohm, 2 watt resistor as shown in Figure 1.
2. Measure the voltage between the probe body and the valve body. The voltage drop must be 0.20 volts or less across the unit. If the voltage drop is larger than 0.20 volts, then return the unit to Tedeco (See 3. Part Replacement.)

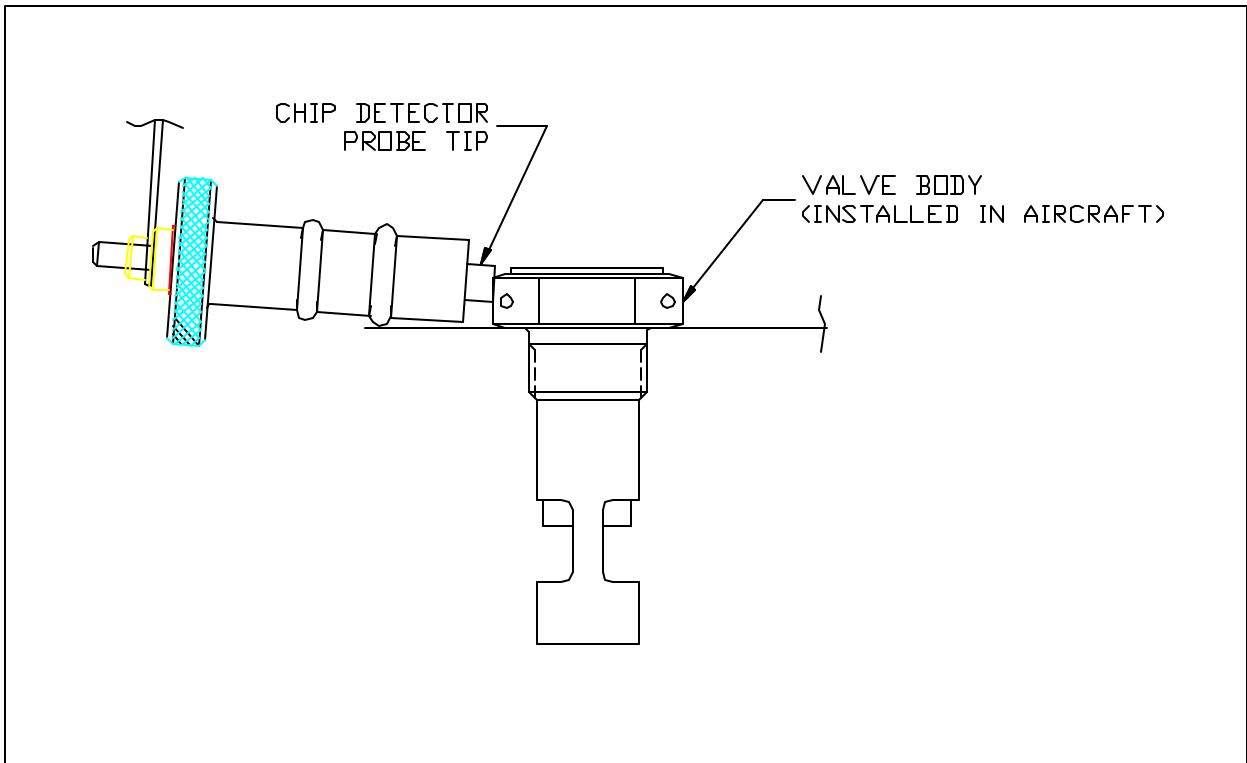
FIGURE 3

If the light still does not illuminate during this check of the valve housing, there is an electrical discontinuity somewhere else in the circuit. Check the remaining electrical circuit between chip detector and cockpit indicator light.

4. Hold the tip of the center stud of the chip detector probe firmly against the valve housing as shown in Figure 3 while checking chip indicator light in cockpit. The cockpit light should illuminate. Illumination of the light in this step isolates the electrical discontinuity to the valve insert. Repair the unit per the repair instructions in section 2 of this document.
