ALERT SERVICE BULLETIN

NO. 205B-02-41

MODEL AFFECTED: 205B

SUBJECT: TAIL ROTOR BLADE ASSEMBLIES P/N 212-010-750-117, INSPECTION AND REWORK OF.

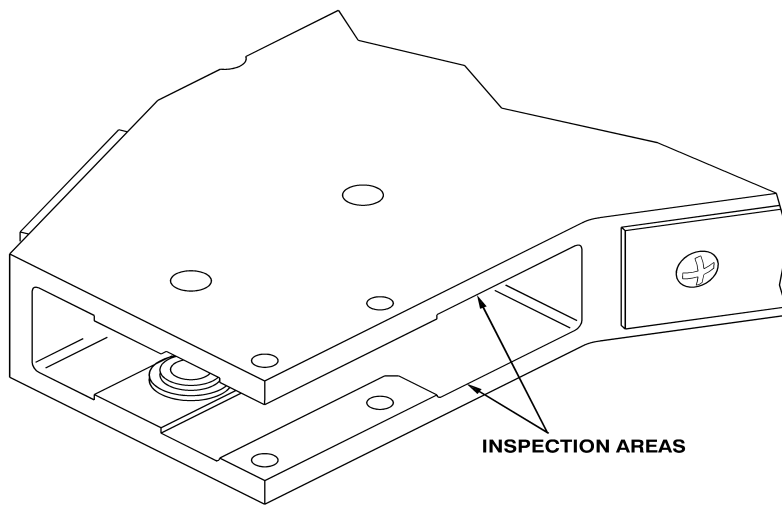
FIGURE 1

Bell Helicopter has discovered that certain serial number tail rotor blades may have been manufactured with mechanical damage located on the inside of the root cuff. The mechanical damage may be identified on the inside of the upper and lower grip plates. The exact location varies, but generally located outboard of the outboard blade bolt attachment hole. See figure 1 and 2.

Inspection Areas

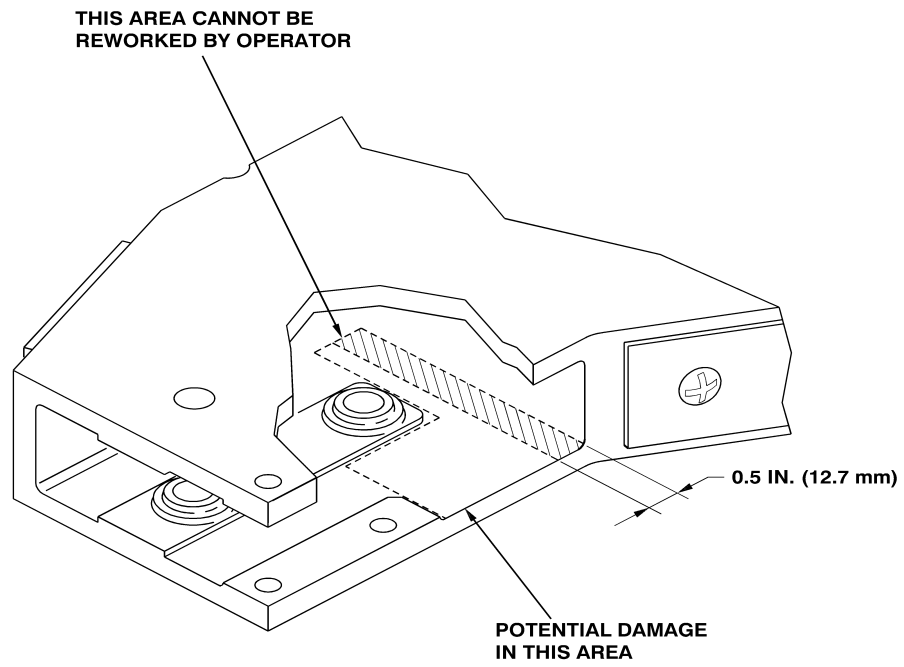
FIGURE 2

If the depth of the damage exceed 0.030 inch (0.762 mm) or the damage is located in the non-reparable area per figure 2, notify Product Support Engineering for further instruction.

Detailed Inspection

7. Blend any damage found to a maximum depth of 0.030 inch (0.762 mm). Blend over a length of at least 10 times the depth on all edges of the damage.
8. Surface finish of repair shall be similar to surrounding area.
9. Apply chemical film (C-100) to reworked area.
10. Refinish tail rotor blade assembly per Bell-212-CR&O.
11. Install pitch horn
12. Install tail rotor blade assemblies on aircraft.
13. Annotate records to indicate compliance with this bulletin.
