ALERT SERVICE BULLETIN

**SUBJECT: REVISION "A" TO ALERT SERVICE BULLETIN 206-00-93 –
COLLECTIVE LEVER ASSEMBLY 206-010-467-001, MODIFICATION
AND NEW COLLECTIVE LEVER ASSEMBLY /-105, INTRODUCTION OF**

NO. 206-00-93

SUBJECT: COLLECTIVE LEVER ASSEMBLY
206-010-467-001, MODIFICATION AND NEW
COLLECTIVE LEVER ASSEMBLY /-105,
INTRODUCTION OF.

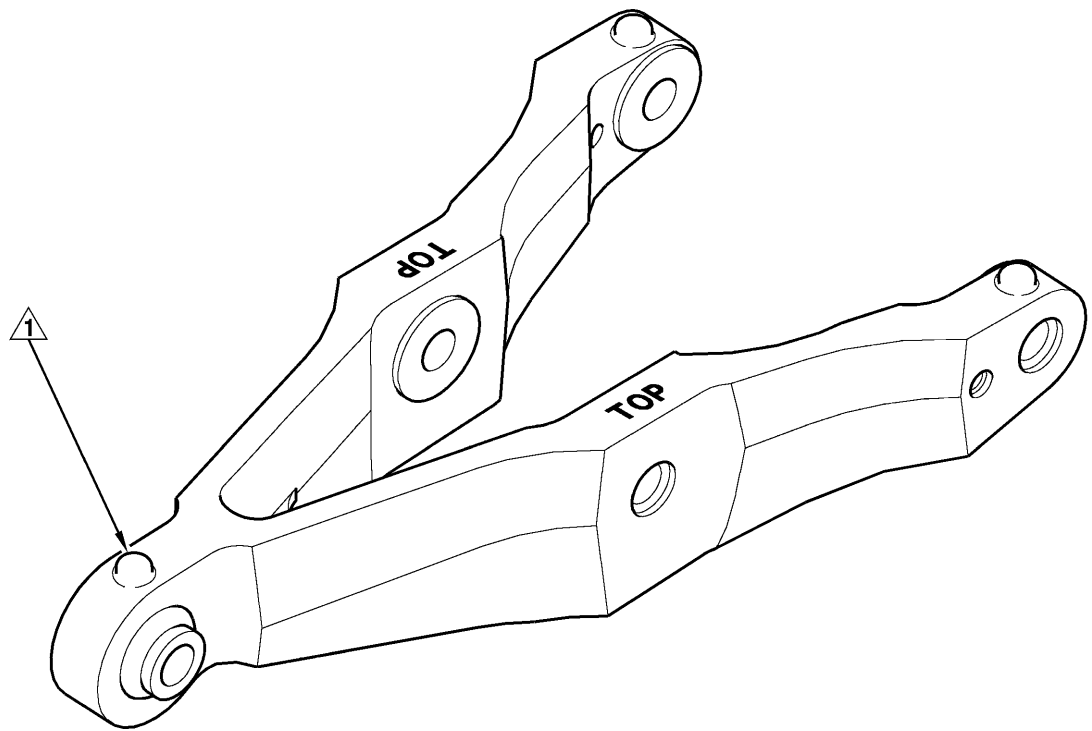
Figure 1. Collective Lever Assembly – Raised Forging Boss – Removal

Bell Helicopter has found that on the collective lever assembly 206-010-467-001, with a raised forging boss remaining (on the "TOP" side of the lever at the end that contains the spherical bearing), a low clearance or a fouling condition with the swashplate outer ring 206-010-453 can result.

1. Examine the collective lever assembly 206-010-467-001 installed on helicopter and in spares stock, for the existence of a raised forging boss. (Refer to Figure 1).

Raised forging boss to be removed.

2. Use a double cut smooth file to remove the raised forging boss on the "TOP" side of the lever at the end that contains the spherical bearing. Remove only sufficient material to follow the lever contour (Refer to Figure 2, Detail A).
3. Finish the reworked area by hand sanding lengthwise with 220 grit followed by 400 grit Aluminum Oxide Cloths.
4. Do a Fluorescent Penetrant Inspection in the area where the raised forging boss has been removed.

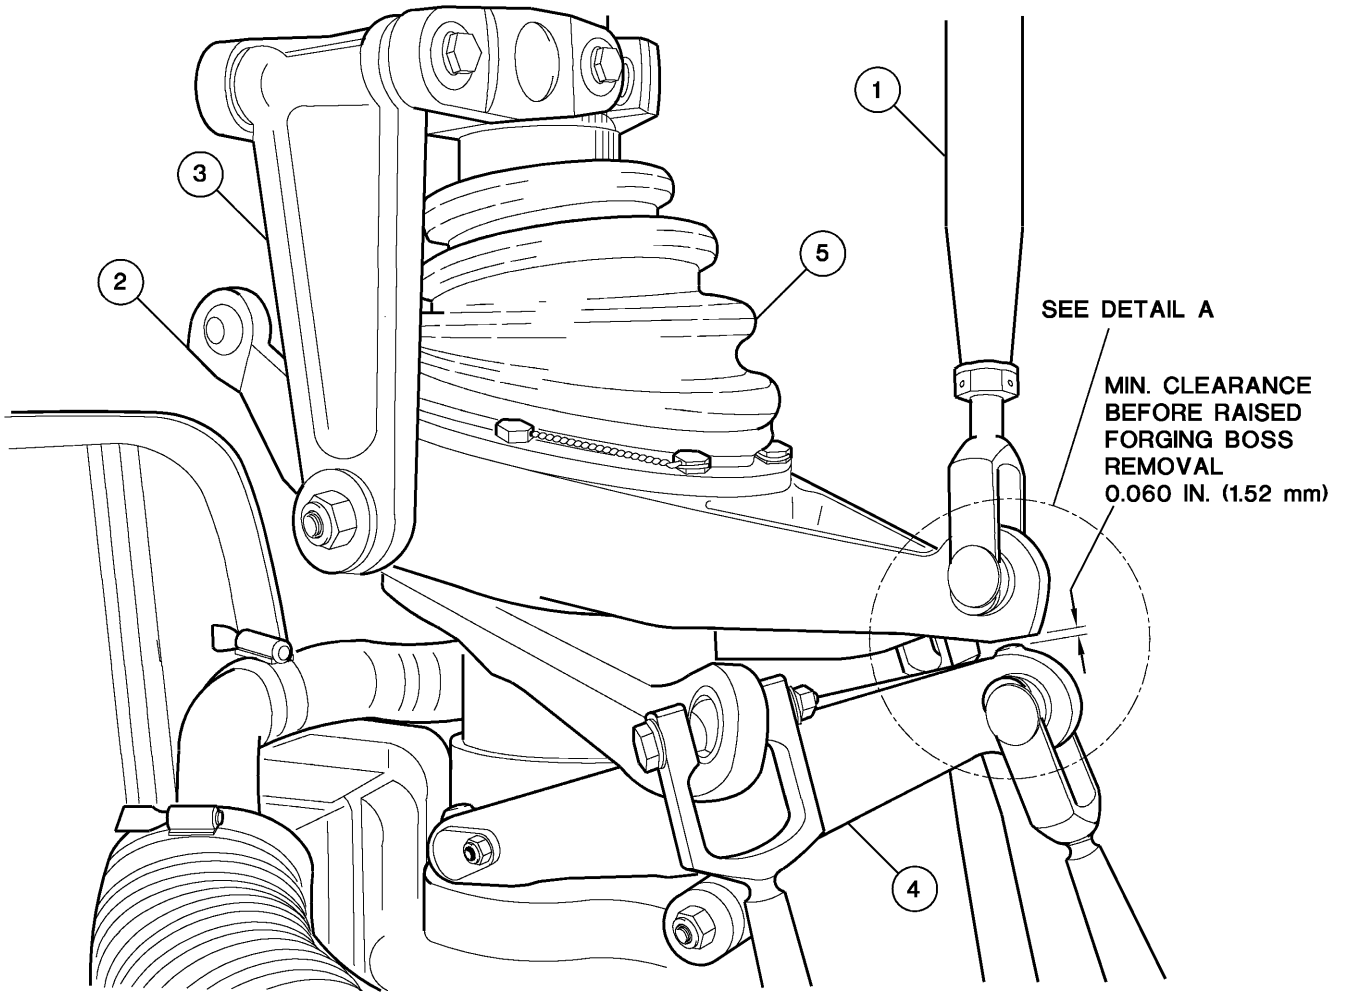
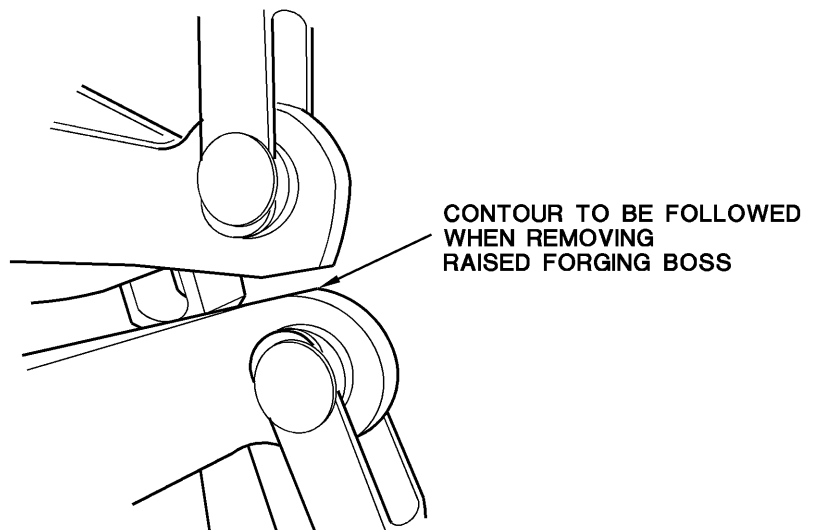
Figure 2. Collective Lever Assembly – Clearance Check/Contour with Boss - Removal

2. Do a check for fouling or a low clearance condition as follows:
- a. Disconnect the main rotor pitch links (1, Figure 2) from the swashplate outer ring (2) (Refer to BHT-206A/B-Series – MM-6).

- e. Slowly rotate the swashplate outer ring (2) by hand to do a check of the clearance between the collective lever assembly (4) and both swashplate outer ring horns. Use a feeler gauge to verify that the clearance between the collective lever assembly raised forging boss and both outer ring horns is more than 0.060 inch (1.52 mm) (Refer to Figure 2).
 - If there is no clearance or if the clearance is 0.060 inch (1.52 mm) or less at one of the outer ring horns, do PART II of this bulletin immediately.
