ALERT SERVICE BULLETIN

SUBJECT: REVISION "A" TO ALERT SERVICE BULLETIN 206-02-99: (MAIN ROTOR BLADES 206-010-200-ALL INSPECTION AND REWORK OF)

NO. 206-02-99

SUBJECT: MAIN ROTOR BLADES 206-010-200-ALL
INSPECTION AND REWORK OF

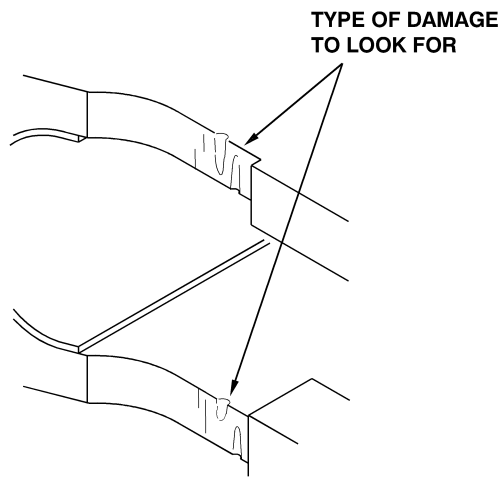
DETAIL A
TYPE OF DAMAGE

- A**
1. Inspect the blade grip plate tangs leading and trailing edges between the wear pads and the inboard radius for presence of tool marks (Figure 1). The surface should be flat, with no waves or notches (Figure 1, DETAIL A).
 2. If a damage or an irregularity on the surface as shown on the Figure 1 is found, do PART II of this Alert Service Bulletin.
 3. If no damage or irregularity on the surface as shown on the Figure 1 is found, the blade is serviceable.
 4. Using a vibrating stylus, mark ASB 206-02-99 on the blade Modification Plate to indicate that this Alert Service Bulletin has been accomplished.
 5. Make an entry in the Helicopter and the Component Historical Records to show that this Alert Service Bulletin is completed.

3. Measure the depth of the damage.
4. If the depth of the damage exceed 0.050 inch (1.27 mm) remove the blade from service.
5. Send the defective blade to Bell Helicopter Customer Property Return with a Malfunction Report attached with the ASB number in reference.
6. If the depth of the damage is at 0.050 inch (1.27 mm) or less do PART III of this Alert Service Bulletin.

1. Using a single cut general purpose half round file No 2 or 3 (smooth cut) blend smooth the damages in a ratio of 10 to 1. As an example, if the damage is 0.040 inch (1.5424 mm) deep, blend 0.400 inch (15.24 mm) on each side of the damage. The maximum depth after rework is 0.050 inch (1.27 mm).
2. After blending with the file, polish the surface with 180-220 grit Aluminum Oxide Fabric Cloth to obtain a finish of 63 RMS.
