SUBJECT: **REVISION "C" TO ALERT SERVICE BULLETIN 206-04-100 (TAIL ROTOR BLADES 206-016-201-133 / -131, CHECK/INSPECTION OF).**

NO. 206-04-100

**MODEL AFFECTED:** 206 A/B

**SUBJECT:** TAIL ROTOR BLADES 206-016-201-133 / -131,  
CHECK/INSPECTION OF

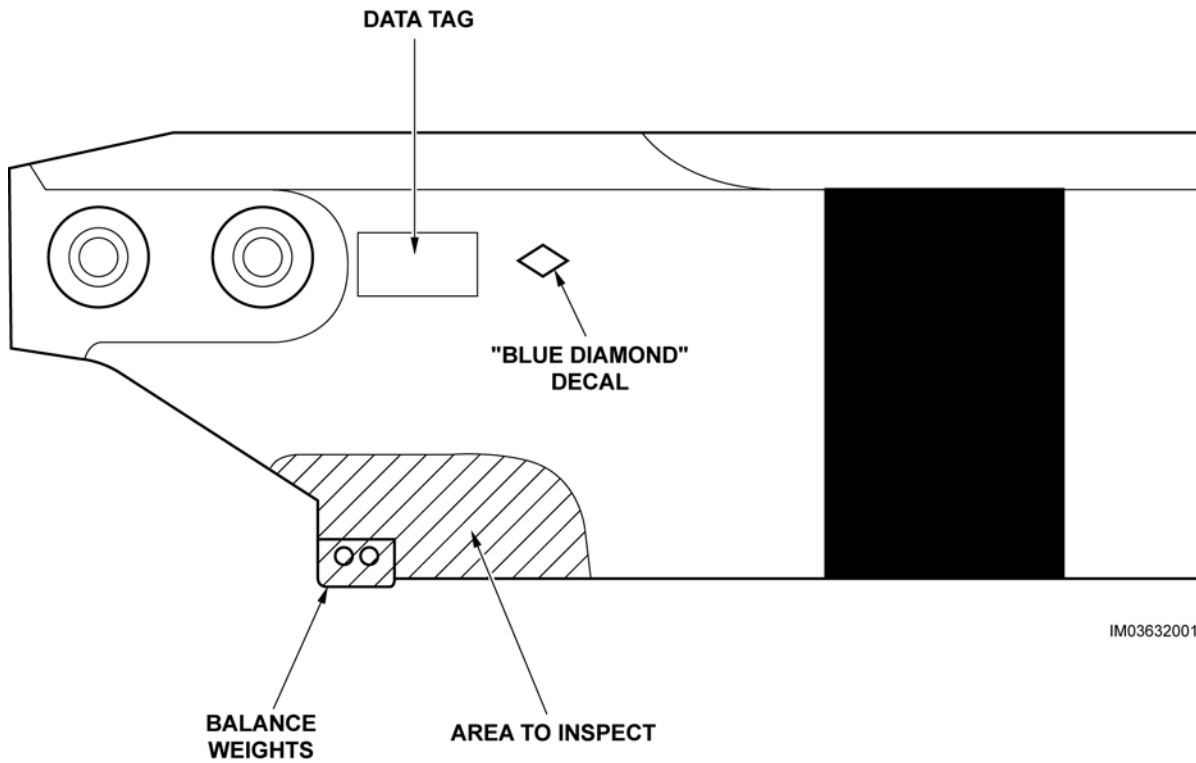
Figure 1. Tail rotor blade inspection.

Bell Helicopter has received three reports of skin crack in the area of the trailing edge balance weight. OSN 206-03-38 published in January 2003 emphasized the requirement to pay particular attention for cracks in the chordwise weights area of the tail rotor blade during daily checks and scheduled inspection.

1. Use detergent (C-318) and thoroughly clean the area to be inspected on both sides of the blade. Refer to Figure 1.
2. Inspect both sides of the blade at the area indicated on the Figure 1 as follows:
  - a. Visually inspect the skin for deformation.

- b. With a 10 X power magnifying glass inspect the skin for cracks.
  - c. If skin deformation or cracks are found remove the blade from service.
  - d. Inspect the weights for bends or deformation.
  - e. If the weights are bent or deformed, remove the blade from service.
3. If no damage is found, the blade is serviceable.
  4. Make log book entries to show that the PART I b. of this Alert Service Bulletin has been accomplished.

1. Use detergent (C-318) and thoroughly clean the area to be checked on both sides of the blade. Refer to Figure 1.
2. Check both sides of the blade at the area indicated on the Figure 1 as follows:
  - a. Visually check the skin for deformation or cracks.
  - b. If deformation or cracks are found, remove the blade from service.
  - c. Check the weights for bends or deformation.
  - d. If the weights are bent or deformed, remove the blade from service.
3. If no damage is found, the blade is serviceable.
4. Make log book entries to show that the PART I a. of this Alert Service Bulletin has been accomplished.

4. In order to provide a quick visual reference and identify the blades affected by this ASB, apply the "blue diamond" decal provided with this ASB on both sides of the blade at the location indicated on the Figure 1. To prolong the life of the decal, apply Edge sealer on the decal. Replace missing or damaged decal as required.
