ALERT SERVICE BULLETIN

NO. 206L-00-116

MODELS AFFECTED: 206L, L1 AND L3

SUBJECT: COLLECTIVE LEVER ASSEMBLY
206-010-467-001, MODIFICATION AND NEW
COLLECTIVE LEVER ASSEMBLY /-105,
INTRODUCTION OF.

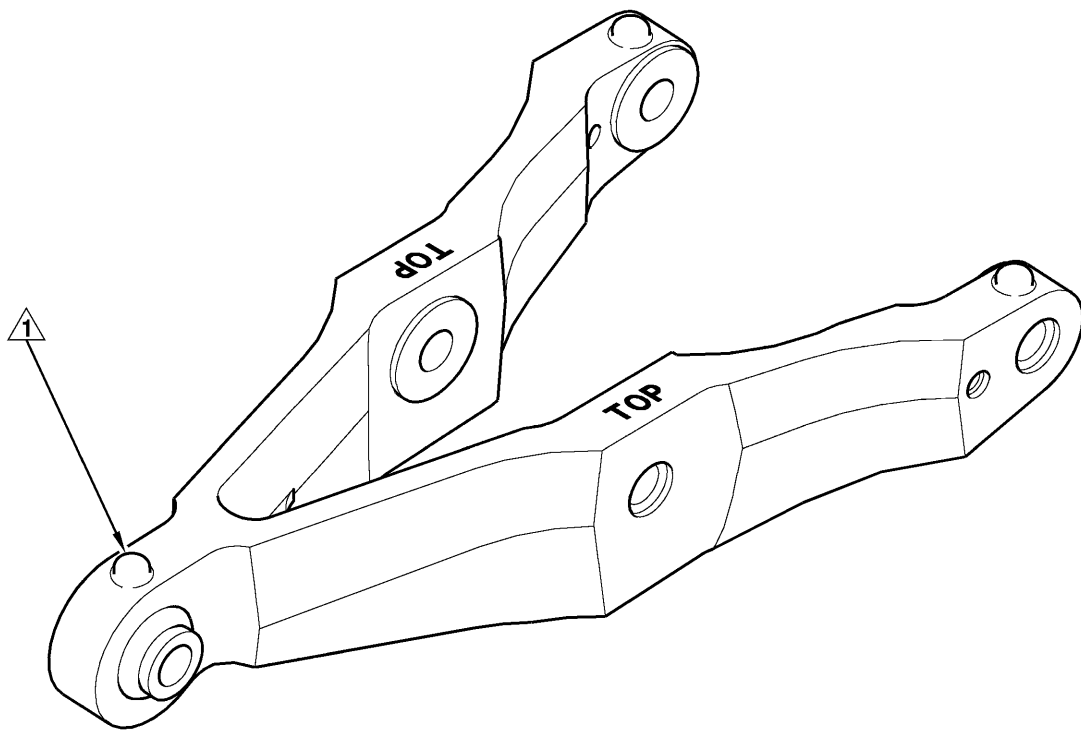
Figure 1. Collective Lever Assembly – Raised Forging Boss – Removal

Bell Helicopter has found that on the collective lever assembly 206-010-467-001, with a raised forging boss remaining (on the "TOP" side of the lever at the end that contains the spherical bearing), a low clearance or a fouling condition with the swashplate outer ring 206-010-453 can result.

1. Examine if there is a raised forging boss on the collective lever assembly 206-010-467-001 installed on helicopters and in spares stock (Refer to Figure I).

Raised forging boss to be removed.

2. Use a double cut smooth file to remove the raised forging boss on the "TOP" side of the lever at the end that contains the spherical bearing. Remove only sufficient material to follow the lever contour (Refer to Figure 2, Detail A).
3. Finish the reworked area by hand-sanding lengthwise with 220 grit followed by 400 grit Aluminium Oxide Cloths.
4. Do a Fluorescent Penetrant Inspection in the area where the raised forging boss has been removed.

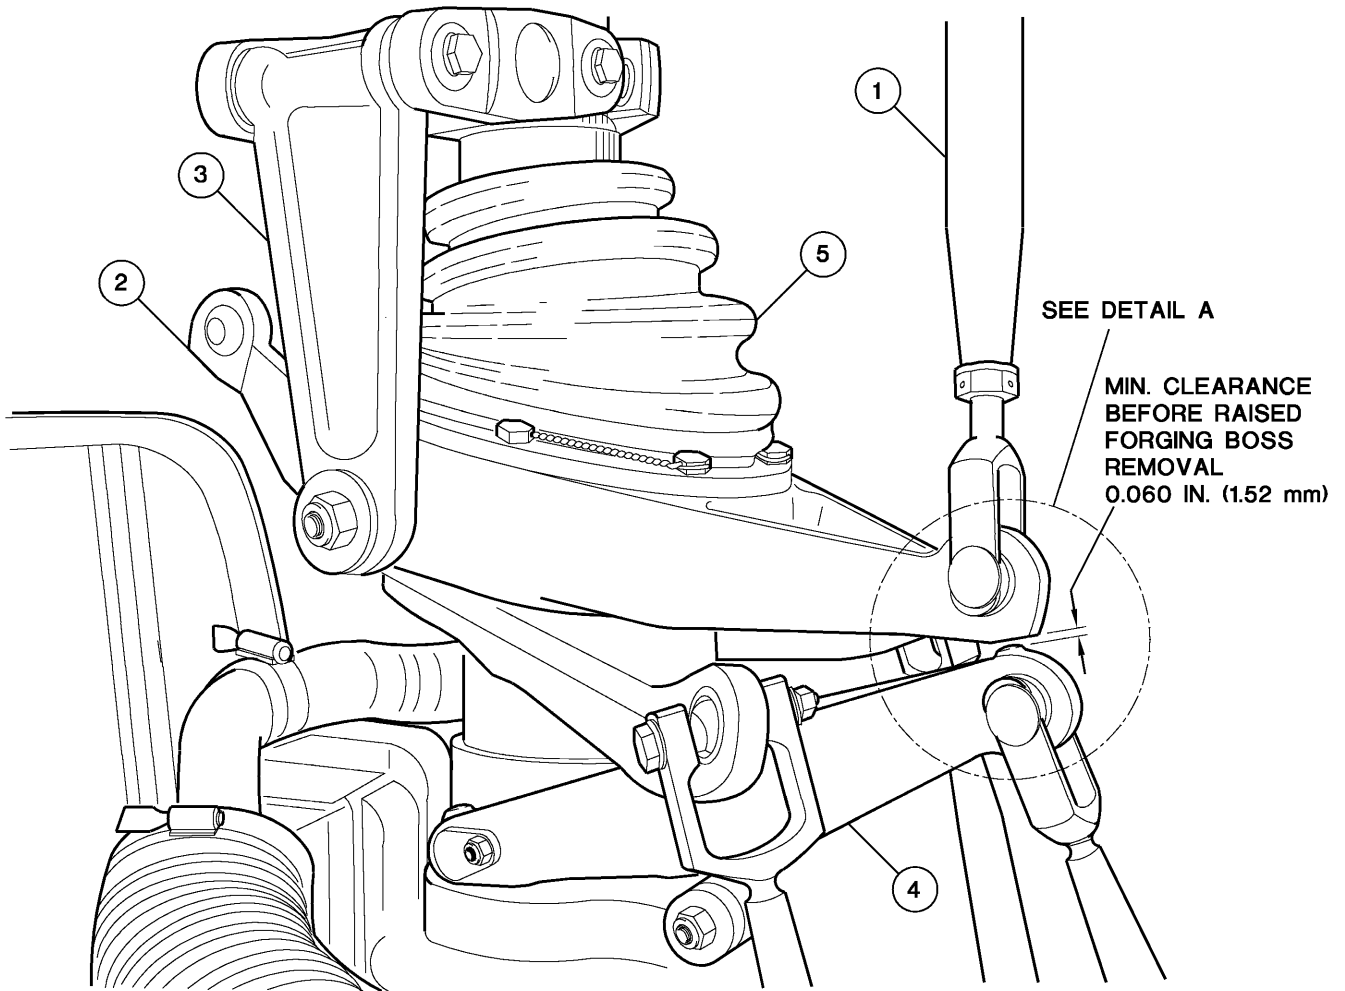
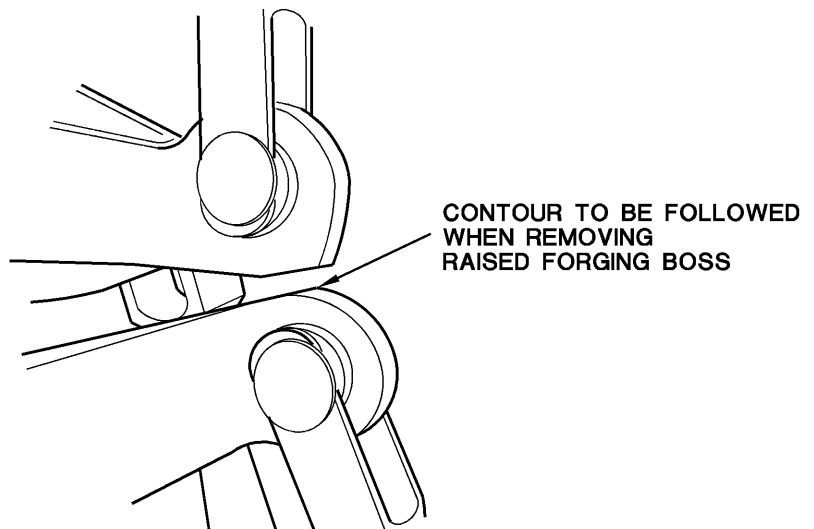
Figure 2. Collective Lever Assembly – Clearance Check/Contour with Boss Removed

- e. Slowly rotate the swashplate outer ring (2) by hand to do a check of the clearance between the collective lever assembly (4) and both swashplate outer ring horns. Use a feeler gauge to verify that the clearance between the collective lever assembly raised forging boss and both outer ring horns is more than 0.060 inch (1.52 mm) (Refer to Figure 2).

- If there is no clearance or if the clearance is 0.060 inch (1.52 mm) or less at one of the outer ring horns, do PART II of this bulletin immediately.
 - If the clearance is more than 0.060 inch (1.52 mm), the aircraft is serviceable and can be returned to flight status. If you choose you can do PART II of this bulletin now or at the next removal of the collective lever assembly 206-010-467-001, but no later than 31 January 2001.
- f. Install main rotor pitch links (1), idler link (3), and boot (5) removed earlier (Refer to applicable 206L model Maintenance Manual).
