ALERT SERVICE BULLETIN

NO. 206L-01-120

MODEL AFFECTED: 206L4

SUBJECT: Tail Rotor Output Shaft 206-040-949-101 By Serial Number Recall Of.

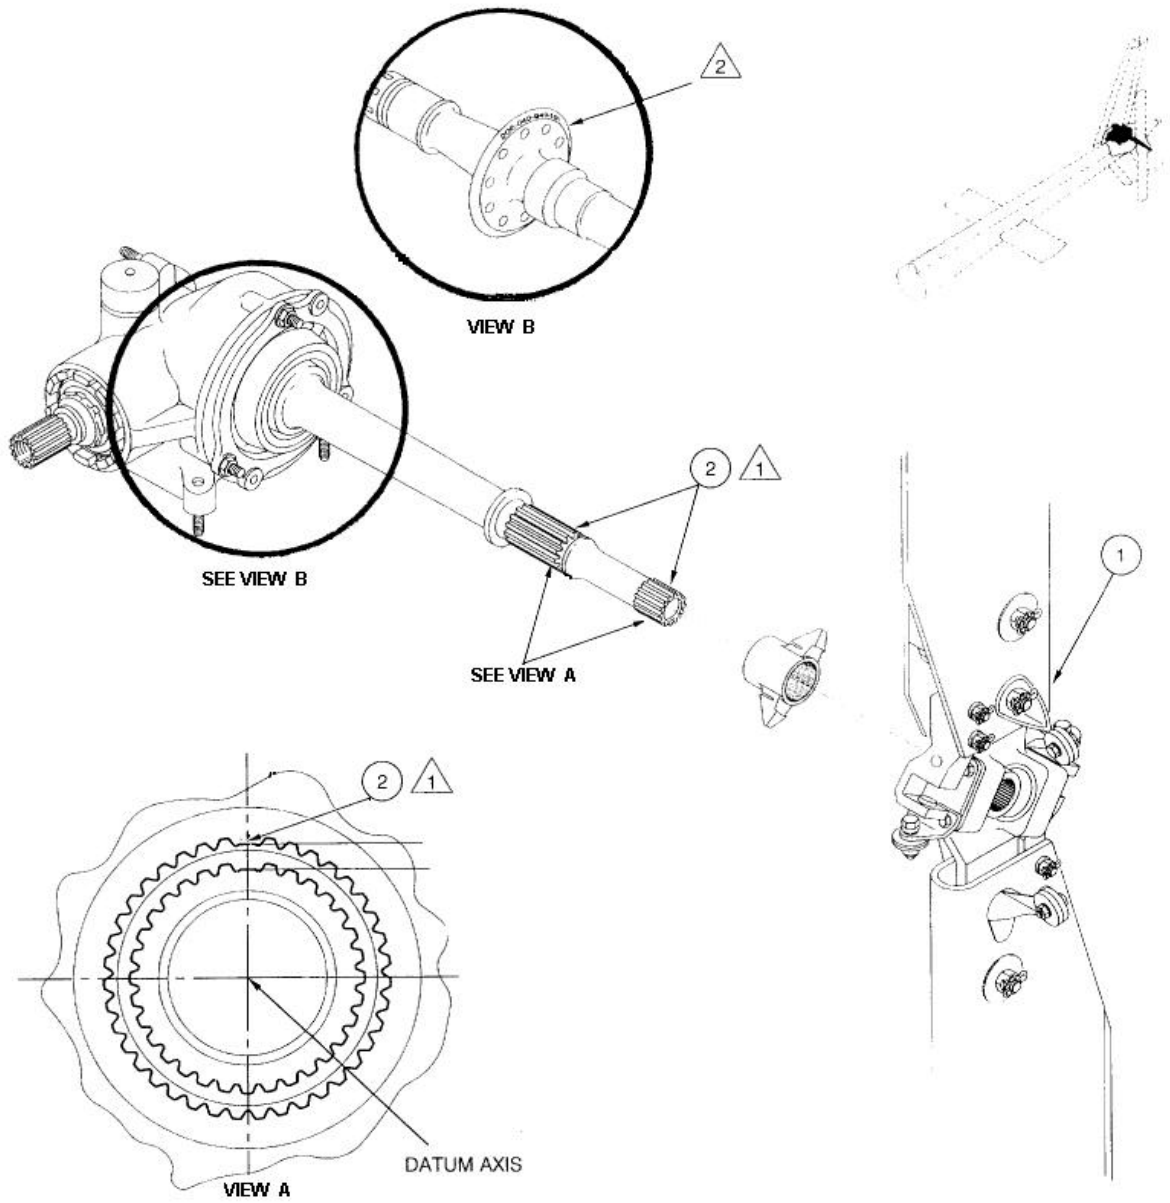
Figure 1. Output Shaft Master Splines - Inspection

4. If the output shafts master splines are not aligned and/or the part number and serial number match the number in Table 1. Remove the shaft from service and contact Bell Helicopter Product Support Engineering

Master splines of cross head and tail rotor trunnion shall be in line.
-

Part number and serial number located to this surface.

5. If the output shaft master splines are aligned no further action is required. Install tail rotor hub and blade assembly (BHT-206-SI-2054 or BHT-206-SI-2057).
