ALERT SERVICE BULLETIN

NO. 206L-03-125

MODEL AFFECTED: 206L SERIES

SUBJECT: MAIN ROTOR BLADES 206-015-001-ALL
INSPECTION AND REWORK OF

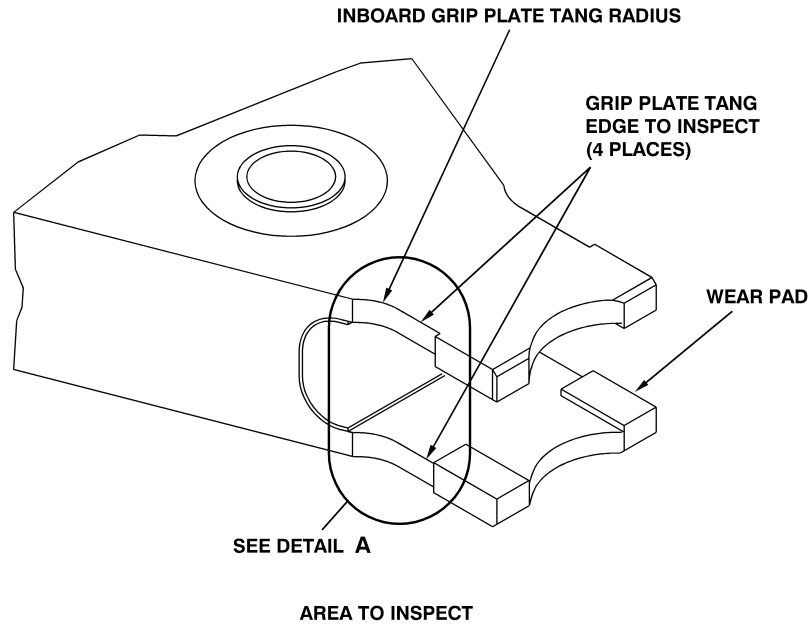
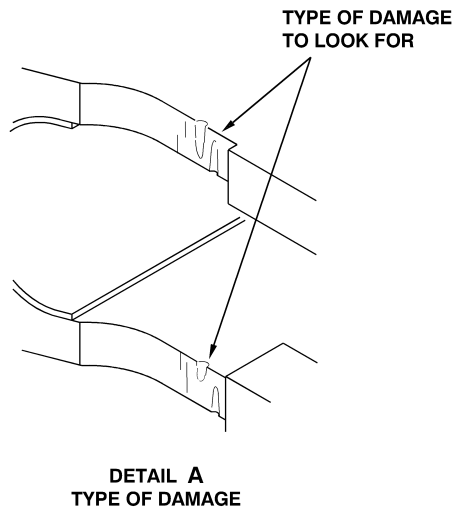
Figure 1. Area to inspect

Bell Helicopter found that some main rotor blades may have tool marks made during manufacturing on the edges of the grip plate tangs. These tool marks if not removed may lead in cracking of the grip plate tang.

1. Inspect the blade grip plate tangs leading and trailing edges between the wear pads and the inboard radius for presence of tool marks (Figure 1). The surface should be flat, with no waves or notches (Figure 1, DETAIL A).
2. If a damage or an irregularity on the surface as shown on the Figure 1 is found do PART II of this Alert Service Bulletin.
3. If no damage or irregularity on the surface as shown on the Figure 1 is found, the blade is serviceable.
4. Using a vibrating stylus, mark ASB 206L-03-125 on the blade Modification Plate to indicate that this Alert Service Bulletin has been accomplished.

3. Measure the depth of the damage.
4. If the depth of the damage exceed 0.050 inch (1.27 mm) remove the blade from service.
5. Send the defective blade to Bell Helicopter Customer Property Return with a Malfunction Report attached with the ASB number in reference.
6. If the depth of the damage is at 0.050 inch (1.27 mm) or less do PART III of this Alert Service Bulletin.

1. Using a single cut general purpose half round file No 2 or 3 (smooth cut) blend smooth the damages in a ratio of 10 to 1. As an example, if the damage is 0.040 inch (1.5424 mm) deep, blend 0.400 inch (15.24 mm) on each side of the damage. The maximum depth after rework is 0.050 inch (1.27 mm).
2. After blending with the file, polish the surface with 180-220 grit Aluminum Oxide Fabric Cloth to obtain a finish of 63 RMS.
3. Thoroughly clean the reworked area with solvent (C-309) or (C-316).
4. Apply a chemical film treatment of Alodine 1200 (C-100) to the bare metal surfaces.
5. Apply a coat of Polyamide Epoxy Primer (C-204) and two coats of Polyurethane paint color # 37038 (C-245).
6. Using a vibrating stylus, mark ASB 206L-03-125 on the blade Modification Plate to indicate that this Alert Service Bulletin has been accomplished.
