SUBJECT: **REVISION "C" TO ALERT SERVICE BULLETIN 206L-04-127 (TAIL ROTOR BLADES 206-016-201-131, CHECK/INSPECTION OF).**

NO. 206L-04-127

DATE	Mar 05, 2005
REV	C

SUBJECT: TAIL ROTOR BLADES 206-016-201-131,
CHECK/INSPECTION OF

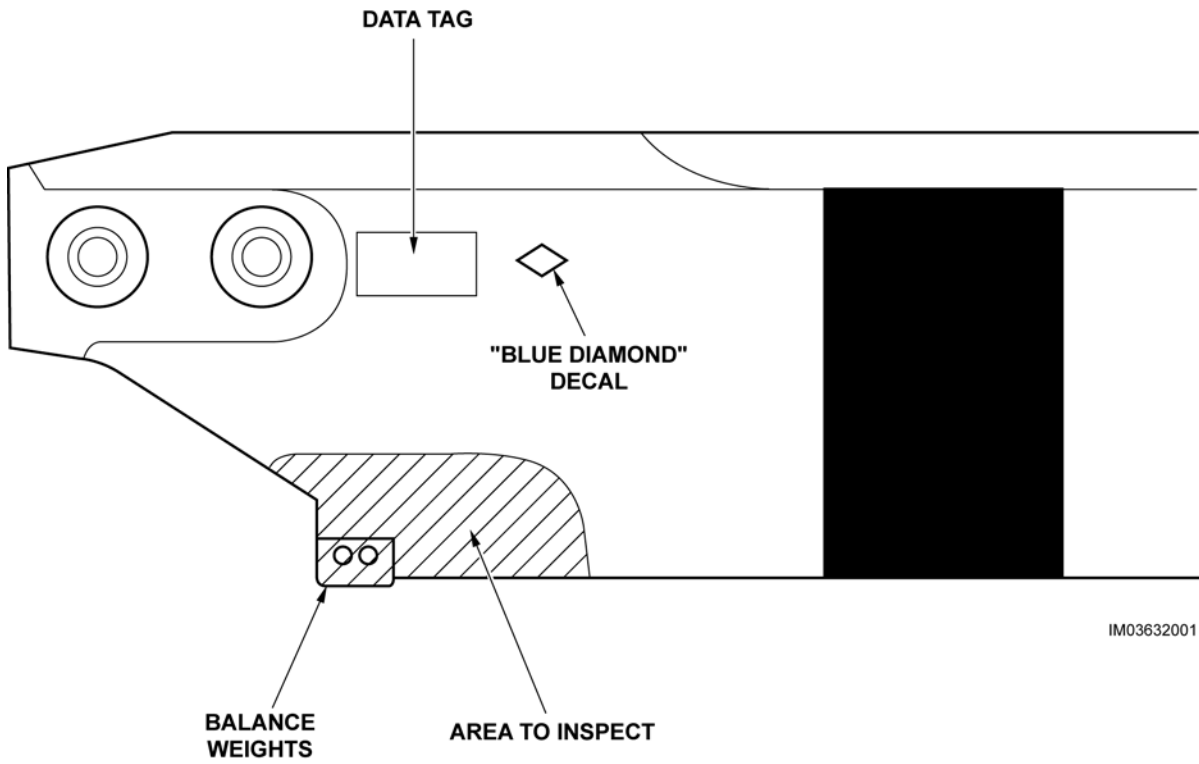
Figure 1. Tail rotor blade inspection.

Bell Helicopter has received three reports of skin crack in the area of the trailing edge balance weight. OSN 206L-03-44 published in January 2003 emphasized the requirement to pay particular attention for cracks in the chordwise weights area of the tail rotor blade during daily checks and scheduled inspection.

1. Use detergent (C-318) and thoroughly clean the area to be checked on both sides of the blade. Refer to Figure 1.
2. Check both sides of the blade at the area indicated on the Figure 1 as follows:
 - a. Visually check the skin for deformation or cracks.
 - b. If deformation or cracks are found, remove the blade from service.
 - c. Check the weights for bends or deformation.

1. Use detergent (C-318) and thoroughly clean the area to be inspected on both sides of the blade. Refer to Figure 1.
2. Inspect both sides of the blade at the area indicated on the Figure 1 as follows:
 - a. Visually inspect the skin for deformation.
 - b. With a 10 X power magnifying glass inspect the skin for cracks.
 - c. If skin deformation or cracks are found remove the blade from service.
 - d. Inspect the weights for bends or deformation.
 - e. If the weights are bent or deformed, remove the blade from service.
3. If no damage is found, the blade is serviceable.
4. Make log book entries to show that the PART I b. of this Alert Service Bulletin has been accomplished.

1. Use detergent (C-318) and thoroughly clean the area to be inspected on both sides of the blade. Refer to Figure 1.
2. Inspect both sides of the blade at the area indicated on the Figure 1 as follows:
 - a. Visually inspect the skin for deformation.
 - b. With a 10 X power magnifying glass inspect the skin for cracks.

- d. If the weights are bent or deformed, remove the blade from service.
3. If no damage is found, the blade is serviceable.
4. Make log book entries to show that the PART I a. of this Alert Service Bulletin has been accomplished.

- c. If skin deformation or cracks are found remove the blade from service.
 - d. Inspect the weights for bends or deformation.
 - e. If the weights are bent or deformed, remove the blade from service.
3. If no damage is found, the blade is serviceable.
 4. In order to provide a quick visual reference and identify the blades affected by this ASB, apply the "blue diamond" decal provided with this ASB on both sides of the blade at the location indicated on the Figure 1. To prolong the life of the decal, apply Edge sealer on the decal. Replace missing or damaged decal as required.
 5. Make log book entries to show that the PART II of this Alert Service Bulletin has been accomplished. Clearly indicate also that the PART I a. or I b. of this Alert Service Bulletin has to be performed every 3 or 12 flight hours as directed by the compliance section.
