SUBJECT: **REVISION "A" TO ALERT SERVICE BULLETIN 206L-04-129:
(FREEWHEEL AFT BEARING CAP 406-040-509-101, INSPECTION
AND REWORK OF)**

NO. 206L-04-129

MODEL AFFECTED: 206L4

SUBJECT: Freewheel aft bearing cap 406-040-509-101, inspection and recall of

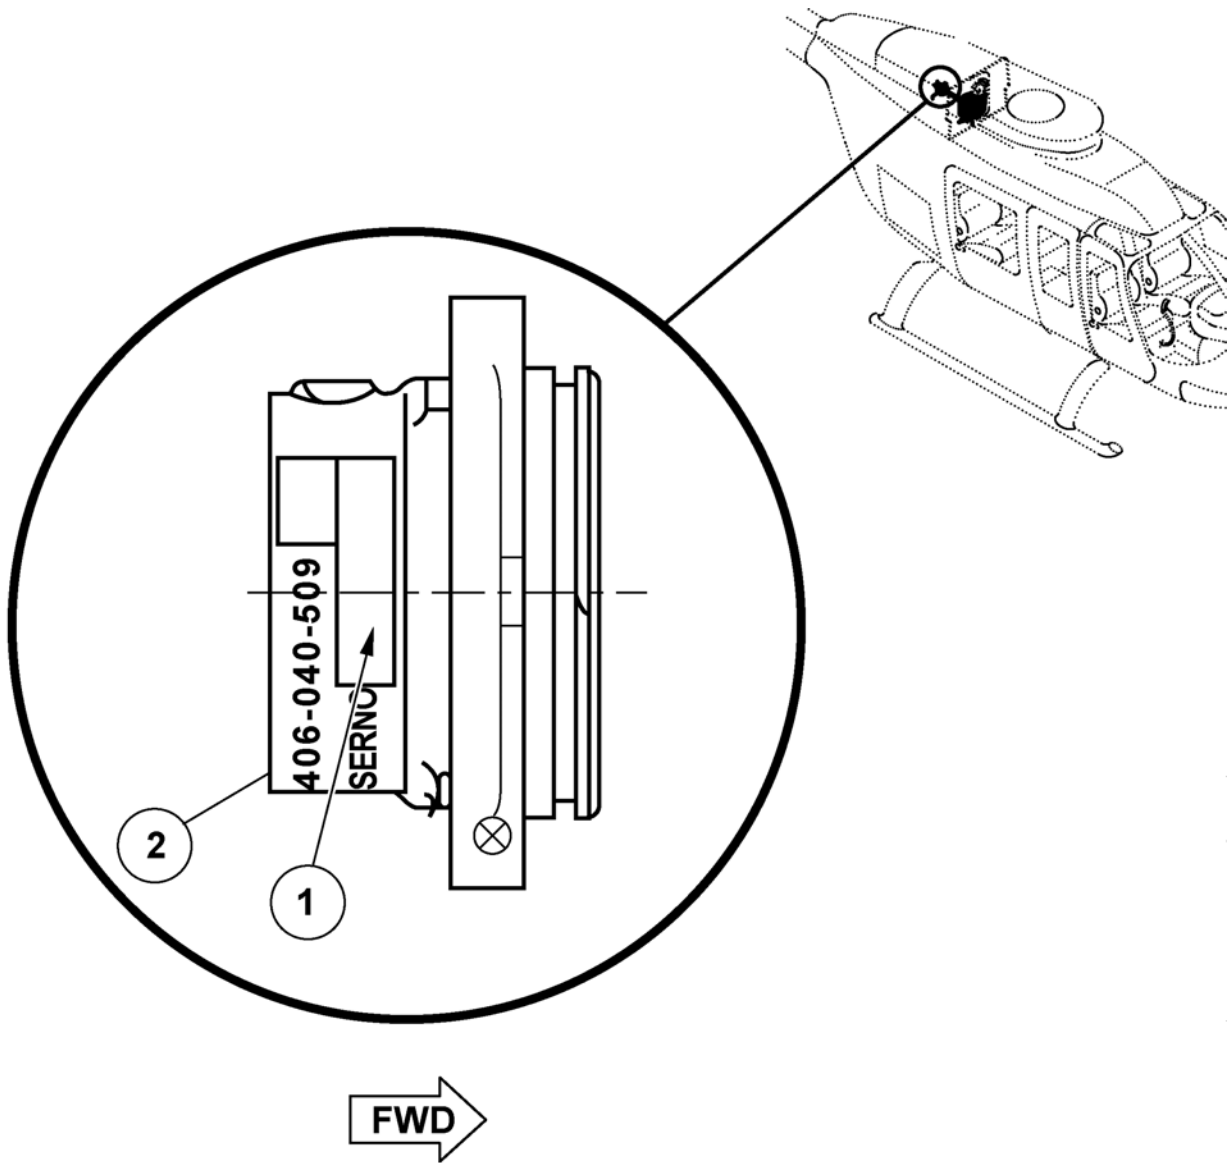
Figure 1. Location of the lubrication channel and the serial number

Bell Helicopter has found that some freewheel aft bearing caps are missing the lubrication channel intended to allow oil flow into the aft bearing support assembly. These caps may have been delivered on production aircraft or as spares.

1. Open the engine access doors.
2. Locate the serial number (1, Figure 1) of the freewheel aft bearing cap (2).
 - a. If the cap serial number is not listed in the HELICOPTER AFFECTED section, no further action is required. Close the access doors and continue with Step 3.
 - b. If the cap serial number is listed in HELICOPTER AFFECTED section, refer to the COMPLIANCE section and accomplish either PART II or III of this bulletin as directed. Contact Product Support Engineering Light Helicopters with the P/N, S/N, TSN, and TSO of the aft bearing cap and freewheel assembly:
