ALERT SERVICE BULLETIN
Bell Helicopter **TEXTRON**

NO. 206L-04-131

MODEL AFFECTED: 206L-SERIES

SUBJECT: TAIL ROTOR BLADE 206-016-201-131, CHECK AND REMOVAL FROM SERVICE OF.

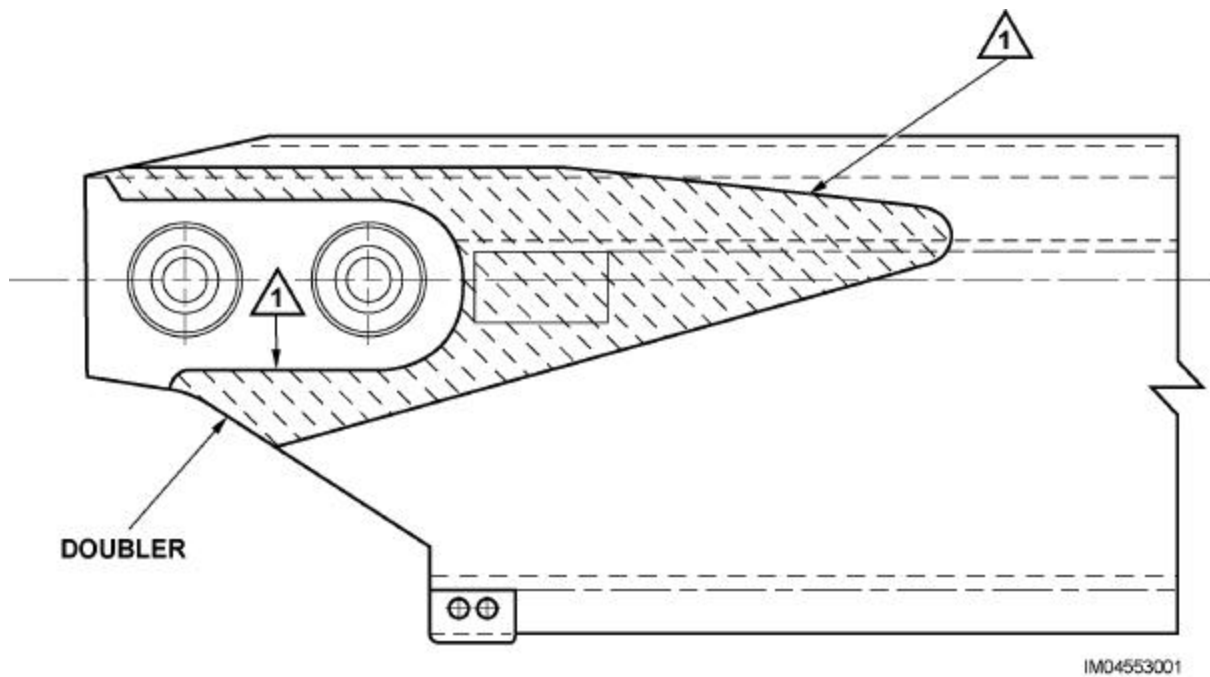
Bell Helicopter has received two reports of de-bonding of the blade root doubler. In both cases this situation was noticed as part of the pre-flight inspection on the affected helicopters. Investigation revealed that inadequate surface preparation on a limited number of blades resulted in poor adherence of the doublers.

Inspect the doubler for edge void or evidence of de-bonding on both sides of the blade.

Figure 1. Inspect the doubler for edge void on both sides of the blade

1. Use detergent (C-318) and thoroughly clean the area to be checked on both sides of the blade. Refer to figure 1.
2. Check both sides of the blade at the area indicated on figure 1 as follows:
 - a. Visually inspect the doubler for edge void on both sides of the blade.
 - b. If void or de-bonding is found, remove the blade from service immediately.
3. If no void or de-bonding is found, the blade is serviceable continue Part I until Part II is completed.
4. Make log book entries to show that the PART I of this Alert Service Bulletin has been accomplished.

1. Remove and replace affected tail rotor blade. (Refer to the applicable 206L-MM)
2. Make log book entries to show that the PART II of this Alert Service Bulletin has been accomplished.
