**ALERT SERVICE BULLETIN**  
REVISION NOTICE  
**Bell Helicopter****TEXTRON**  
A Subsidiary of Textron Inc.

SUBJECT: **REVISION "A" TO ALERT SERVICE BULLETIN 206L-04-132:  
LOW LEVEL DETECTOR SWITCH UNIT P/N 206-063-613-003,  
REMOVAL FROM SERVICE OF**

**NO.** 206L-04-132

**SUBJECT:** LOW LEVEL DETECTOR SWITCH UNIT P/N 206-063-613-003, REMOVAL FROM SERVICE OF

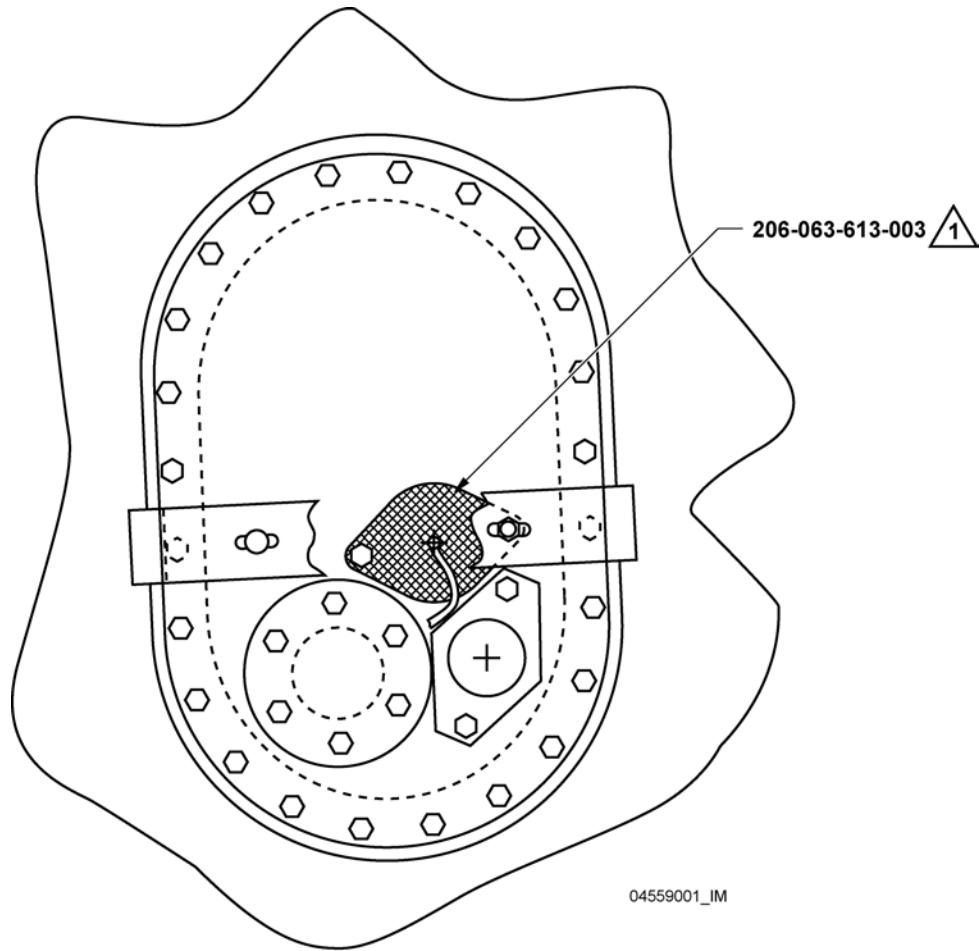
Figure 1

Bell Helicopter has determined that several Fuel Low Level Detector switches that were sold as spare units from April 19, 2004 through July 26, 2004 can "hang-up" in the high position and fail to indicate low fuel condition. This bulletin is issued to mandate the removal of the eight (8) affected units.

The serial number for the switch may be found on the outside face of the unit attachment flange. The switch is located on the aft fuel boost pump assembly. Refer to figure 1.

Serial Number of the affected switches is ink stamped, therefore may be partially or completely erased and difficult to read.

**NOTE**  
1 Part number and serial number are located in the cross hatched area.

1. Remove the affected switch and replace with a serviceable unit. (refer to applicable Maintenance Manual).
2. Annotate the aircraft records to indicate compliance with this bulletin.
